# OUR SHORE Coastal Erosion Assessments and Site Reports: Chebeague Island

Emma Polhemus, Shore Corps Steward, Maine Conservation Corps & Island Institute  
January 2026

## **OUR SHORE Coastal Erosion Assessments and Site Reports: Chebeague Island**

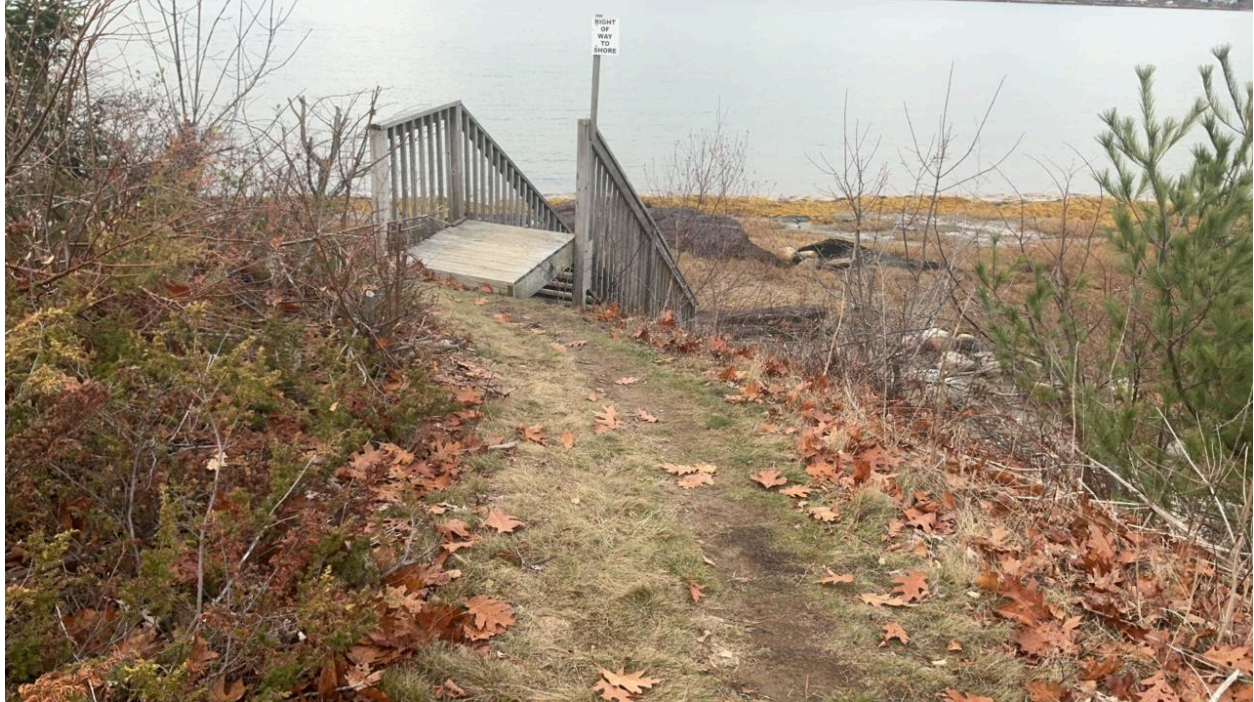
In 2020, MGS evaluated the bluff at the Division Point ROW as unstable, with a gently sloping to steep slope, some areas of exposed soil on the bluff face, and bent or tilting trees present (Fig. 7). The site is an area of concern for the town, since the access stairway is at risk as the underlying bluff recedes from erosion.

**Figure 1:** Photo of the Division Point ROW from the upper bluff edge.

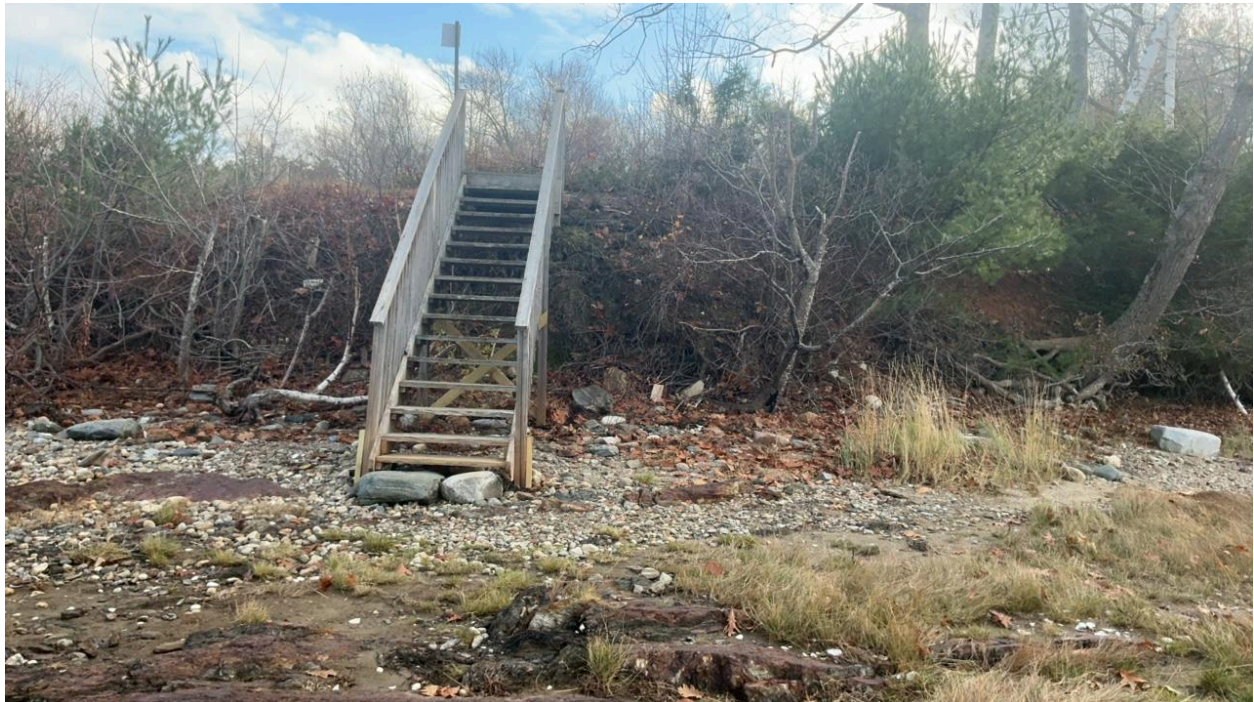
**Figure 2:** Photo of the Division Point ROW from the beach.

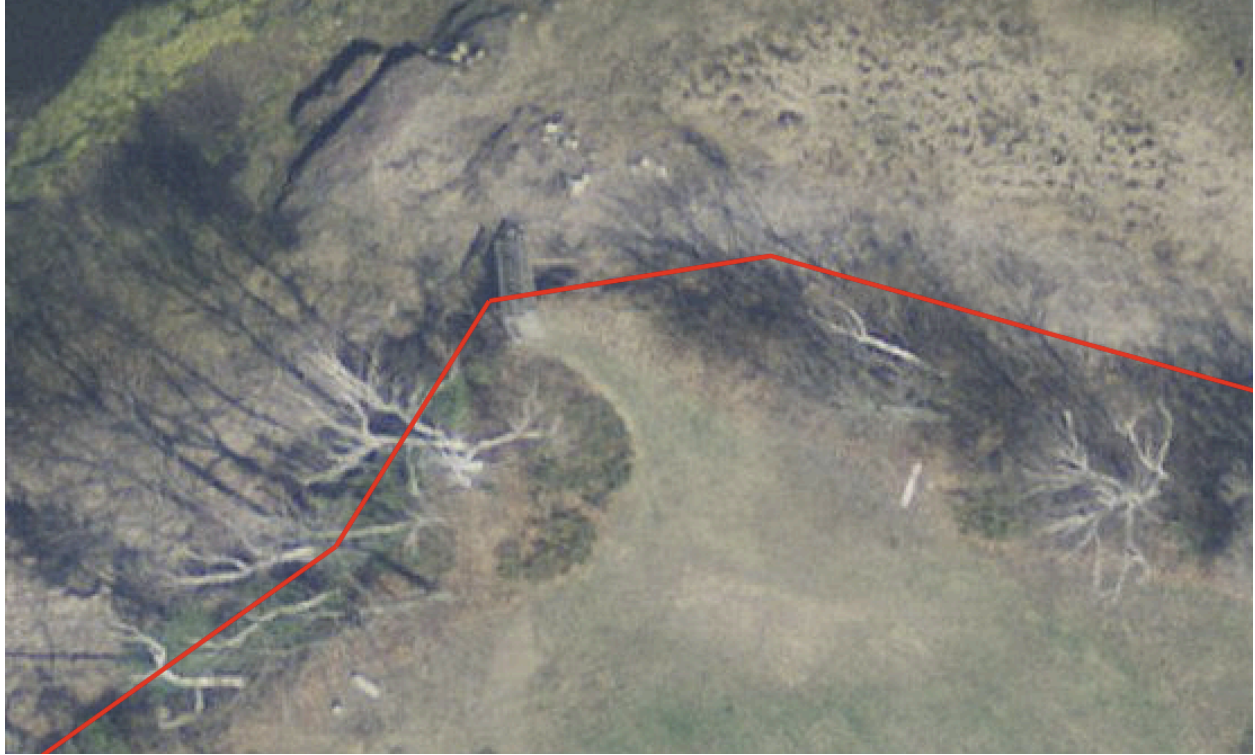
**Figure 3:** Maine Geological Survey map of the Division Point ROW and adjacent areas showing the highest astronomical tide elevation in red. The wooden stairs at the ROW are visible near the center of the image.

The impacts of sea level rise should be considered with any shoreline stabilization project, but especially in those at or near the current astronomical high tide like the Division Point ROW (Fig. 3). The Maine Climate Council has adopted a “Commit to Manage” sea level rise scenario of 1.5 feet by 2050 and 3.9 feet by 2100 (Maine Climate Council, 2020, p. 25). These conditions will expose areas higher up the bluff to more frequent inundation and wave action, which should be

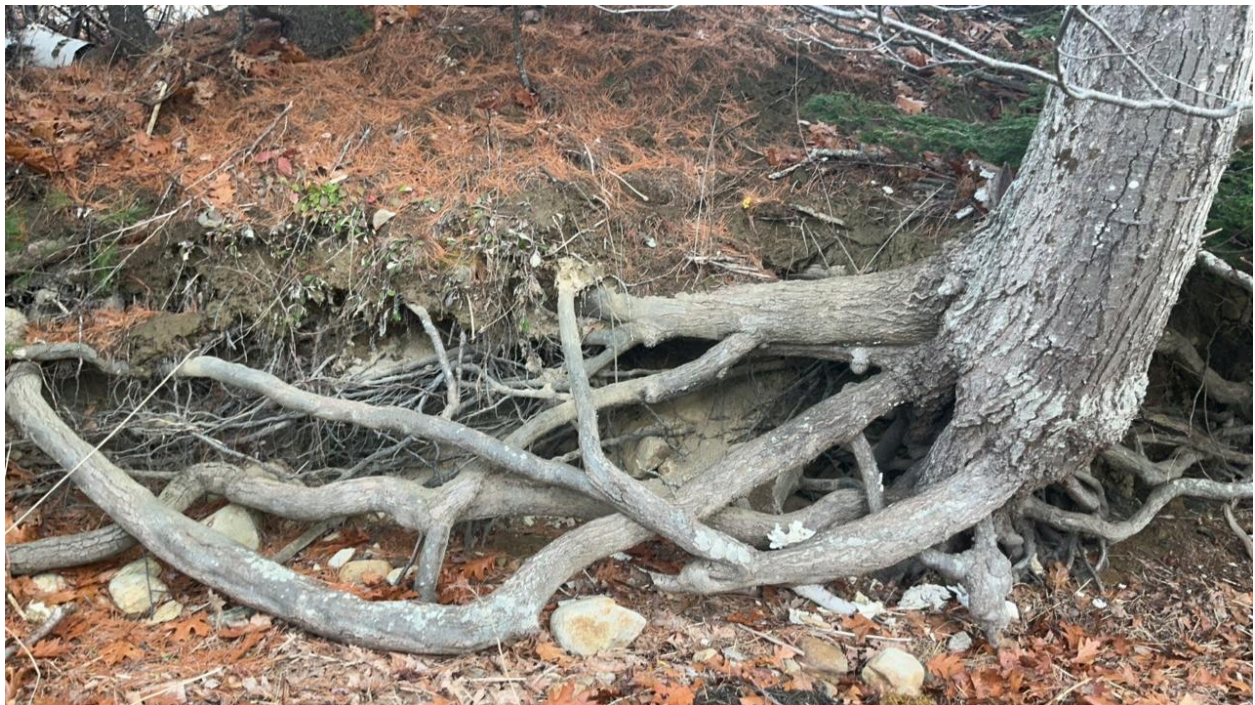
Leaning trees are common on eroding bluffs like the Division Point ROW. They may start to lean when the underlying soil is eroded, or when the tree and associated soil mass slide down the face of the bluff in a slope failure. This issue can be addressed in different ways depending on the severity of the leaning, the size of the tree, and whether the tree could fall on buildings or other structures.

**Figure 9:** An undercut and leaning tree at the Division Point ROW.

A tree that is more severely undercut, one that is positioned where it creates a hazard, or one that is likely to pull large soil masses from the bluff if it falls may need to be cut for safety and overall bank stability. Some species of trees, if cut in the dormant season, will sprout new growth from the stump and maintain a living plant and root system. This practice is referred to as coppicing or pollarding, depending on the height of the cut. If the tree cannot be coppiced, leaving the root wad in place to minimize soil disturbance and retain the supportive structure of the roots is highly recommended. The town Code Enforcement Officer or a licensed arborist can assist with the determination of hazard trees.

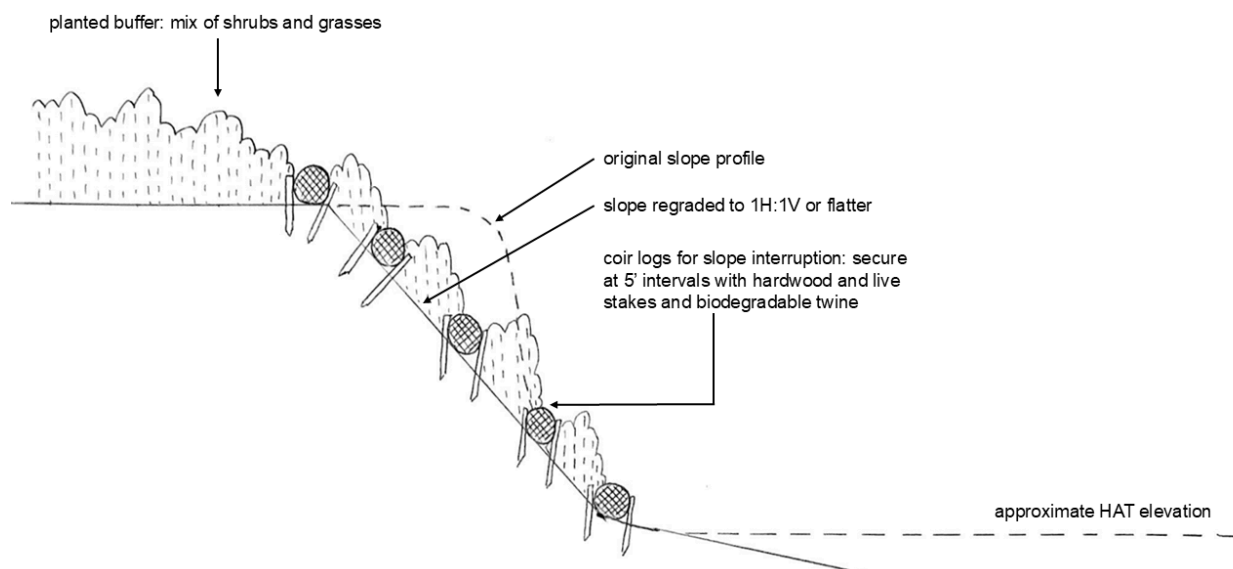
**Figure 10:** Cross-sectional diagrams of an erosion management alternative for the Division Point ROW combining slope regrading, coir logs for slope interruption, and a vegetated buffer.

Gradual slopes have a lower risk of slope failure and more effectively diffuse wave energy. For oversteepened slopes like the bluff at Division Point, creating a more gradual slope by cutting away soil at the top of the bank can provide a more stable foundation for green or gray stabilization techniques. The Division Point ROW is a good candidate for regrading because there are no large structures near the bank that would need to be moved. The wooden stairs would need to be relocated or replaced during the regrading process.

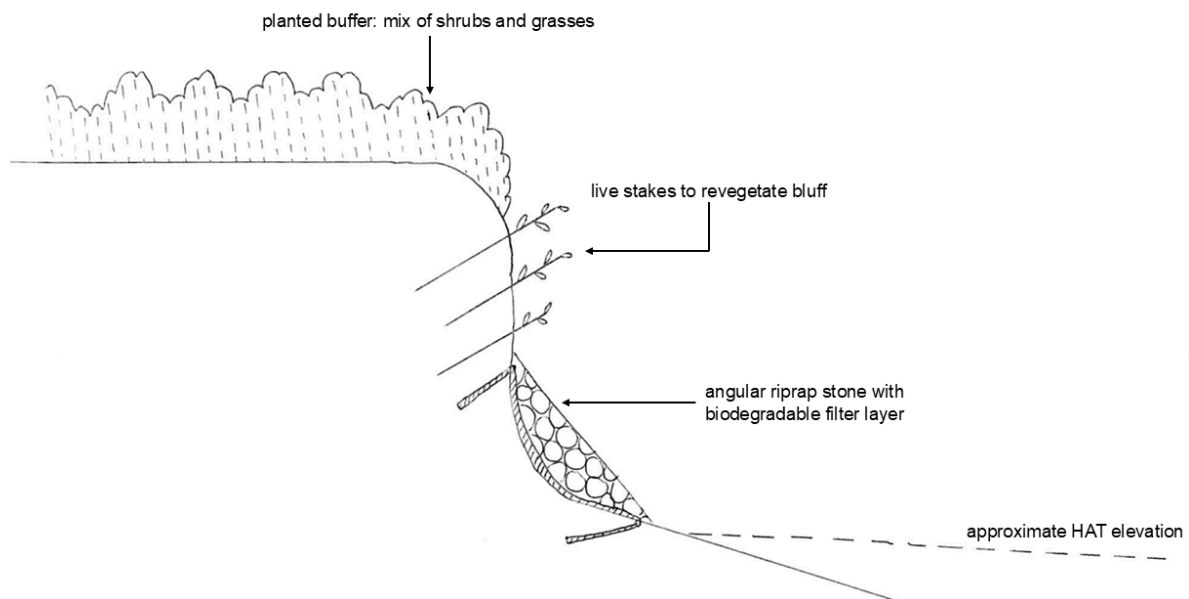
**Figure 10:** Cross-sectional diagrams of an erosion management alternative for the Division Point ROW using a riprap stone toe with planted vegetation on the upper bluff face and upland areas of the ROW.

As with many eroding coastal bluffs, erosion at the toe or base of the Division Point bluff appears to be a significant factor in erosion of the bluff as a whole. Often, erosion occurs fastest at the toe of a bluff, creating undercut areas of the bank which slide or collapse as support is lost. The bent and leaning trees at Division Point ROW are an indicator of bank failure from toe erosion. Because the bluff is located at the highest astronomical tide line and is impacted by regular wave action, toe protection using riprap stone will likely provide the most effective protection. A riprap toe can be installed with or without major slope regrading.

Opting for targeted toe stabilization instead of placing riprap across the entire bank is recommended by OUR SHORE to minimize soil disturbance and negative impacts on shoreline habitat. Adding vegetation to the riprap design will increase resilience and longevity of the riprap and reduce the unwanted consequences of hardened structures like scouring and end-effect erosion. Vegetating riprap begins with choosing an appropriate filter layer beneath the stones. Traditional riprap designs often use plastic geotextile fabric which inhibits root growth. Replacing synthetic filter layers with graded gravel and small stones or a natural fabric like coconut coir can provide the same filter role in a design while allowing plant growth. After riprap installation, vegetation can be added by filling voids in the stone with soil, mulch, and seeds, or by installing live stakes through the stone.

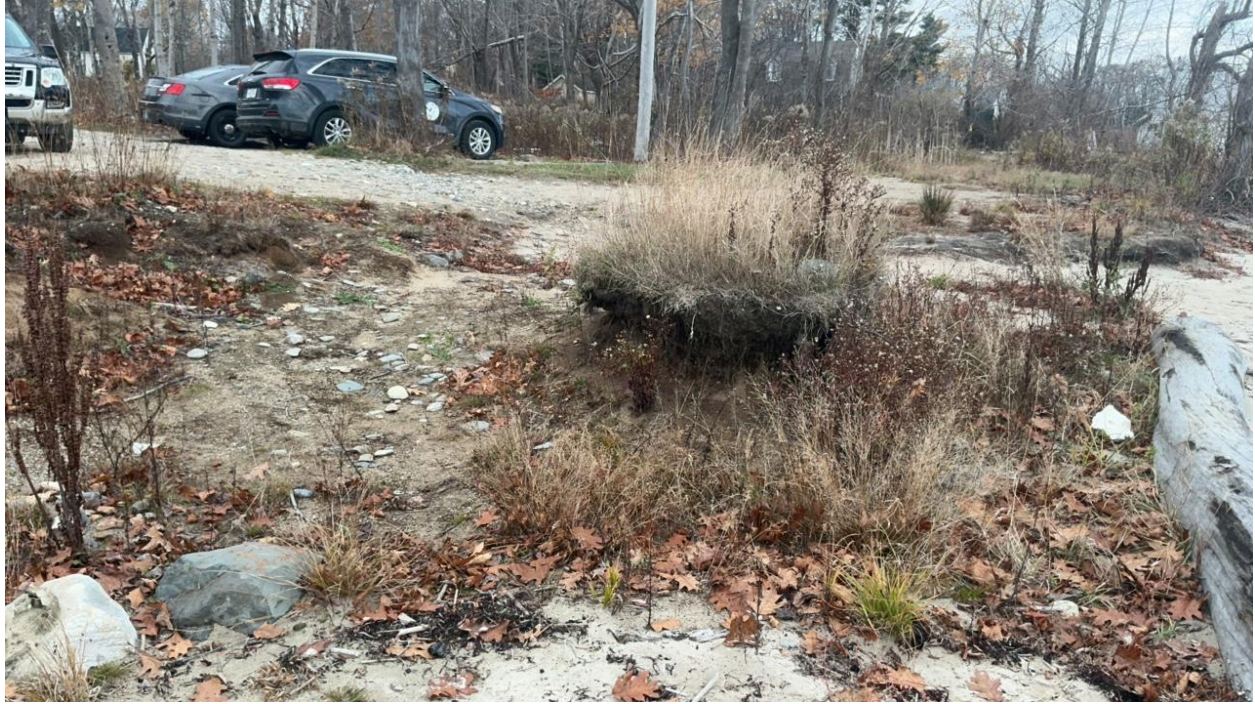
During the winter storms in January 2024, the bank of Hamilton Beach ROW eroded an estimated 10 ft landward. Figure 1 shows the extent of this erosion: the raised, vegetated area was part of the continuous bank prior to these winter storms. Erosion from 2024 winter storms and long-term erosion has led to loss of parts of the parking area and a grassy buffer between the parking area and beach.

**Figure 1:** Photo of the Hamilton Beach ROW facing north. The clump of soil and grass visible in the center of the image indicates the edge of the soil and vegetation layer in this area of the ROW prior to January 2024.

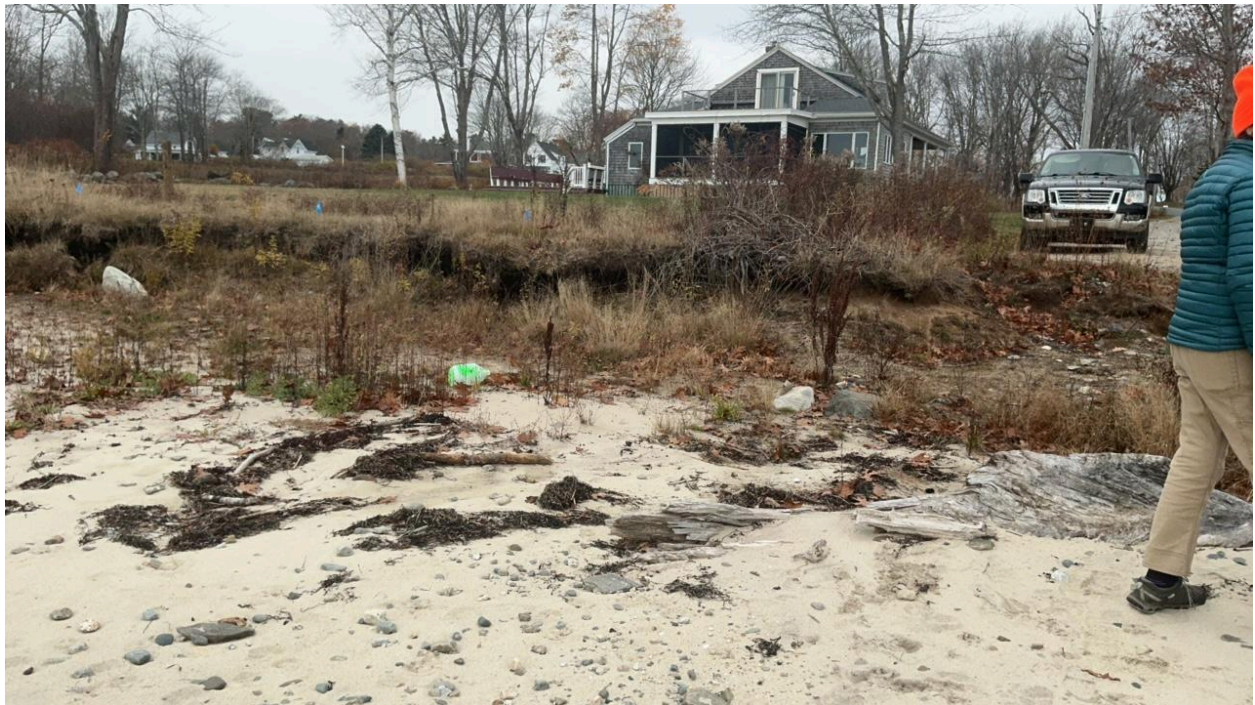
**Figure 2:** Photo of the Hamilton Beach ROW facing inland.

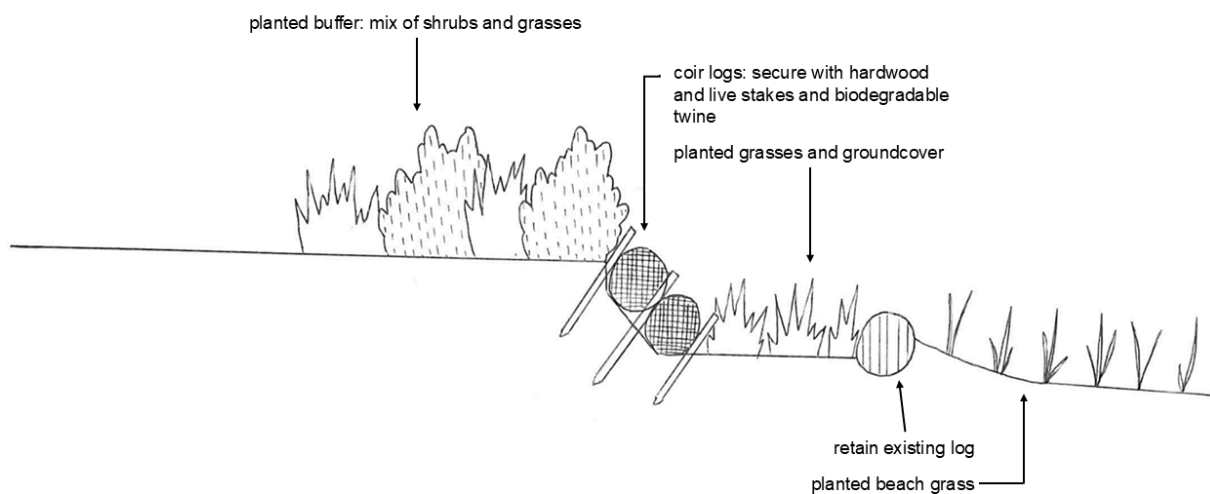
**Figure 7:** Cross-sectional diagram of recommended erosion management techniques at the Hamilton Beach ROW including coir log installation and replanting vegetation.

This method uses biodegradable materials, often coconut coir logs, to protect and stabilize the base, or toe, of the eroding slope. The coir logs are staked and anchored in place against the eroding toe. Native plants are introduced using various methods, so as the coir logs biodegrade over a period of 8-10 years, mature vegetation replaces the logs as the primary source of protection and stability. Revegetation of this area should focus on restoring a combination of native shrubs, grasses, and groundcover plants to create a strong network of root systems and aboveground plant material.

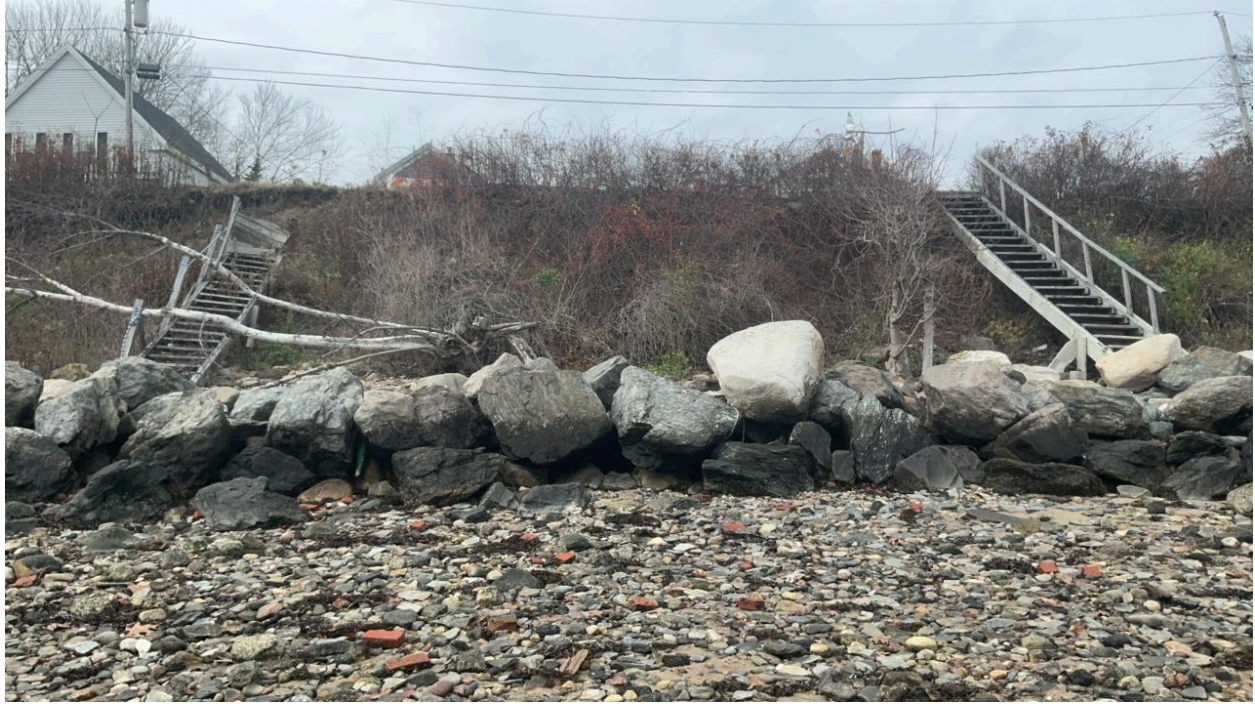
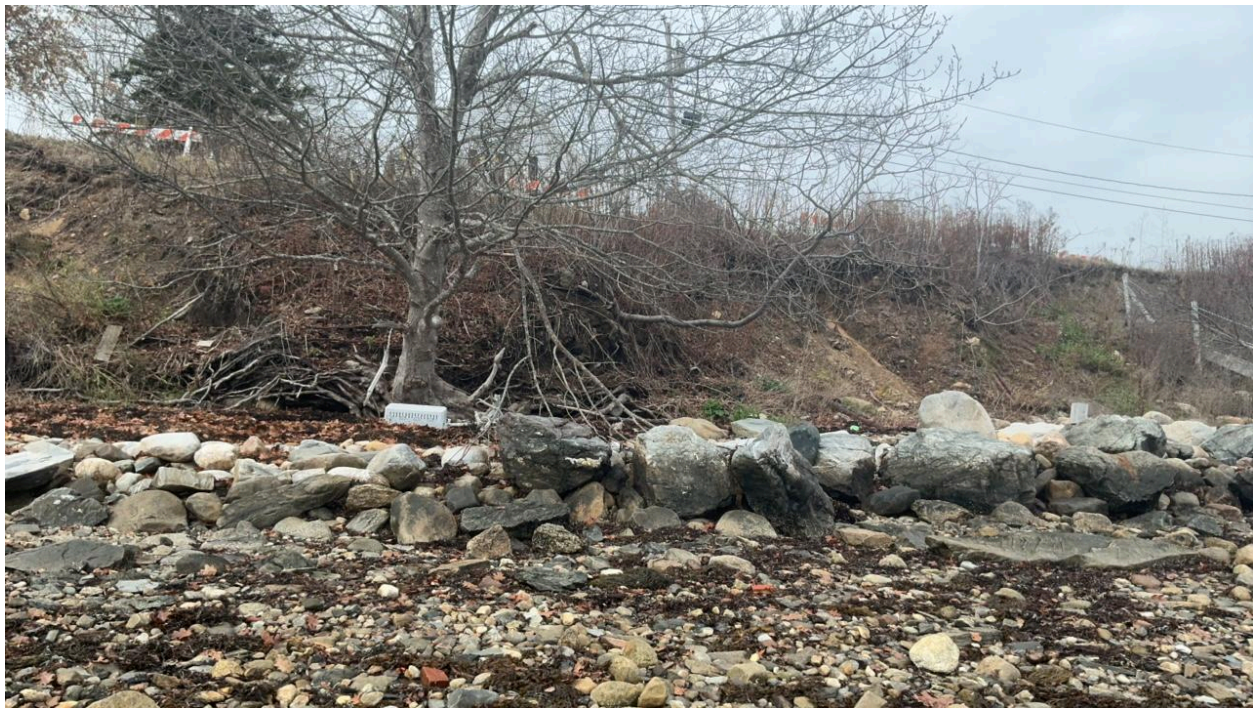
The bluff at South Shore Drive was damaged during the winter storms of 2024, exacerbating existing bluff erosion. The bluff slope has areas of bare soil, there are leaning trees indicating slope failure, and the bluff edge has receded closer to the existing road. This infrastructure risk led the Town to contract GEI Consultants, Inc. (GEI) to conduct a site assessment and provide conceptual design alternatives to stabilize the bluff. Two short-term alternatives were provided in the report: a toe stone riprap revetment with a vegetated upper bank, or a full slope riprap revetment. The goal of this report is to support the Town in selecting a stabilization option by providing information on how state OUR SHORE guidance may align with project design for South Shore Drive.

**Figures 3 & 4:** Photos showing sections of the bluff including access stairs, fallen and leaning trees, and rocks placed in a previous shoreline protection attempt.

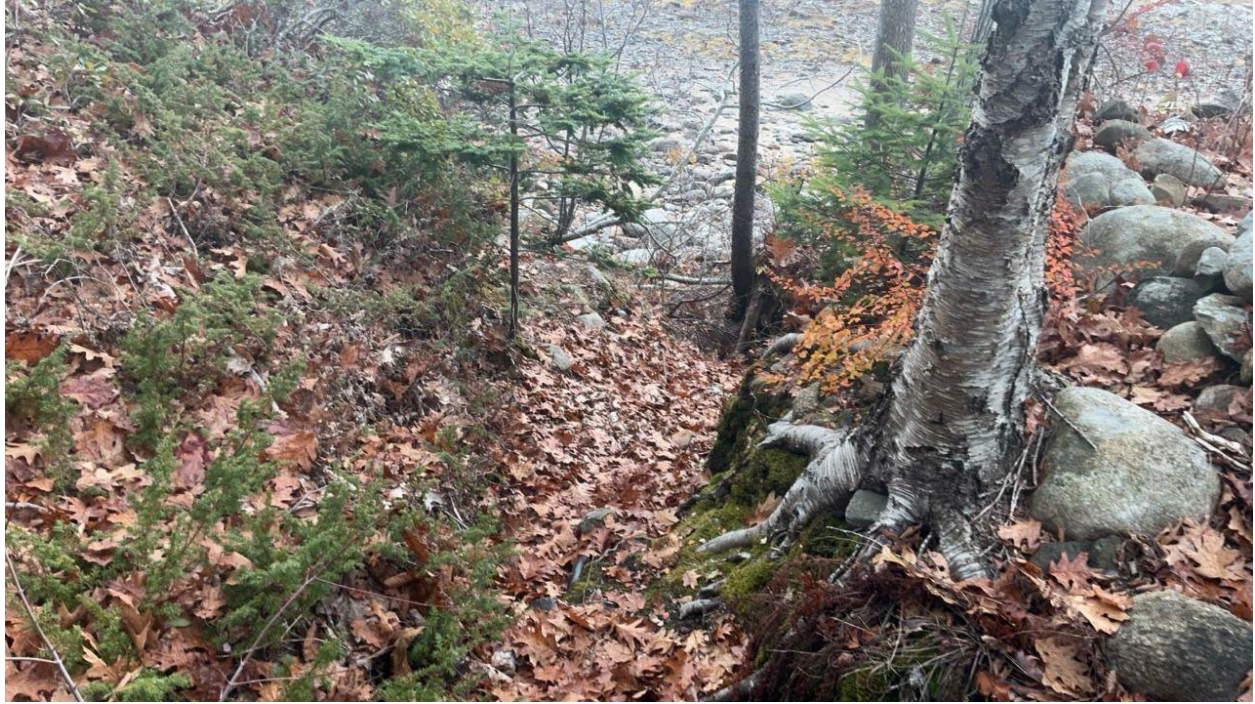
**Figure 1:** A gully on the property that contains an intermittent stream.

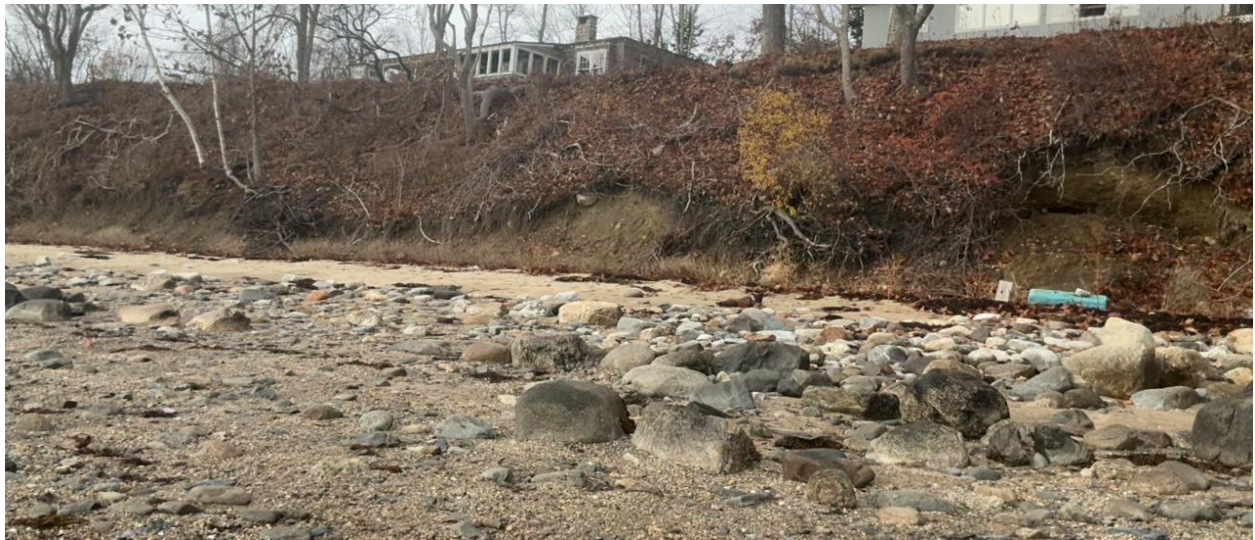
The coastal bluff system at the site was characterized as Unstable by the Maine Geological Survey in 2020. Signs of erosion observed at the site visit indicate that the bluff has likely progressed from Unstable to Highly Unstable. Some factors indicating a progression to Highly Unstable classification observed at the site were fallen trees on the bluff and displaced blocks of sediment from the bluff face (Fig. 3). The progressive instability at this site aligns with the coastal bluff erosion cycle, wherein increased toe erosion leads to slope failure which then restabilizes the bluff. However, severe storms including the winter storms in 2024 have exacerbated erosion at the site, and the property owner is concerned about bluff retreat encroaching on the house.

**Figure 2:** Partial view of the bluff face and intertidal zone. Bare soil on the lower bluff indicates eroding areas from wave action.

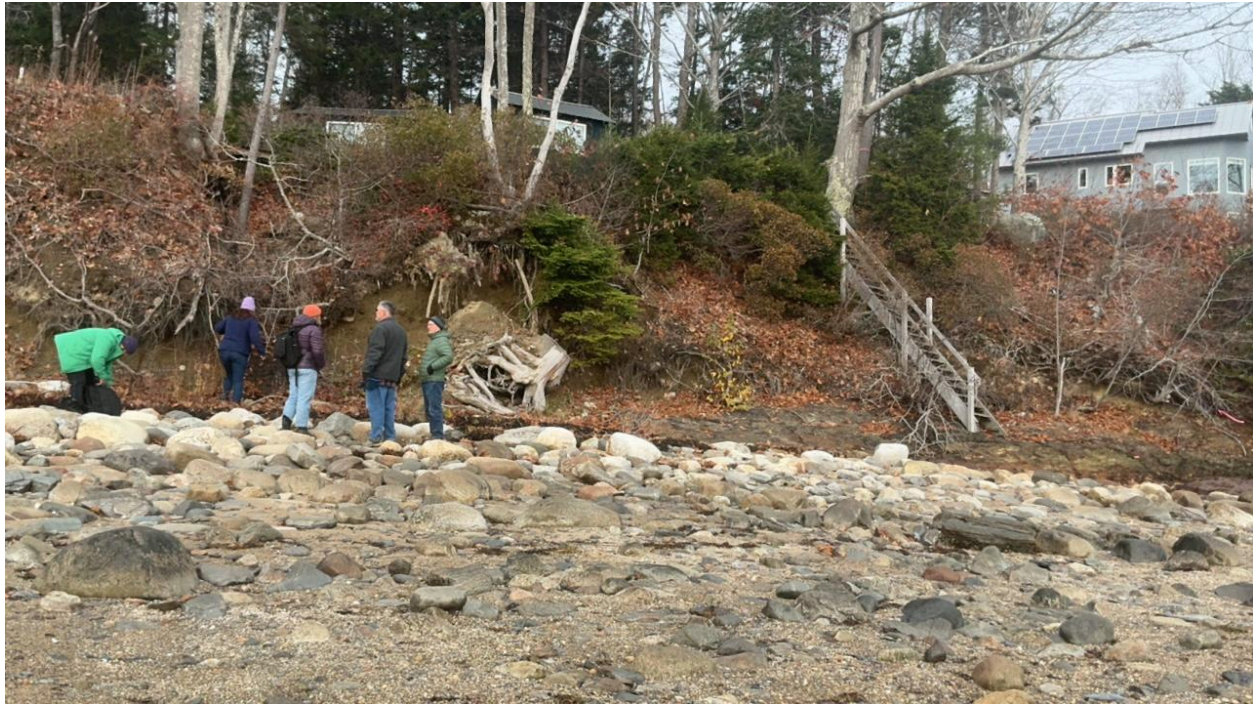
**Figure 3:** Partial view of the bluff face and intertidal zone. A tree stump that has fallen as a result of erosion and slope failure is visible near the center of the photo.

Trees can create increased erosion risks on steep or failing slopes, since they can pull large amounts of soil with the root wad. When trees on a slope get undercut by erosion or they are leaning severely, cutting the tree should be considered as an erosion management strategy. However, tree roots also provide stability to soil, and this protective capacity can be preserved by leaving trees that are not leaning in place, and retaining the root wad in place when trees have to be cut. A licensed arborist or the town Code Enforcement Officer can help you determine whether a tree is a hazard.

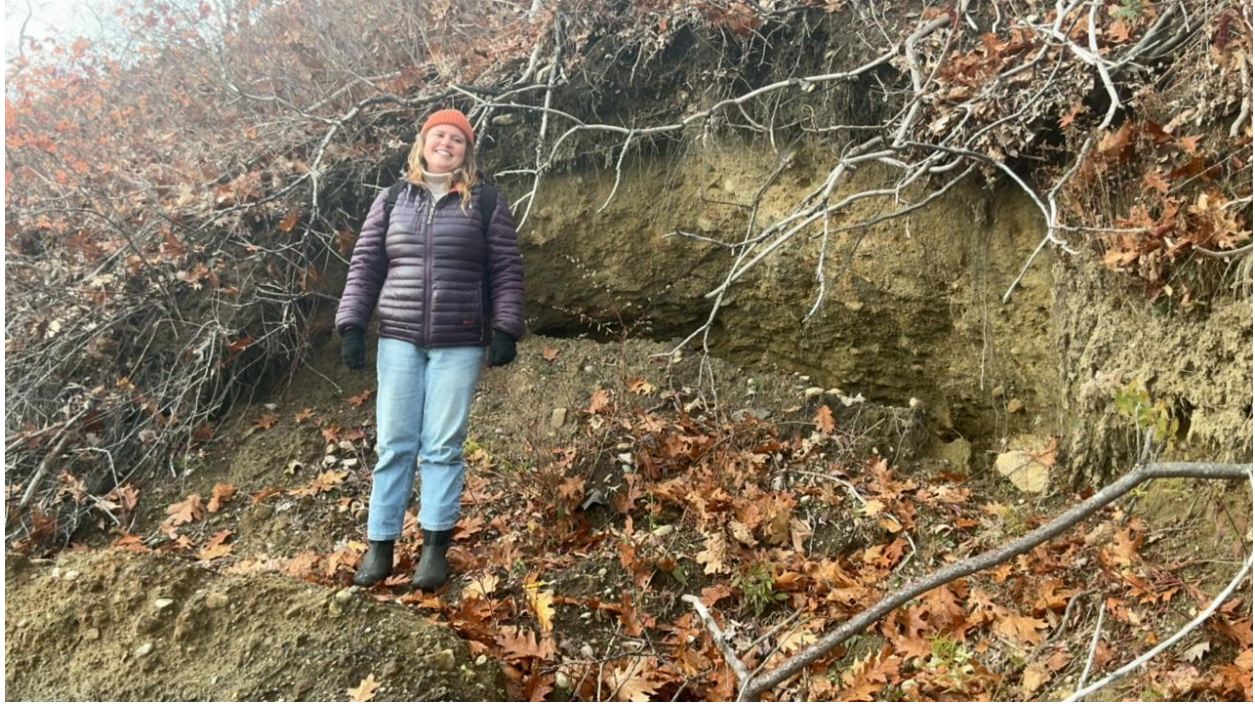
**Figure 7:** Large block of displaced soil at the base of the bluff.

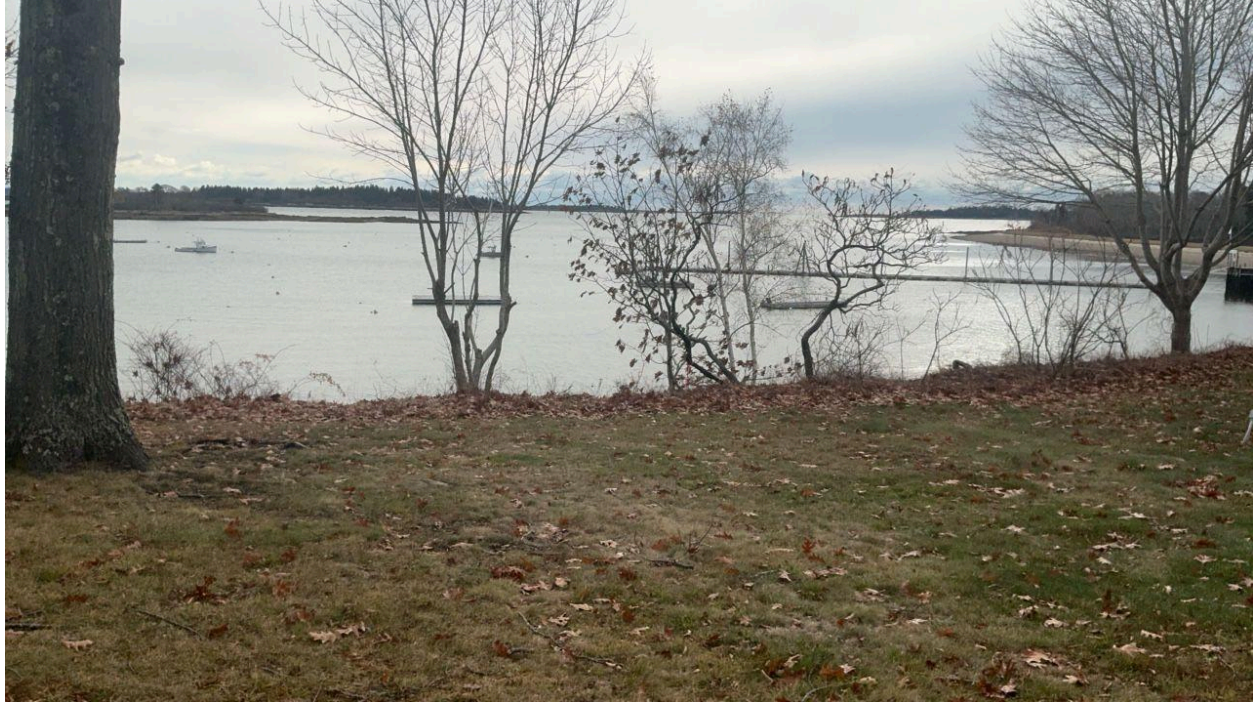
When bluff soils become oversaturated with groundwater, the bluff becomes weaker and more vulnerable to wave erosion and slumping. Soils that have layers of clay, as seen at this site, become saturated quickly since groundwater cannot infiltrate through these impermeable layers and becomes trapped in the bluff. The most straightforward method of mitigating groundwater saturation is by replacing turf grass with shrubs and native, deep-rooted herbaceous plants, which uptake more water from the soil. It is recommended that at least the first 10-15 feet of land from the upper bluff edge are vegetated for improved stability.

**Figure 8:** Grass lawn extending to the bluff edge. Planting denser, taller vegetation in this area will help reduce groundwater saturation and increase bluff stability.

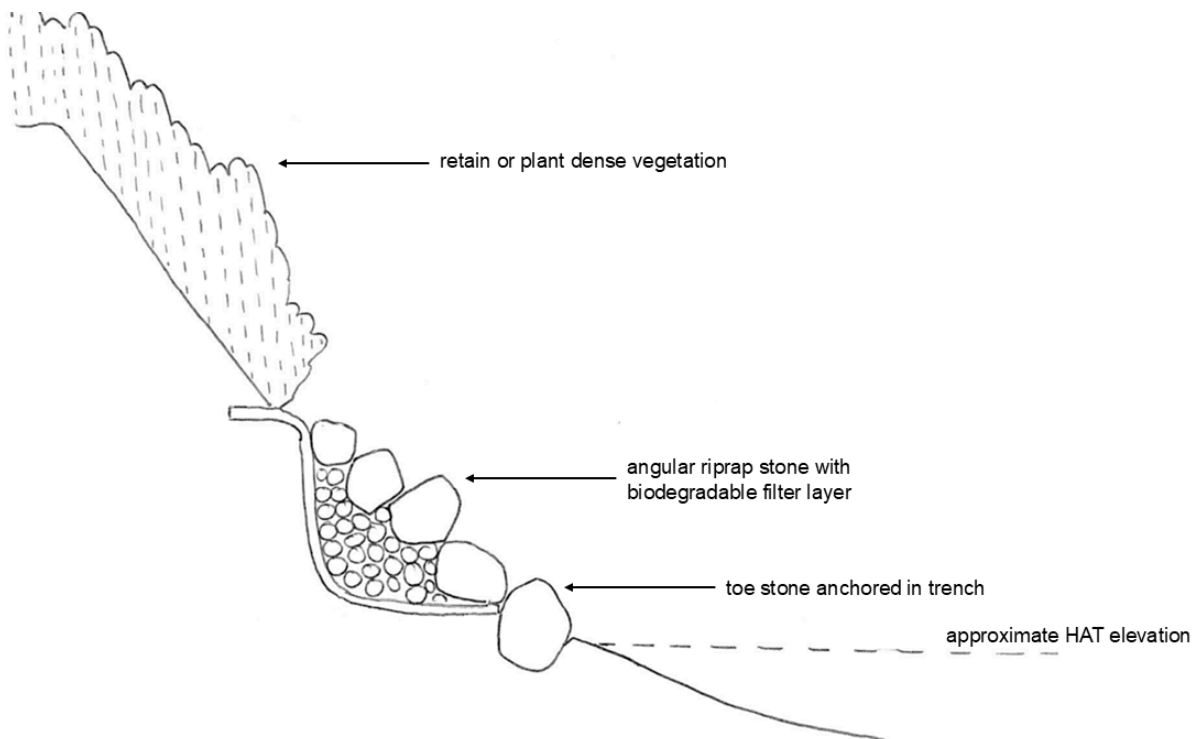
**Figure 9:** Diagram of recommended stabilization techniques utilizing a riprap stone toe with native vegetation on the upper bluff.

Based on the level of bluff instability and the proximity of the house to the eroding bluff edge at this site, a partial riprap revetment to support and protect the toe slope may be appropriate. Targeting riprap stabilization only in the most impacted areas of the bank minimizes the project cost and environmental impacts. At this site, erosion is most severe at the toe. The upper bluff has been indirectly impacted by slumping of unsupported sediment blocks, but intact vegetation on the upper bluff indicates that direct wave impacts are minimal above the toe. OUR SHORE guidelines recommend the use of a biodegradable filter fabric such as coconut coir rather than synthetic geotextile filter fabric to create the foundation behind riprap. A biodegradable fabric allows for revegetation of the riprap over time, increasing stability of the installation and restoring habitat.

Above the riprap toe, OUR SHORE guidelines recommend maintaining or restoring a densely vegetated slope with a mixture of shrubs, small trees, and herbaceous plants. Shrubs and small trees provide the benefits of strong, extensive root systems without the additional weight and erosion hazard that large trees may cause on steeper slopes. When viewing the bluff from the beach, the area to the left of the access stairs is thickly vegetated with small fir trees, bayberry shrubs, and other small woody plants. These plants appear to have survived through the severe winter storms in 2024 and continue to provide effective protection to the upper bluff face. This area will provide an effective reference for selecting vegetation well-suited to the environmental conditions of the site. Replicating the density and composition of this reference area across the bluff will increase soil protection and resilience. Additional recommendations for resilient, salt-tolerant native plants suitable for coastal shoreline stabilization can be found in the attached planting guides.

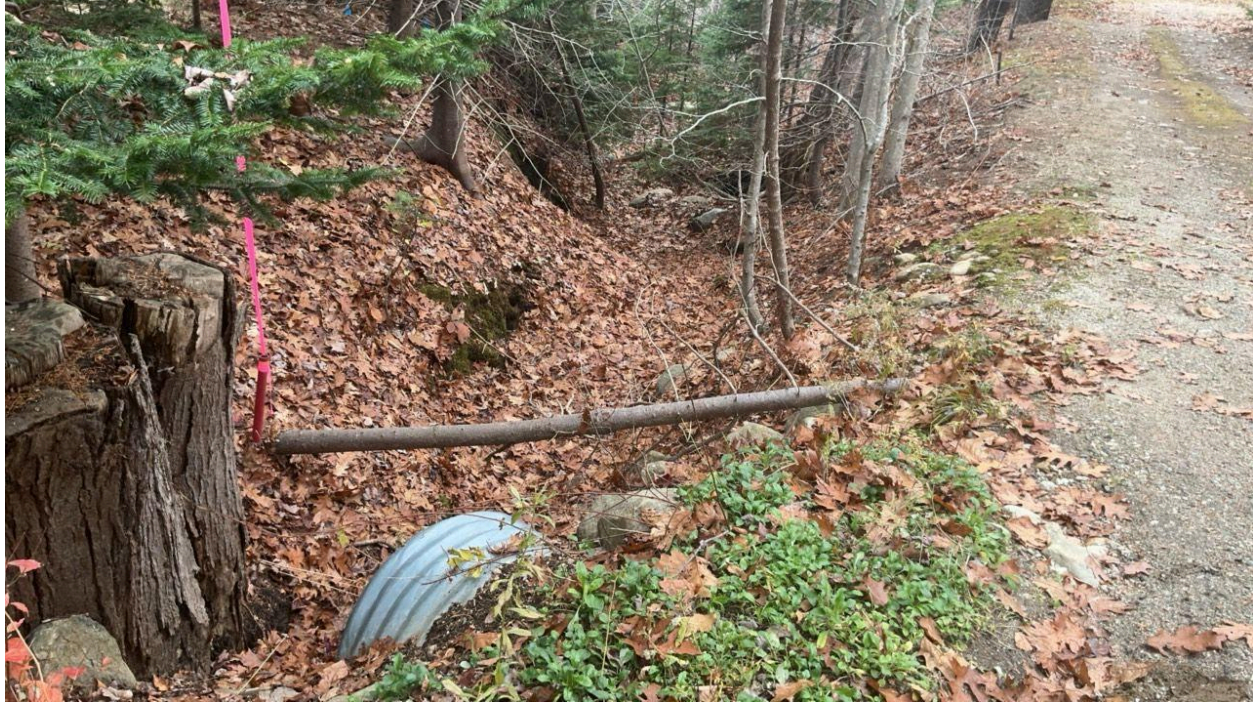
**Figure 1:** The culvert and seasonal stream located at the north edge of the property.

The drainage ditch that borders this site to the north appears to be contributing to bluff instability and erosion impacts. Further assessment of the drainage system would be needed to

fully address the erosion occurring as a result of the stream. However, there are general recommendations for managing erosion in and around streams that could be applied to the site. The culvert at the top of the property appears undersized, which increases the velocity and erosive capacity of the stream during heavy rain events. The Maine Audubon StreamSmart program recommends sizing culverts at 1.2 times the natural width of the stream for unrestricted flow. Stream channel modifications to increase fallen logs and other coarse woody debris or minor streambed regrading to create pooling areas are common techniques for slowing the flow of a stream to mitigate erosion.

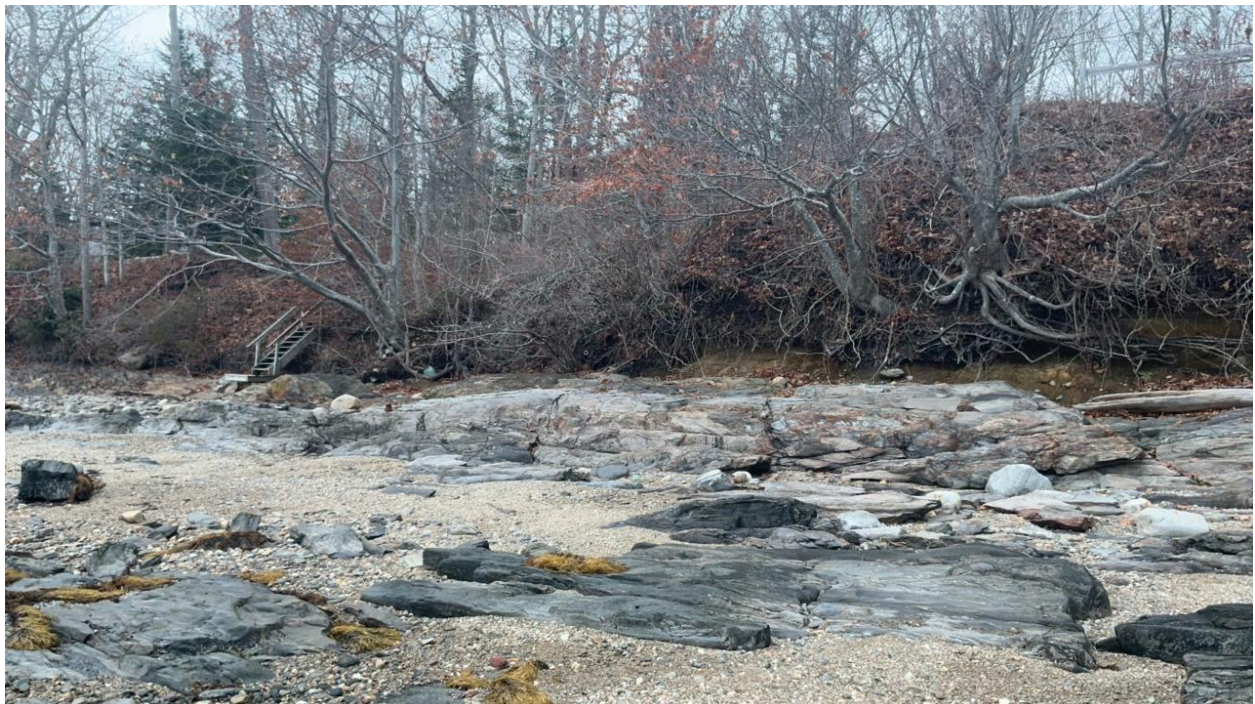
**Figure 2:** Partial view of the bluff and beach at the site photographed from the low water line.

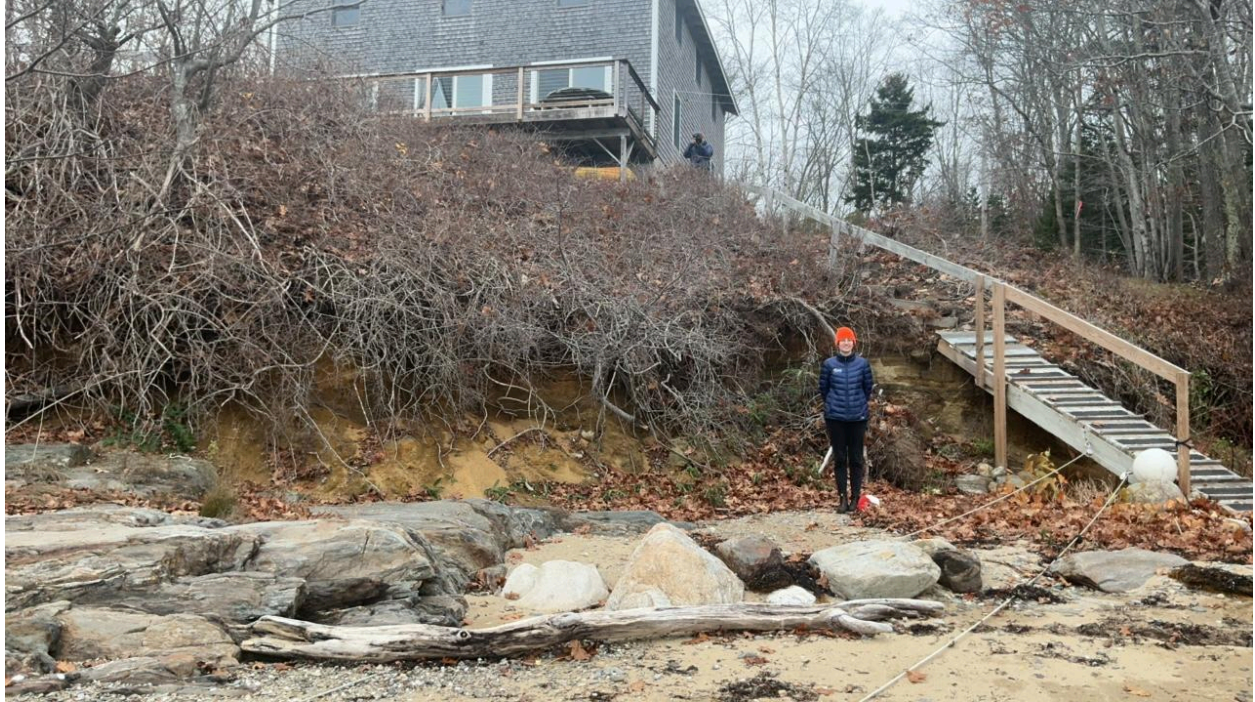
The coastal bluff at this property was mapped as stable in the northern section and unstable in the southern section in 2020 (Fig. 6). The bluff has been eroded and damaged during storms in the last several years, leaving signs of instability such as leaning trees, exposed sediment, and blocks of displaced sediment at the bluff base (Fig. 3). Erosion of the bluff is more severe near the drainage ditch on the north boundary of the property. The property owner at the site has hired a coastal protection contractor to install bank protection, and site plans are in development. The goal of this report is to provide options for hybrid green-gray stabilization options and overland water management strategies that can be integrated into the site design.

**Figure 3:** Partial view of the bluff and beach. Exposed soil and displaced soil blocks are visible.

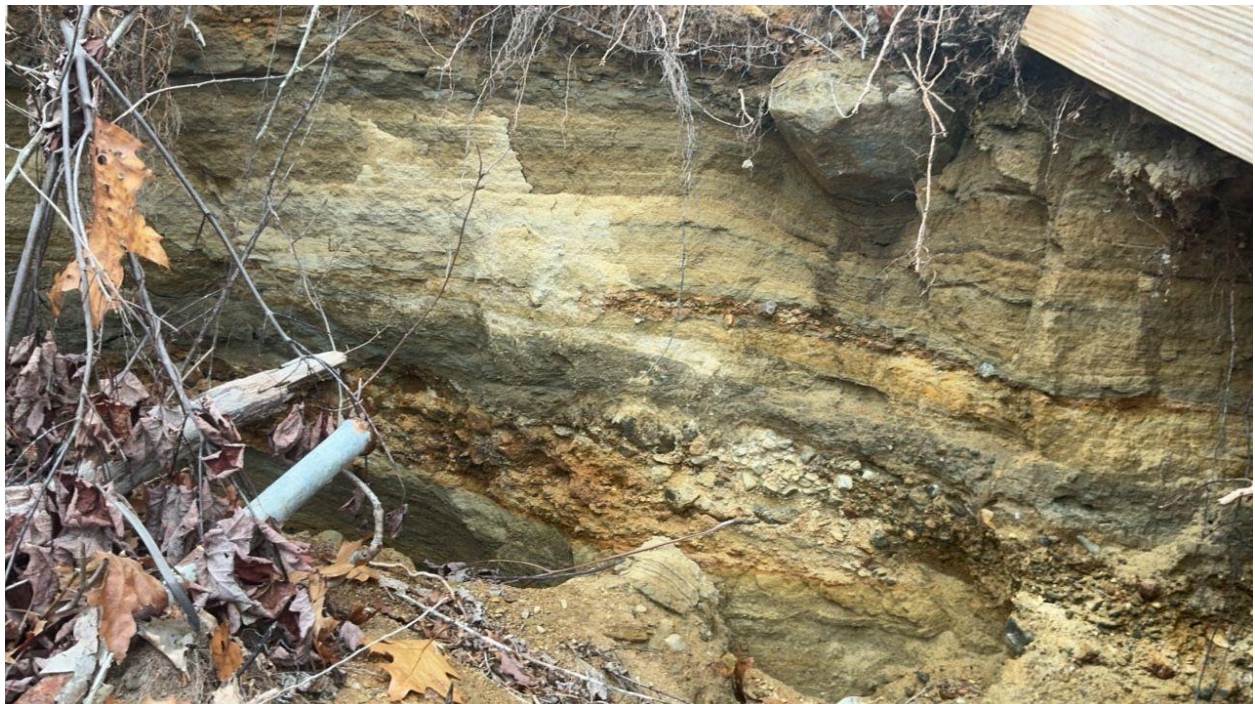
**Figure 4:** Close-up photo of the bluff sediment taken near the access stairs. Layers of sandy and clay soils are visible.

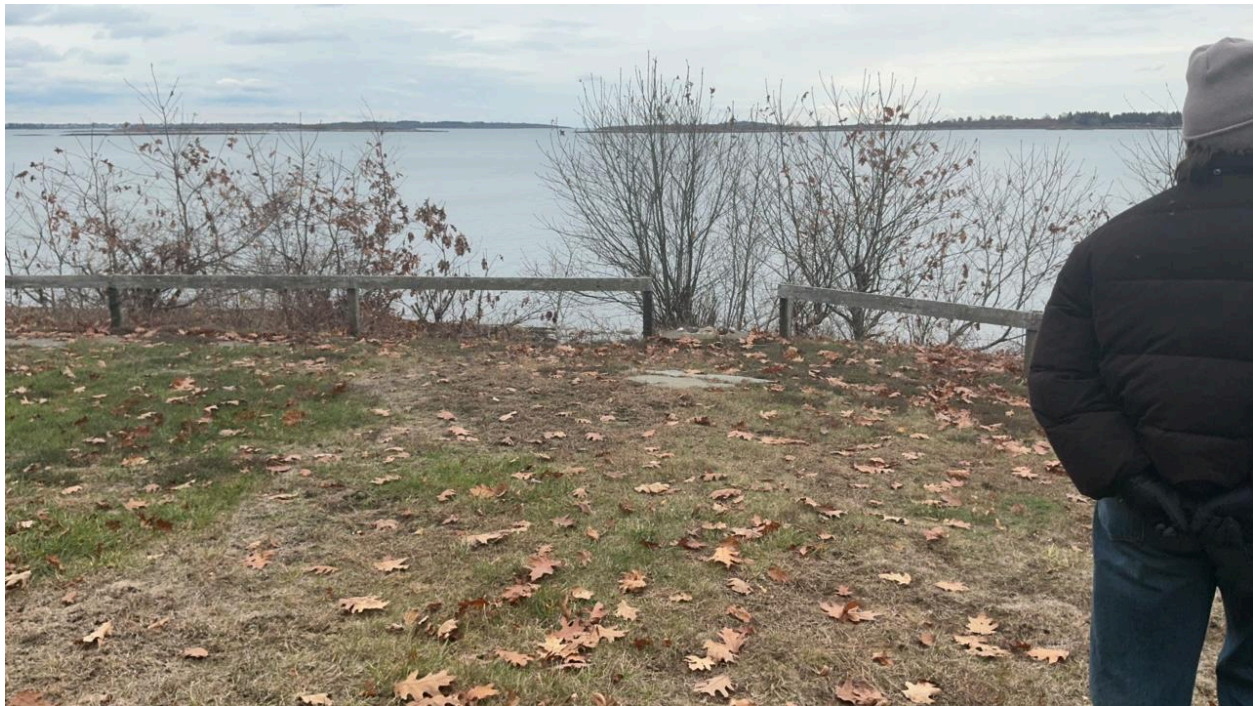
**Figure 7:** Lawn area on the property extends to the bluff edge. Adding shrubs and deep-rooted herbaceous plants to this area will increase groundwater uptake and bank stability.

**Groundwater Mitigation:** Woody plants and other deep-rooted vegetation take up water from the soil, mitigating groundwater saturation. Replacing some of the grass lawn near the bluff edge with larger, deeper-rooted plants will improve water uptake and overall bank stability. The recommended width for planted buffers is at least 10-15 feet wide where space allows. If view obstruction is a concern, there are many native woody shrubs like creeping juniper and sweet-fern that grow low to the ground but still have well-developed root systems.
