# OUR SHORE Coastal Erosion Assessments and Site Reports: Cliff Island

Emma Polhemus, Shore Corps Steward, Maine Conservation Corps & Island Institute  
May 2026

## **OUR SHORE Coastal Erosion Assessments and Site Reports: Cliff Island**

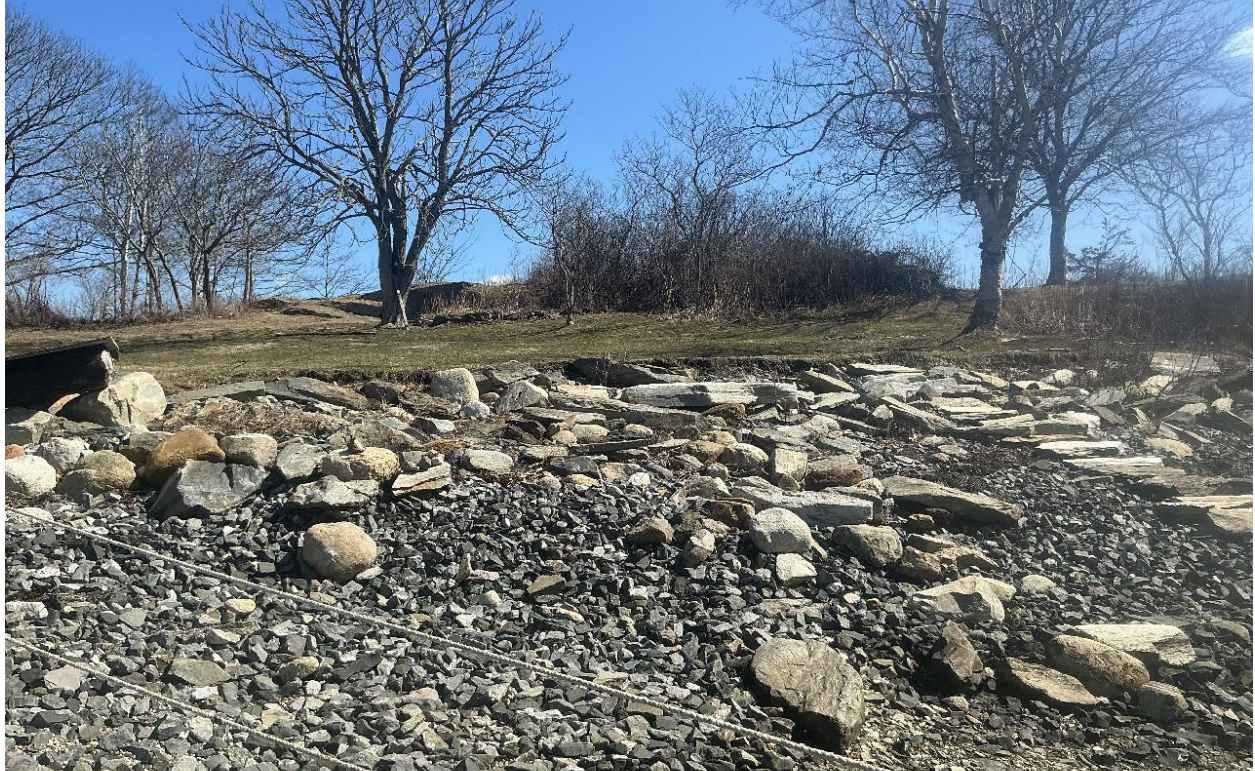
The toe of the bank shows signs of erosion just above the high tide line. Stones have been placed along the bank to control erosion, but the edge of the bank has continued to recede.

**Figure 2:** Photograph of the beach and lawn area of Griffin's Cove. Larger stones placed for erosion control are visible along the upper beach edge.

Living shoreline and nature-based techniques will likely be highly successful at Griffin's Cove based environmental conditions at the site. The addition of deeply-rooted native plants along the upper edge of the beach will help stabilize the bank and hold soil in place, supplementing the current stone protection. If suitable growing conditions are present and vegetation spreads into the riprap area of the upper beach, this will also help hold the riprap stones in place and enhance overall shoreline resilience. A vegetated buffer width of 10-15' is recommended at minimum to provide shoreline stability. This buffer should be made up of a variety of densely planted native plants including both woody plants like shrubs or trees and herbaceous plants like grasses, flowers, and groundcover plants.

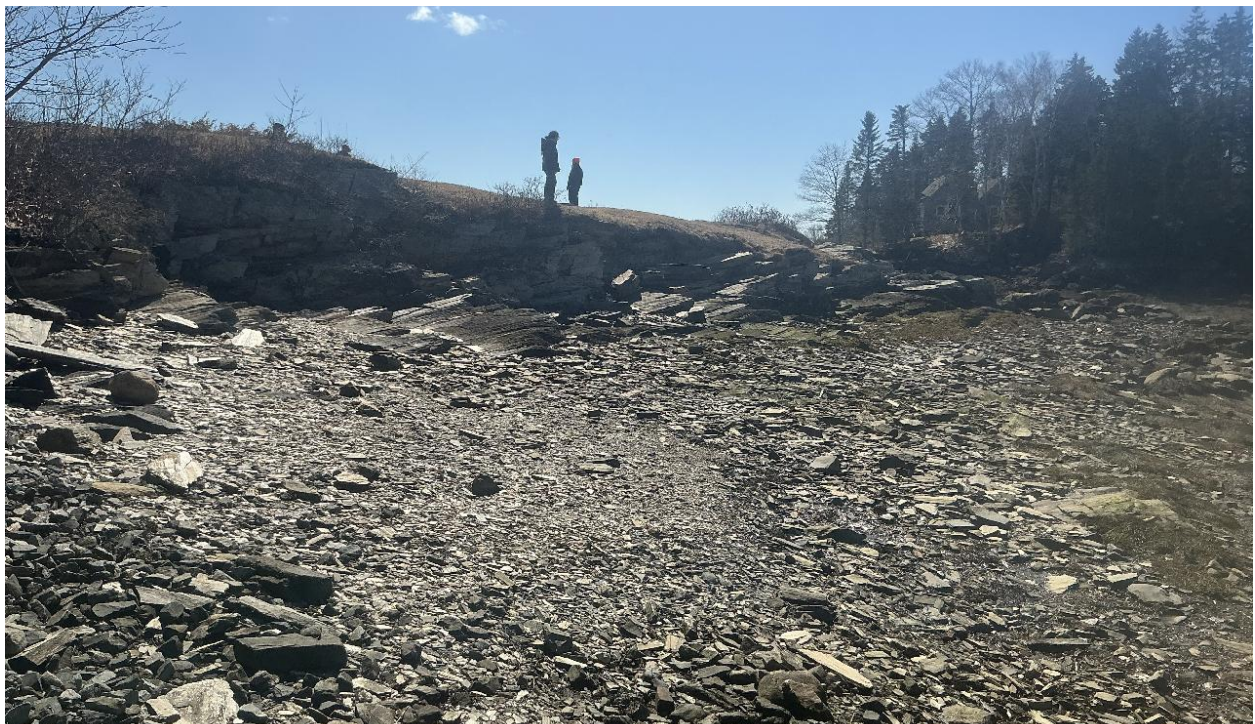
**Figure 3:** Photograph of Griffin's Cove facing east.

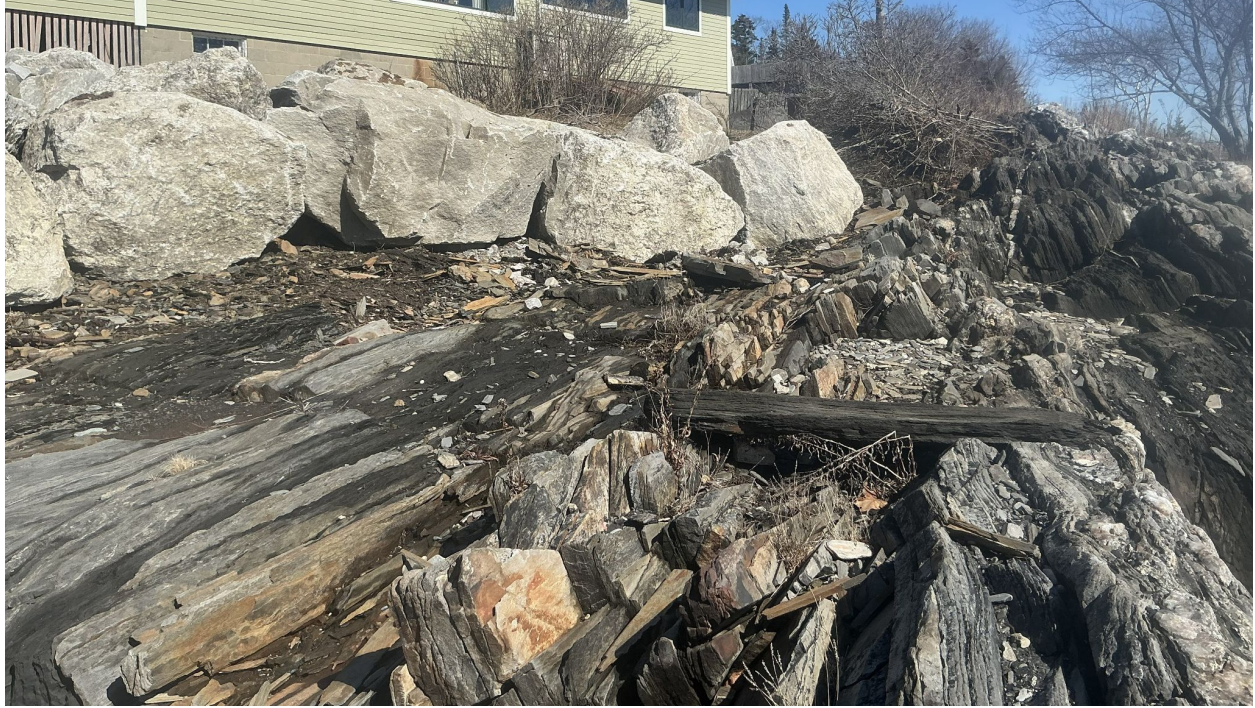
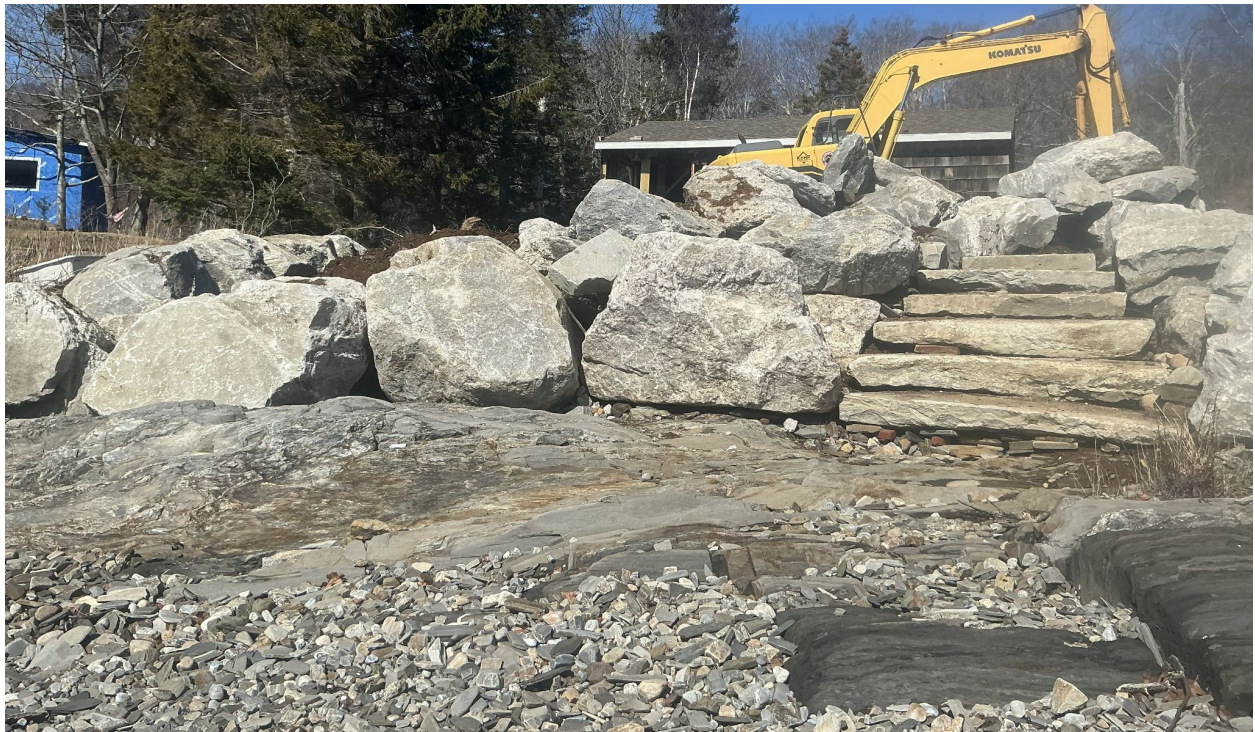
Both properties have installed or are in the process of installing structural stabilization to prevent shoreline erosion. One property is using gabions, wire mesh baskets filled with stones and anchored to the shoreline. The other property is installing large stone riprap. This report provides recommendations on integrating OUR SHORE principles into these stabilization designs to increase resilience and longevity of the structures, minimize end-effect erosion on neighboring properties, and improve coastal habitat quality.

**Figures 1 & 2:** Photographs of one of two private properties including the stones being installed for shoreline stabilization.

Vegetation can easily be added to existing riprap through a planting technique called live staking. Live stakes are cuttings of certain shrubs that will re-root and grow when pushed into the soil. Live stakes can be planted directly into the soil between the large riprap stones. If a plastic geotextile fabric was installed underneath the riprap, a piece of rebar can be used to create a pilot hole for the live stake to be planted into.

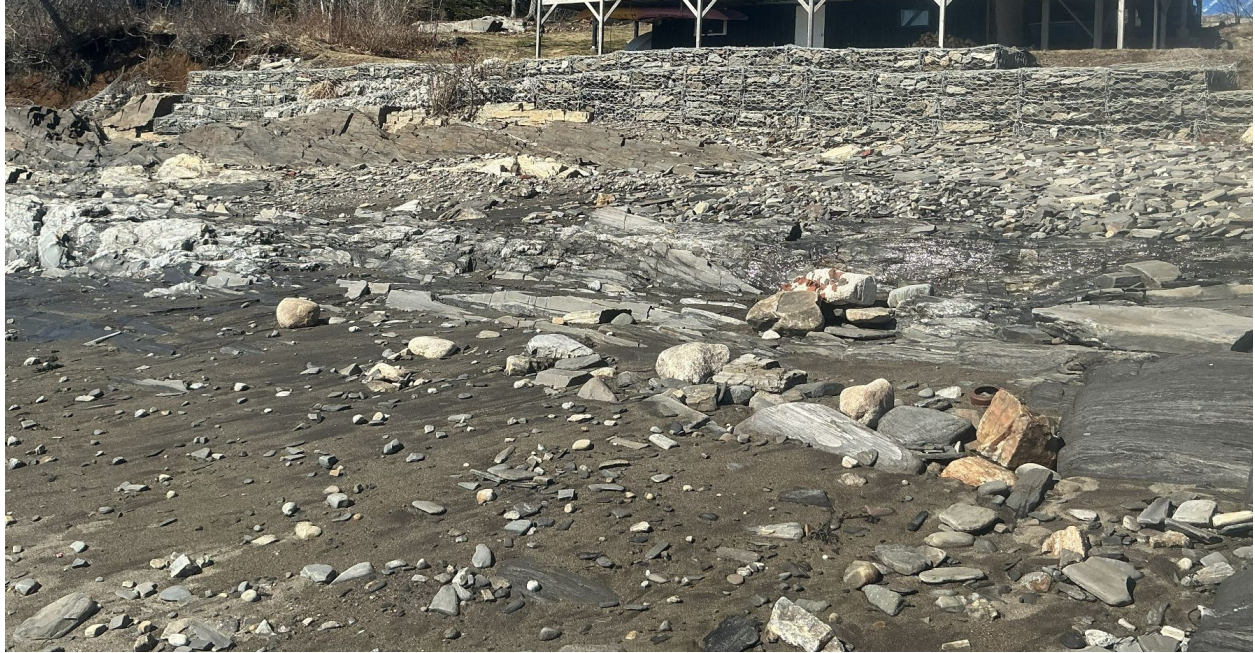
**Figure 3:** Photograph of the second property including gabions installed for shoreline stabilization.

Retrofitting gabions that are already installed is more difficult, but if additional gabions are installed they can be vegetated with a similar live staking method. As the gabions are placed and filled, live stakes are planted horizontally into the soil as layers between the stones. Live stakes can also be layered between subsequent layers of gabions, as long as they have enough soil contact to form root systems. Soil and seed mixes wrapped in biodegradable fabrics such as coconut coir can also be layered into gabions during construction to provide a growing media and encourage revegetation.

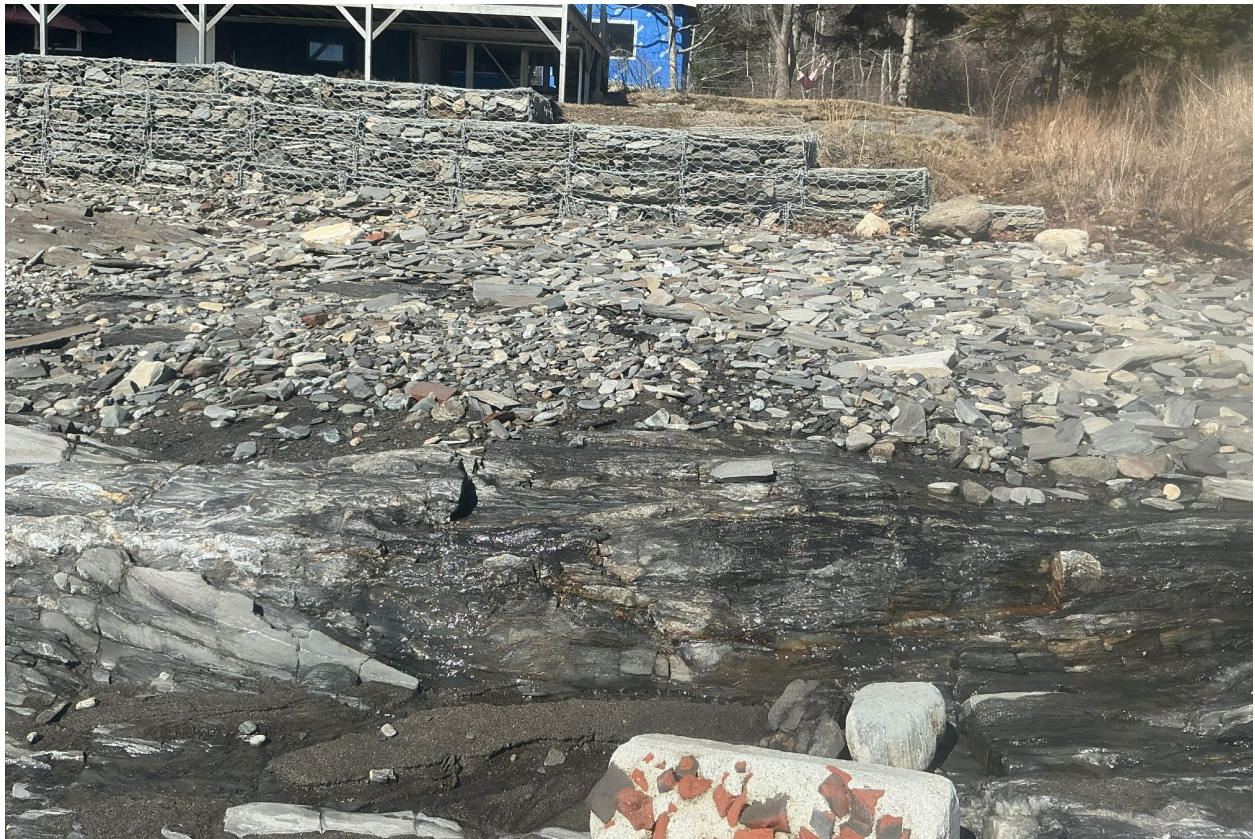
A drainage ditch passes between the two properties, fed by a culvert passing under Church Rd. A small freshwater wetland is located inland of the house on one of the properties. A groundwater seep was noted exiting the bank just above the bedrock layer.

**Figure 4:** Photograph of the groundwater seep observed on the shoreline.

| <b>Groundwater</b> | Moderate - Evidence of limited or seasonal groundwater seepage or impacts to slope |

When structural stabilization like gabions or riprap is installed on a shoreline, creating a vegetated buffer inland of the structure is still important to improve the structure's long-term durability and manage groundwater and surface runoff contributions to erosion. Shoreline armoring techniques do not address upland water contributions to erosion, and continued groundwater and surface runoff interactions can pull soil out from under a structure and lead to increased maintenance needs. Maintaining a healthy buffer of native vegetation helps reduce groundwater saturation and slow the movement of surface water. The root systems of a vegetated buffer also help to lock soil in place behind the structure for additional stabilization.

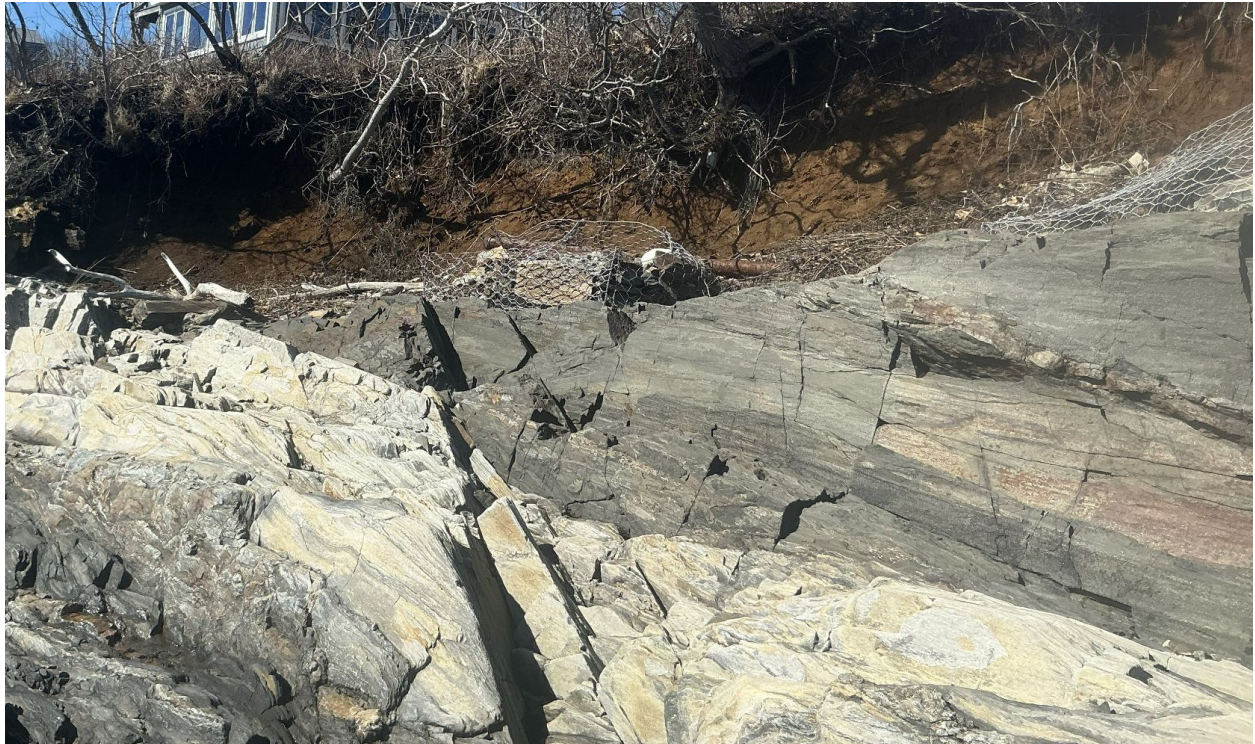
The shoreline of the site is primarily a rocky cliff with small, flat areas of gravel and sand. Above the highest astronomical tide line, the ledge transitions to soil and lawn areas. Across most of the shoreline, the soil bank is gently sloped and no more than three feet tall, but a small section to the southwest has a deeper soil layer that has eroded to form a steep bank 5-6 ft tall.

**Figure 5:** Erosion has formed a steep slope with bare soil on this section of shoreline.

A minimum buffer width of 10-15 ft from the edge of the riprap or gabion inward is recommended when possible. An effective vegetated buffer will include a diverse mix of native shrubs and herbaceous plants like ornamental grasses and groundcovers. Lawn grass is not considered a buffer, as it has shallow roots that cannot take up water or stabilize soil as effectively.

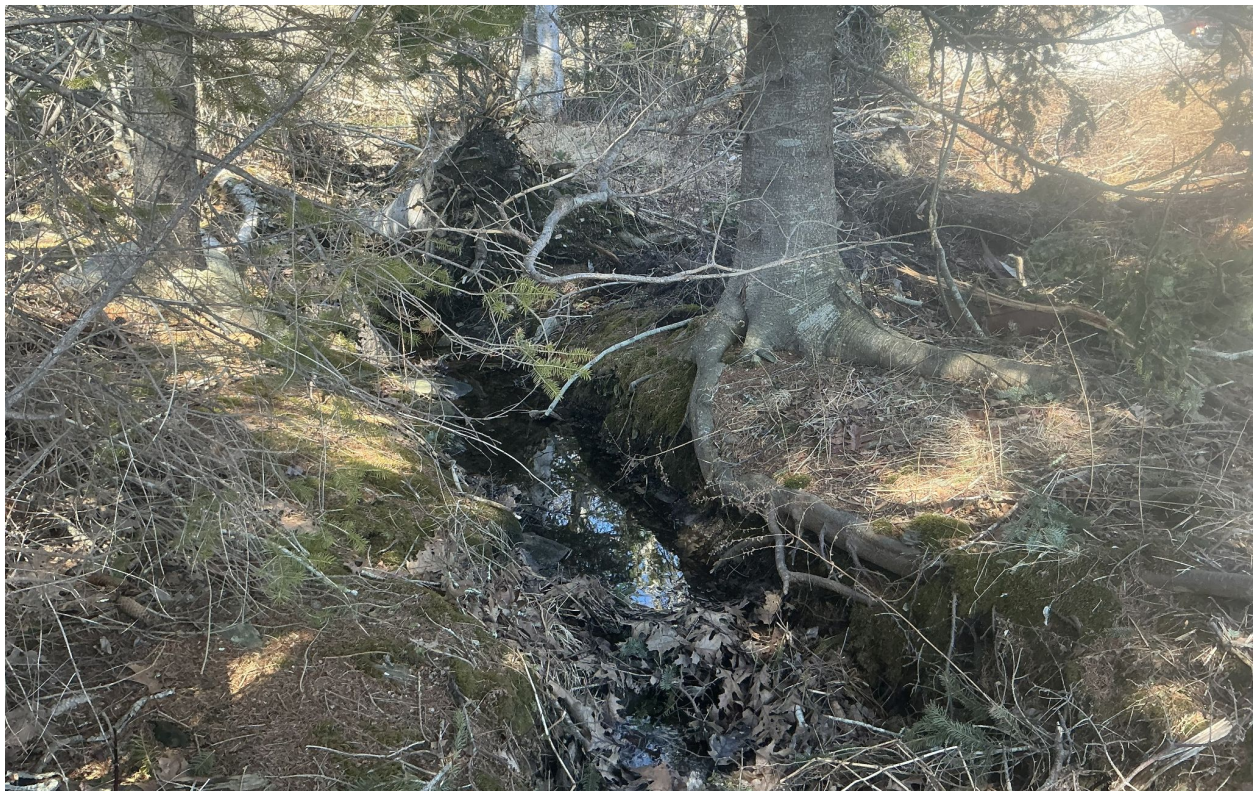
**Figure 6:** The drainage ditch that runs between the two properties.

| <b>Surface Water Flow to Bank</b> | Moderate - Some concentrated or channelized flow is directed toward the eroding bank resulting in minimal sheet or rill erosion |
