# OUR SHORE Coastal Erosion Assessments and Site Reports: Great Diamond Island

Emma Polhemus, Shore Corps Steward, Maine Conservation Corps & Island Institute  
May 2026

Alongside community partners and Island Institute staff, the Shore Corps Steward visited three coastal sites on Great Diamond Island in April 2026 to complete OUR SHORE Assessments of coastal erosion. The following report documents the results of these assessments along with recommended erosion management actions that align with OUR SHORE guidelines and prioritize nature-based and hybrid strategies.

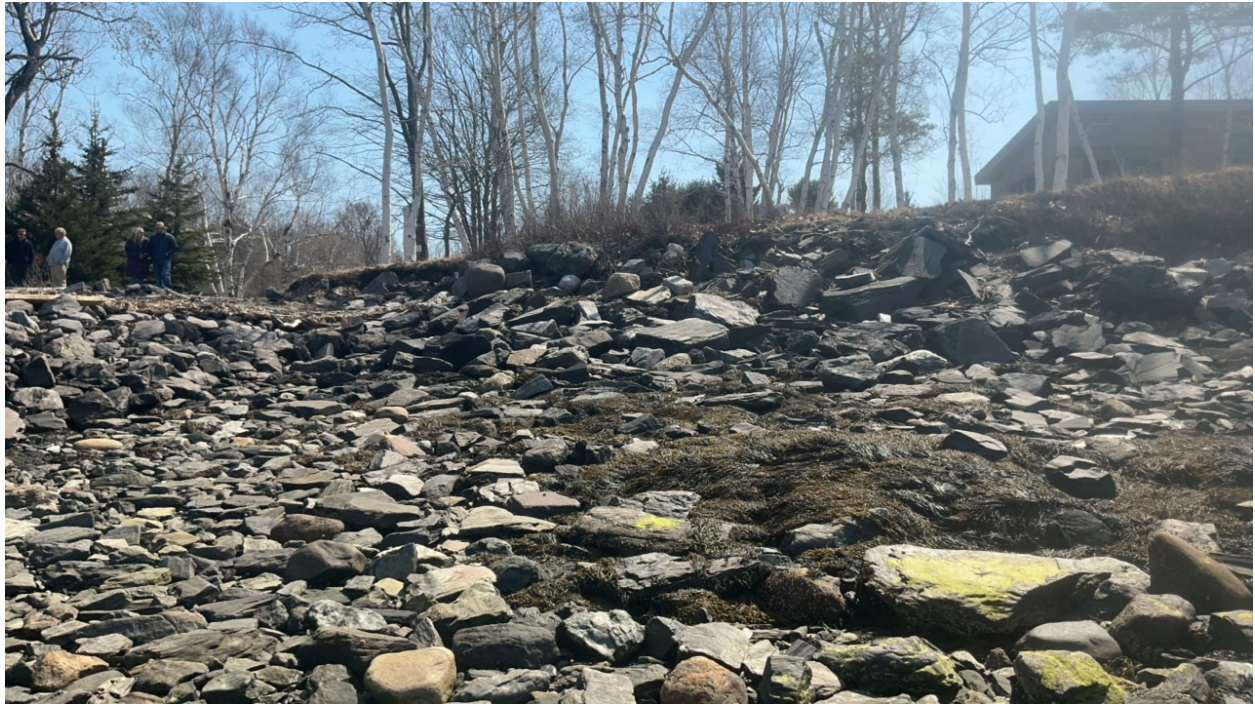
**Figure 1:** A section of the shoreline including the barge landing to the left.

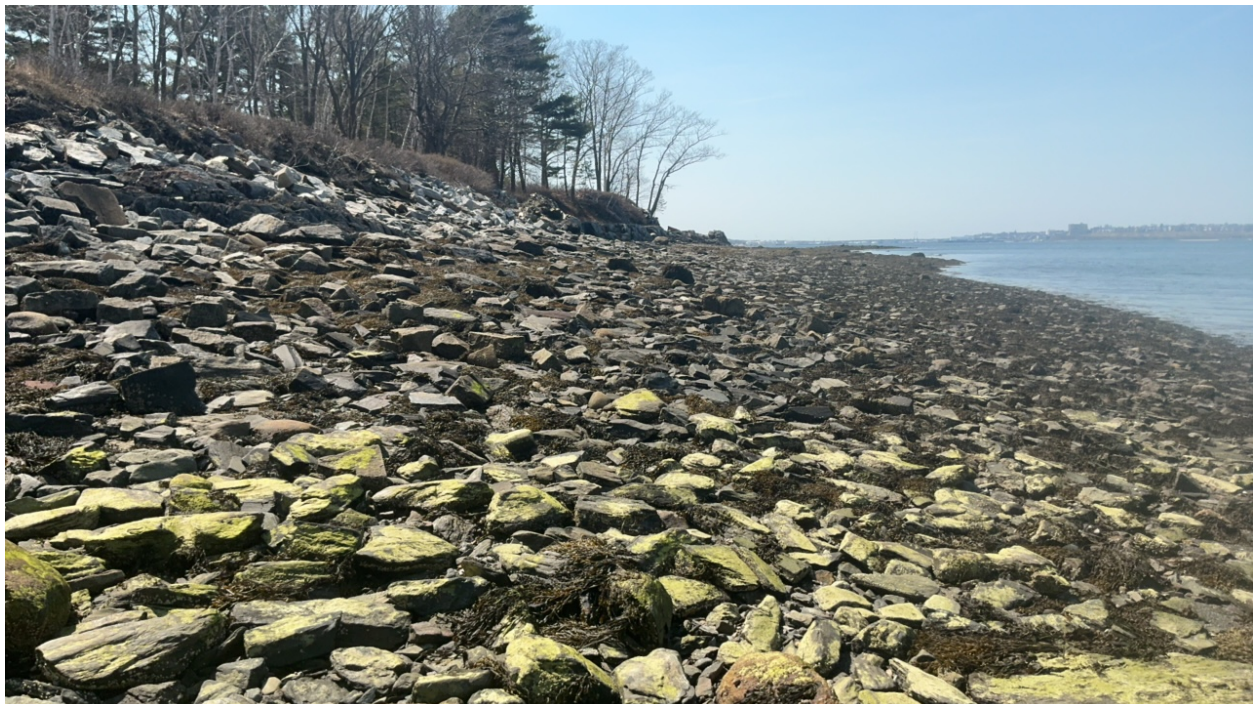
**Figure 2:** The shoreline viewed from the edge of the barge landing.

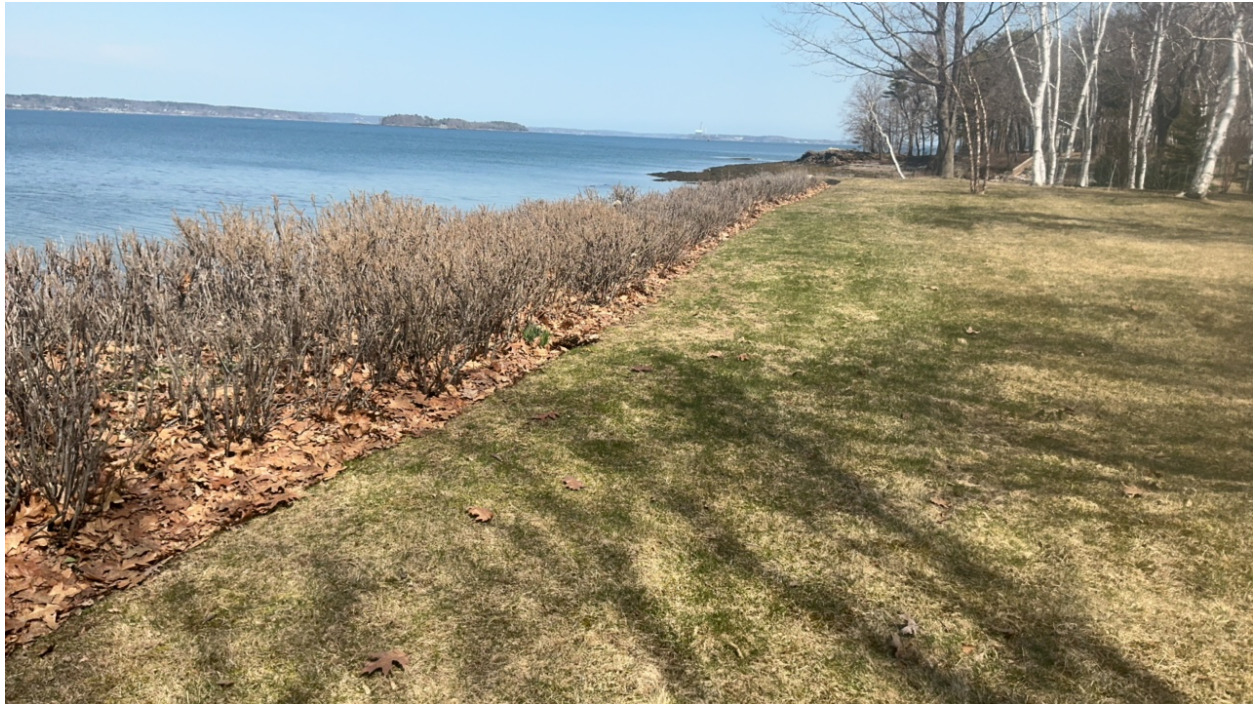
**Figure 3:** The private property inland of the bluff crest.

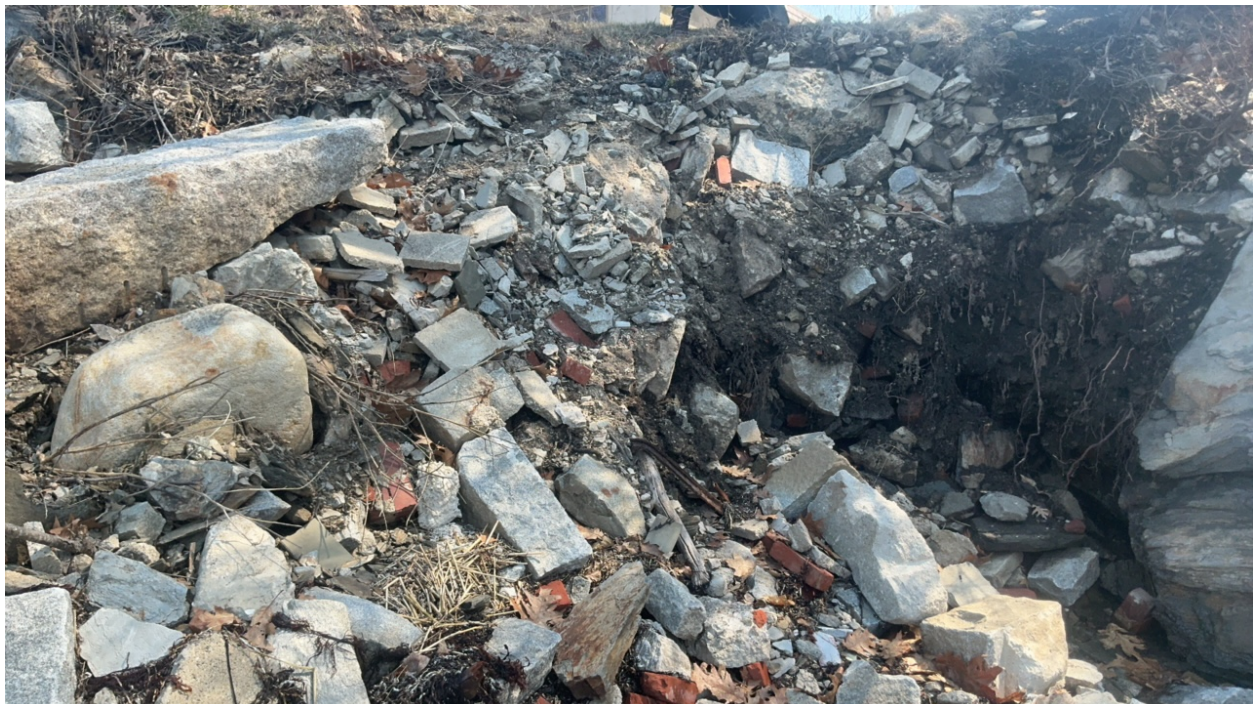
This area of Great Diamond Island was altered by past military land uses. Impacts to the site environment include the presence of stone and construction debris within and in front of the bank. The outfall of a drainage pipe used to exit the bank on the shoreline of Property X but the pipe failed in 2025 and water now drains directly out of the bluff face.

The aging stone stabilization at the site is degraded, and soil erosion is visible above the current extent of the stabilization. The failed drainage system is contributing to worsened erosion where water now drains from the bank.

**Figure 4:** Water now drains from this section of bank after a drainage pipe failed. Bricks and debris are visible in the bank.

An effective and resilient shoreline stabilization design should incorporate elements that minimize the impacts of groundwater and surface water in addition to wave erosion. At this site, a degraded drainage system is eroding soil and creating a saturated, vulnerable section of the bank. Addressing this source of instability will reduce the amount of intervention needed in other areas of the bank.

When stabilizing an area of the bank that drains a high volume of water or concentrated flows, targeted stone stabilization may be necessary. A layer of gravel underneath larger stones will help water drain from the bank while stabilizing the underlying soil. Adding vegetation to the drainage area will create a root network that can filter out soil particles so they do not get washed out through the stone.

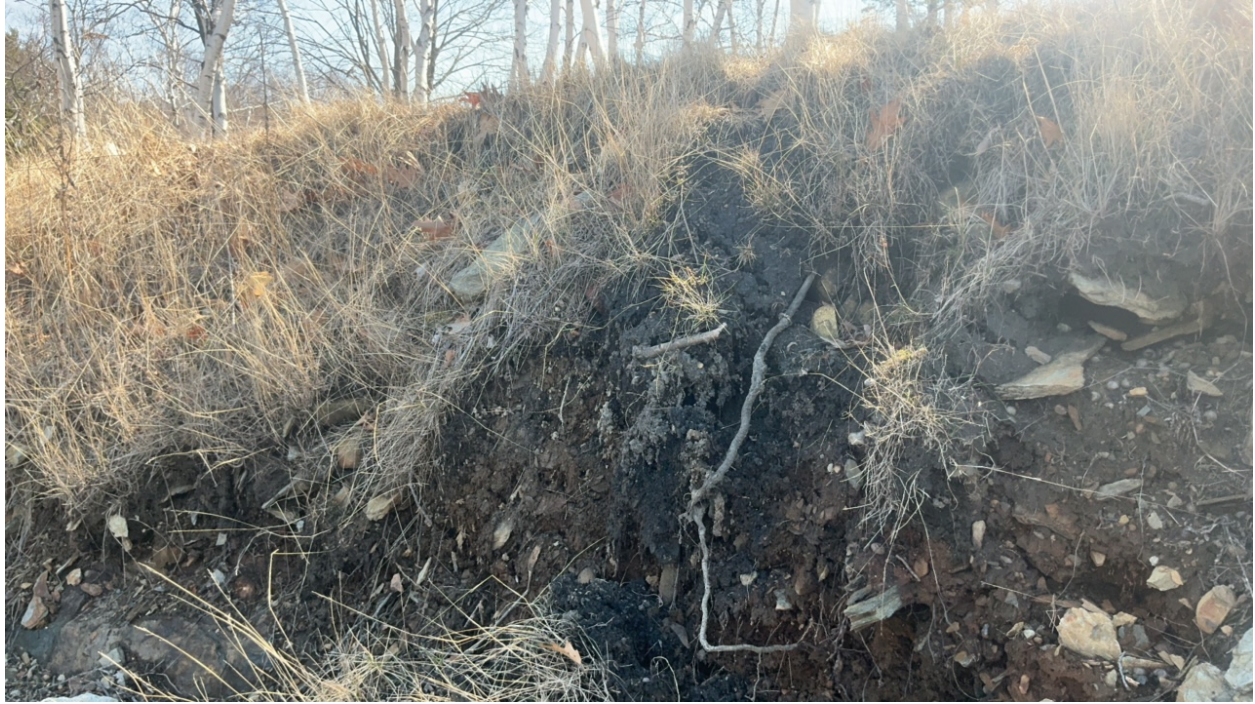
**Figure 5:** Soil erosion is visible above the top of the placed stone in this section of bank adjacent to the barge landing.

The stone slope protection that was previously placed has degraded and is no longer functioning as intended. Shifting and slumping of the stones has contributed to this degradation. Adding vegetation throughout the riprap on the bank connects the stones to the underlying soil, holding them in place and creating a more durable design that becomes stronger over time as the plants mature. A "rooted" riprap design also improves the quality of the shoreline habitat for wildlife.

Live staking is an effective method of adding vegetation to existing riprap stabilization on a shoreline that does not have a geotextile filter layer. This technique uses branch cuttings of dormant native shrubs from certain quickly-rooting species. These live stakes are able to produce roots and grow into a new plant when pushed into the soil. Live stakes can easily be planted into existing gaps within the riprap stones so they reach the underlying soil, allowing for revegetation without having to disturb or remove the existing riprap.

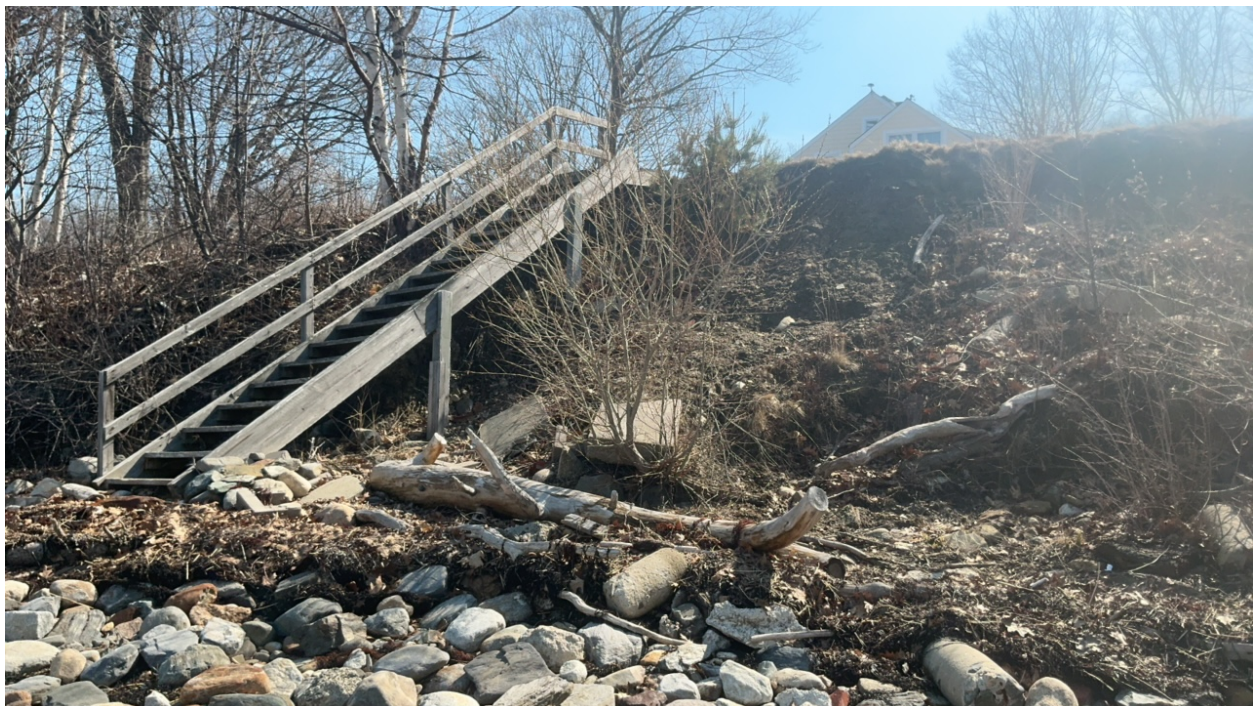
**Figure 2:** Photograph of a portion of the bluff face at the site near the north end of the property.

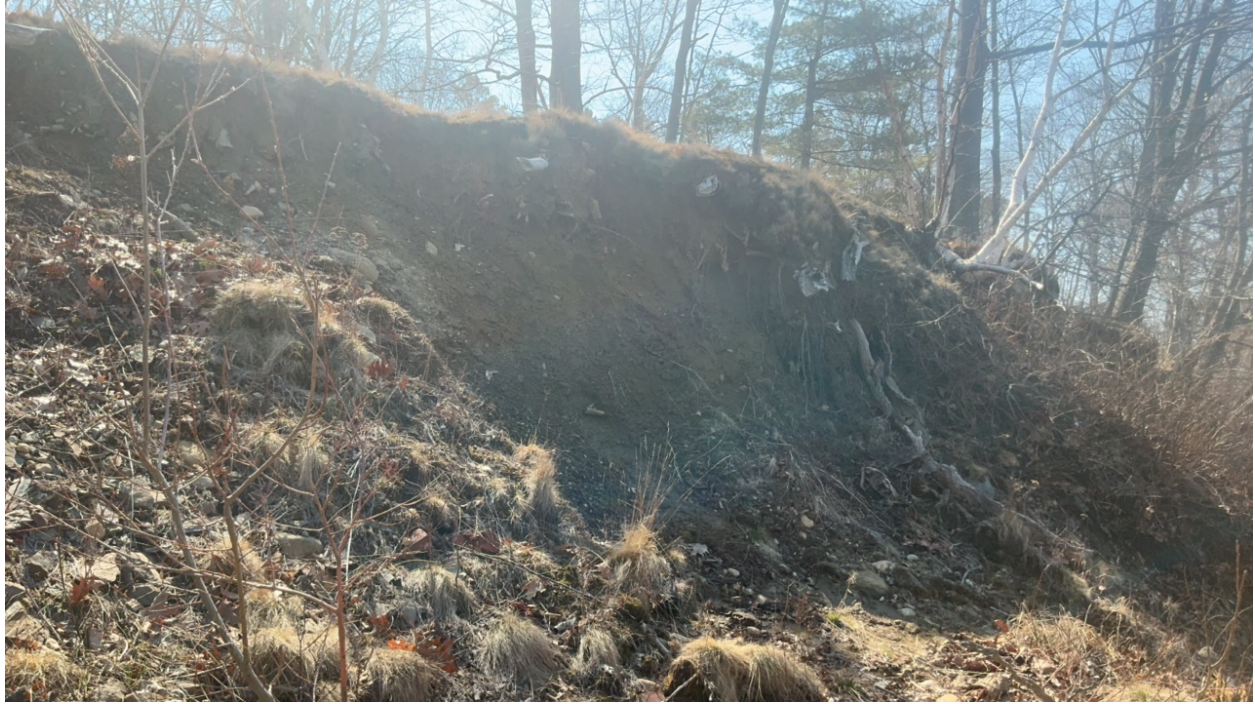
**Figure 3:** Photograph of a portion of the bluff face at the site near the south end of the property.

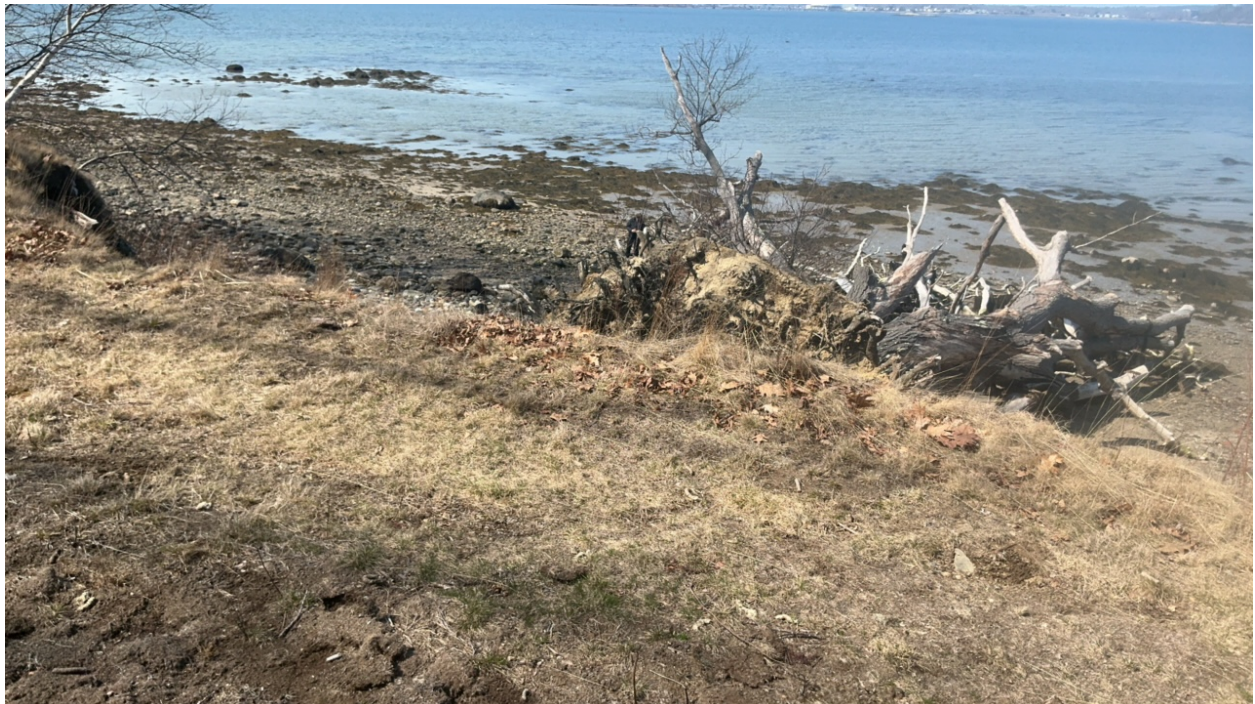
**Figure 4:** Photograph from the top of the bluff at the site showing the bluff edge and sand and cobble beach.

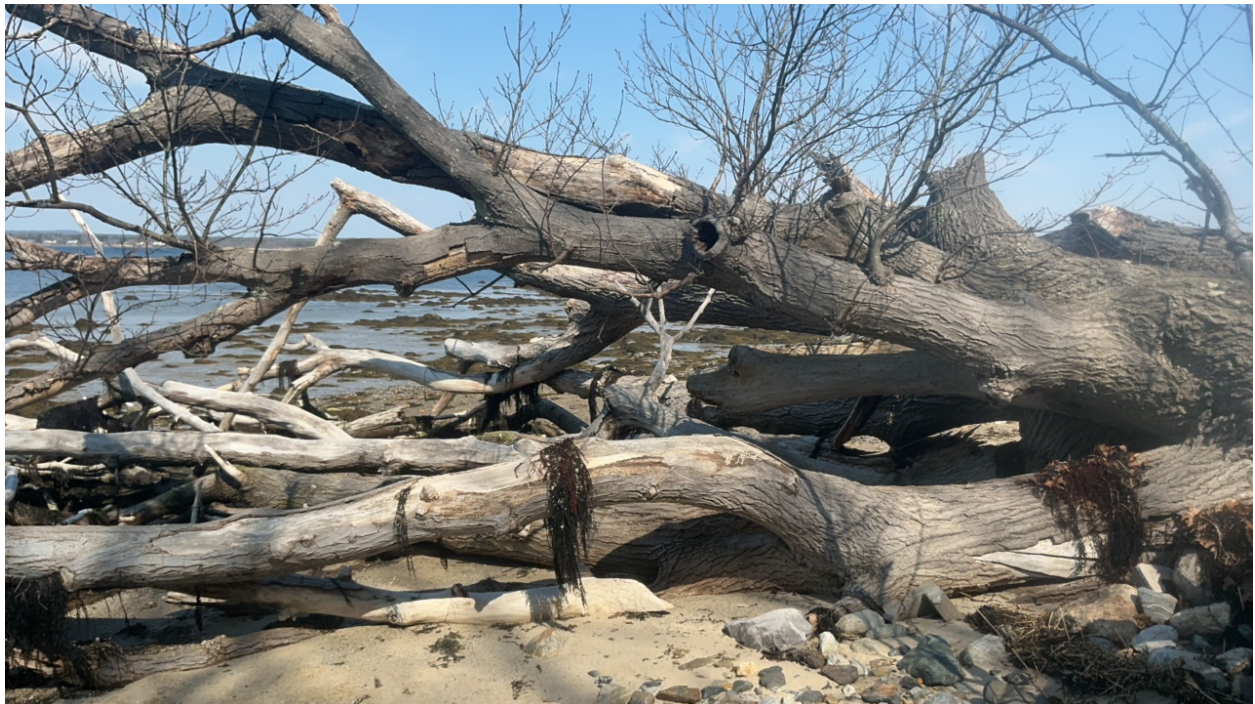
**Figure 8:** This large oak tree fell from the top of the bluff due to toe erosion and slumping.

The large oak tree that fell from the bank at this site clearly demonstrates how hazard trees can increase bank instability and erosion. When possible, it is best to cut trees that are beginning to lean or fall near the bank to remove weight and reduce the chance of the stump falling. After the tree falls, leaving the trunk and root wad in place, as has been done at this site, is beneficial for shoreline stability. The structure of the branches and roots creates roughness that helps to diffuse energy from oncoming waves.

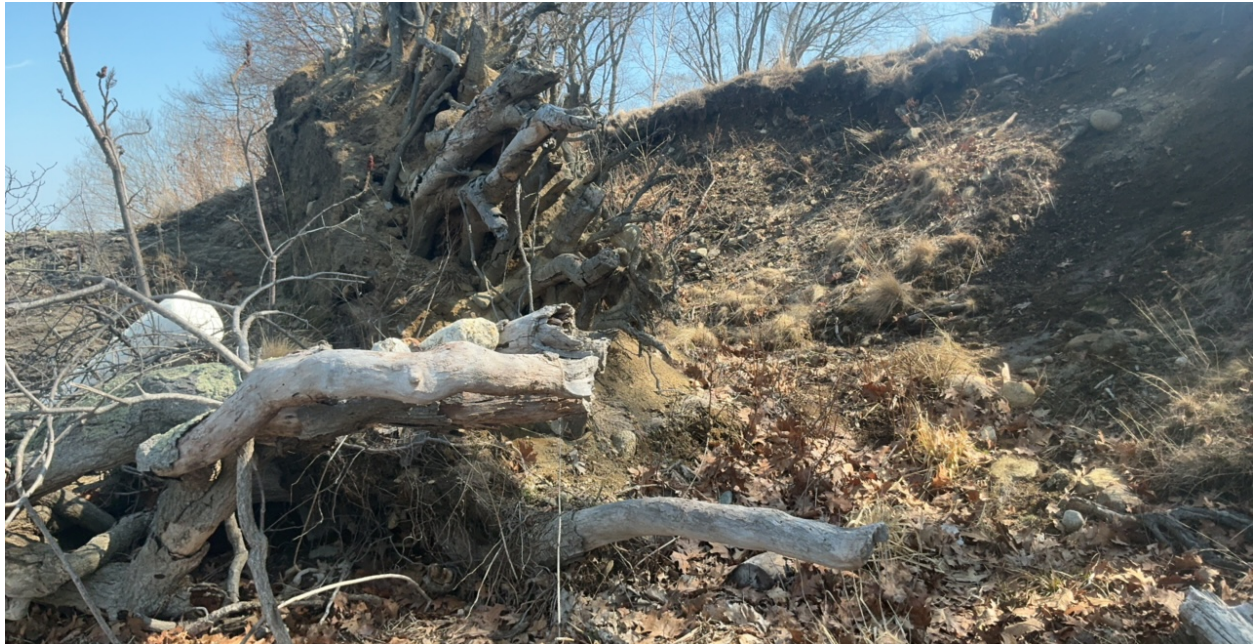
**Figure 9:** Photograph showing the root wad of the fallen oak tree and the resulting exposed and displaced soil on the bluff face.

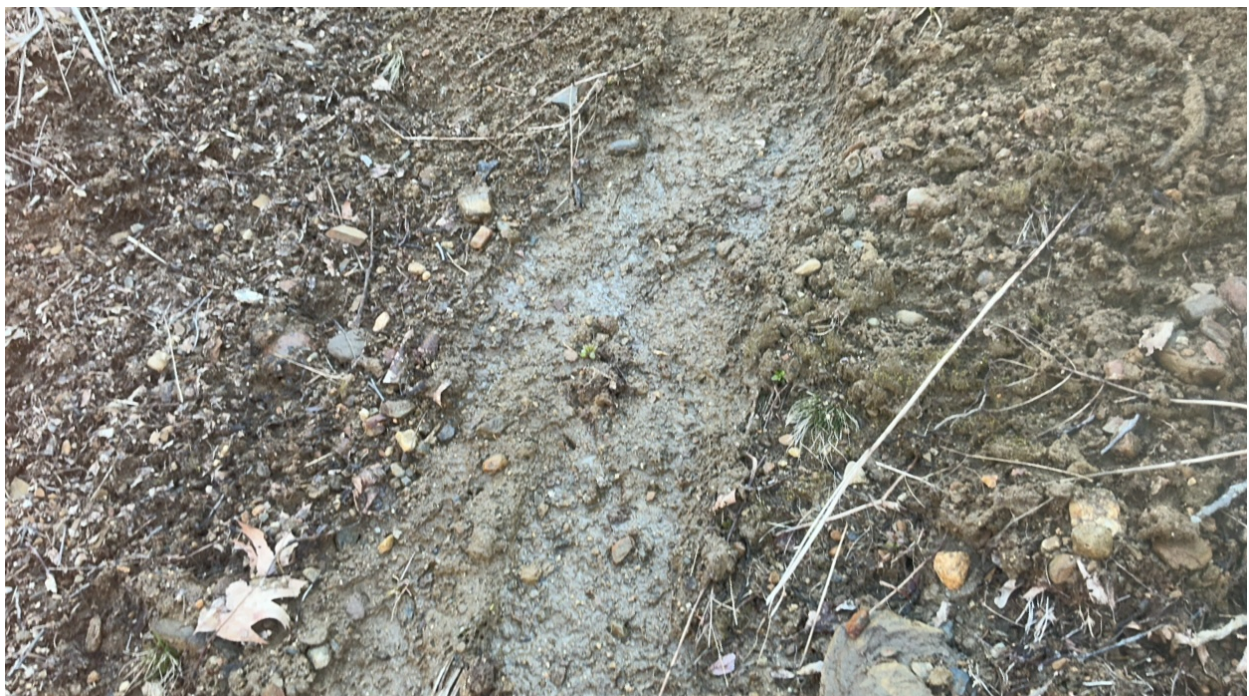
**Figure 10:** Photograph of the groundwater seep, visible as an area of shimmery, wet soil.

Groundwater saturation may be a result of natural hydrology of the site or caused by land use factors like lawn irrigation or septic systems. The property owners described the approximate location of the property's septic system as directly inland from the position of the groundwater seep on the bluff face, which suggests that contributions from the septic system may be leading to bluff saturation. A septic professional can help identify and manage issues like aging or damaged systems. Following the recommended septic tank pumping schedule is also important to prevent excess groundwater contributions.

Remaining groundwater saturation can be mitigated by installing and maintaining a dense vegetated buffer near the bank. Vegetation draws water into its roots from the bank, and larger, deeper rooted plants remove more water than lawn grass. A minimum buffer width of 10 ft from the edge of the bluff inland is recommended, and further reducing lawn area will continue to increase groundwater uptake and bank stability.

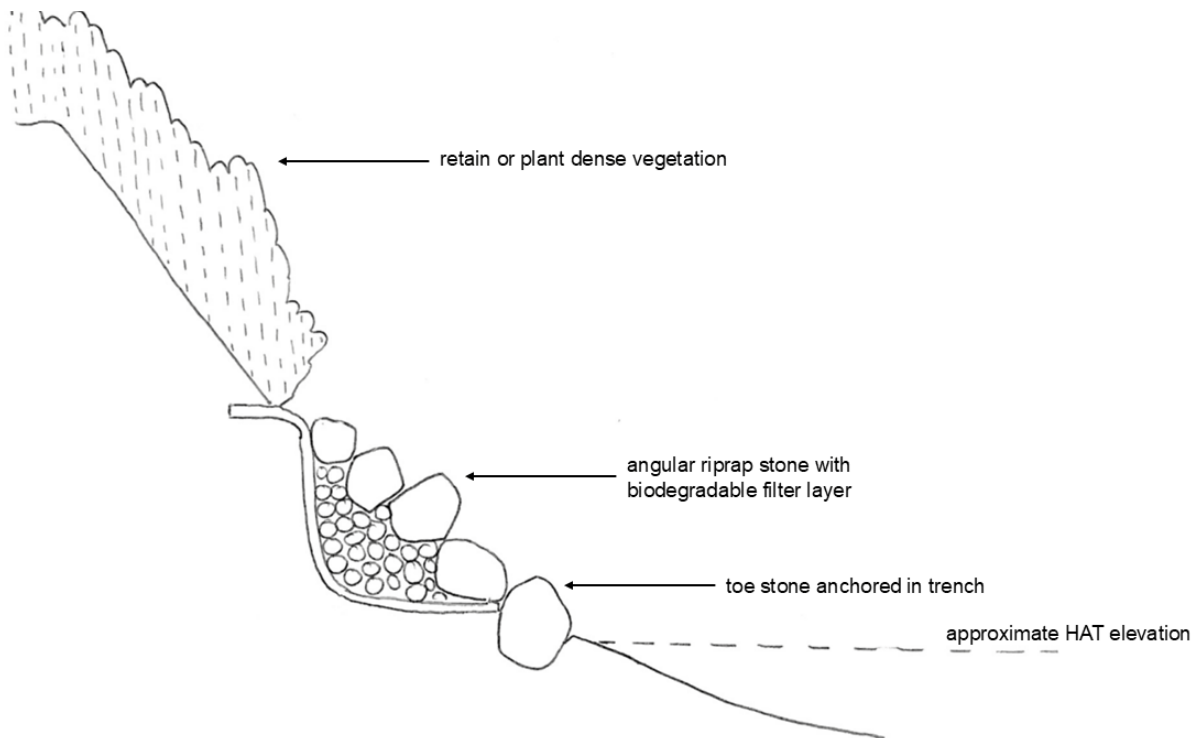
**Figure 11:** Cross-sectional diagram of the recommended erosion control plan utilizing a riprap stone toe combined with native vegetation for slope protection and groundwater management.

Based on the proximity of the cottage to the bank and the current extent of erosion at the site, a hybrid structural design may be necessary to protect the cottage in its current location. When stone and structural components are used, OUR SHORE principles recommend minimizing the amount of intervention and increasing opportunities for revegetation. Using riprap stones only at the toe of the bluff to provide the bank with a stable foundation is an effective method of minimizing habitat impacts and project costs for many coastal banks. Most bluff erosion occurs following a cycle of erosion and undercutting of the sediment at the toe which causes slumping of the overlying bluff, so protecting the toe is often sufficient to stabilize the entire bluff. Riprap stones for toe protection typically extend 1-2 ft higher than the mapped base flood elevation at the site. Above this elevation, the bank is protected with native vegetation.

The OUR SHORE program also recommends some modifications to standard riprap designs to encourage vegetation of the riprap. Vegetated riprap is more resistant to wave energy than unvegetated riprap, and provides better habitat quality and connectivity. A filter layer is an important component of any riprap design, especially when the slope has high groundwater saturation. However, the plastic geotextile fabrics that are commonly used as filter layers

prevent plants from rooting through the riprap. Recommended alternatives include filter fabrics made of natural materials, like coconut coir or heavy jute, or graded layers of fine gravel and small stones between the soil and large riprap layer. Planting directly into the riprap when it's installed using live stakes, seeds, or mature plants is also recommended to speed up the process of revegetation of the protected area.

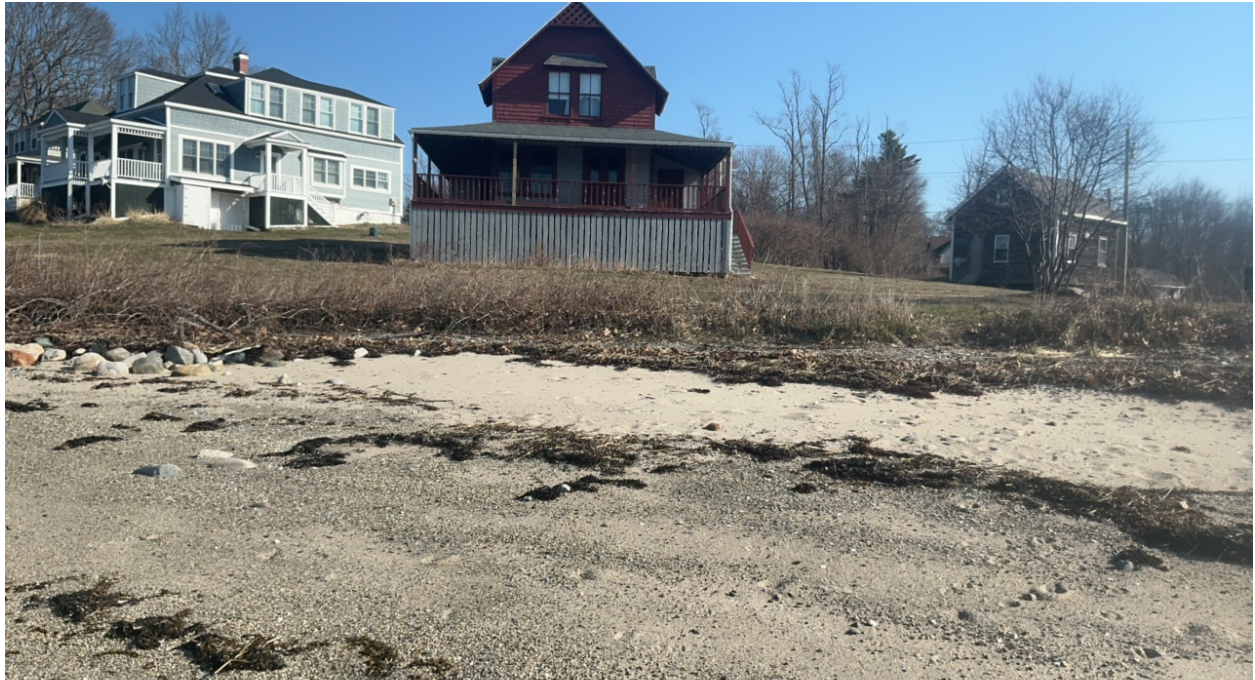
The property owners have observed long-term shoreline change and erosion exacerbated by severe winter storms in 2024. Historical photos from the early 1900s show a salt marsh extending along the shoreline of the property which is no longer present. Sea level rise is also impacting the property; the seaward point of the historical tax parcel is now below the highest astronomical tide line.

**Figure 1:** Photo of the cottage and shoreline in 2026.

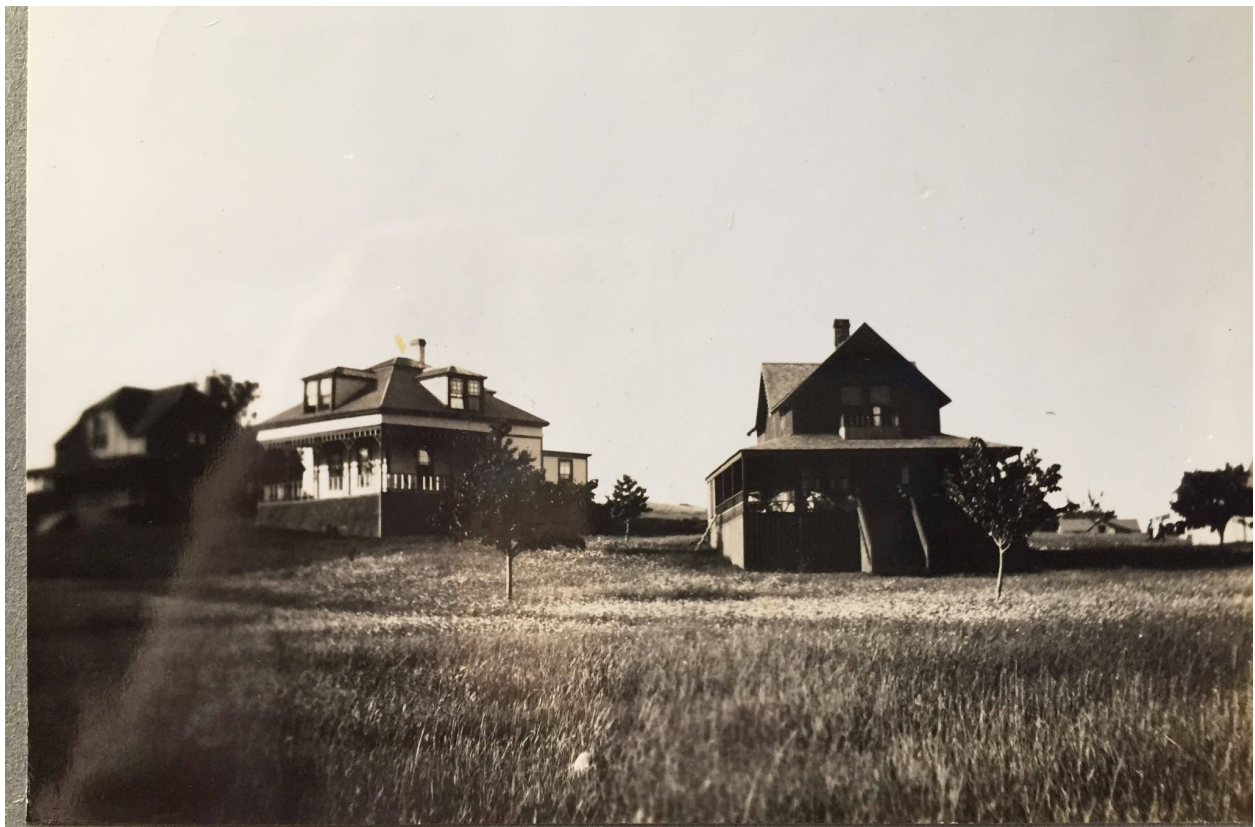
**Figure 2:** Historical photo of the cottage and shoreline taken in the early 1900s. Photo by Paul R. Stevens, provided by the Stevens family.

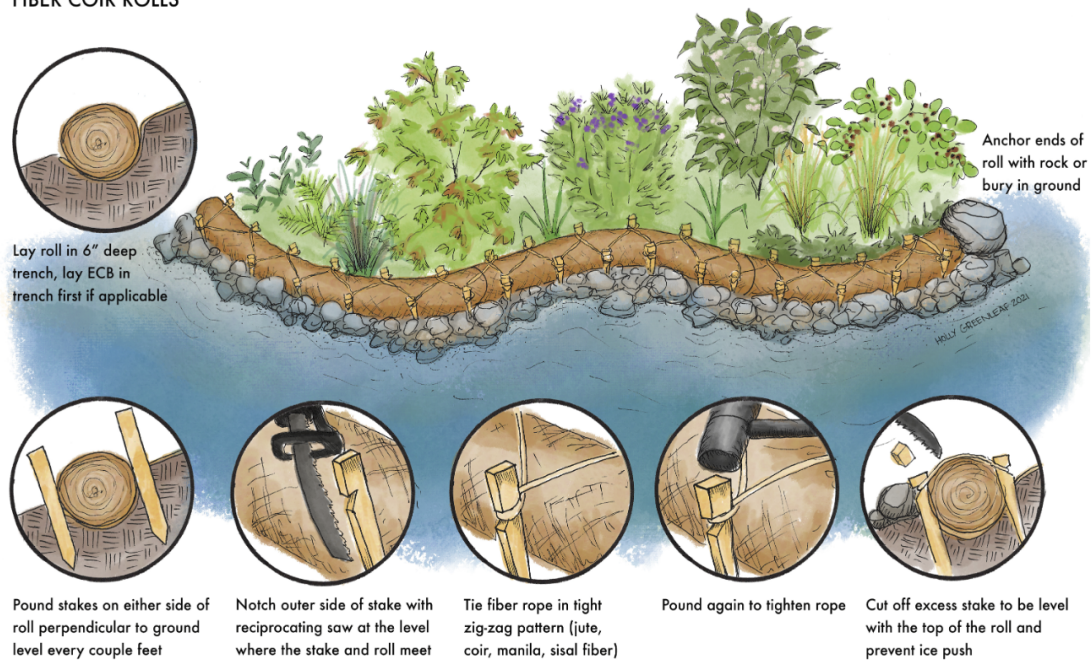
**Figure 7:** Illustration of coir log installation for toe protection from the Vermont Bioengineering Manual.

Because the toe of the bank has eroded, a biodegradable stabilization material such as coconut coir logs are recommended to provide additional support while plantings establish. The coir log should be placed directly along the eroding edge of the bank and staked in place (Fig. 7). Vegetation is added for long-term stability and slope protection. Vegetation can be seeded or planted directly into the coir log, or into the soil behind the log.
