# OUR SHORE Coastal Erosion Assessments and Site Reports: Little Diamond Island

Emma Polhemus, Shore Corps Steward, Maine Conservation Corps & Island Institute  
May 2026

**OURSHORE Quick Assessment: Bishop Healy Woods**  
**Rockledge Ave, Little Diamond Island, ME**

**OURSHORE Quick Assessment: West Shore Beach**  
**Elizabeth Rd, Little Diamond Island, ME**

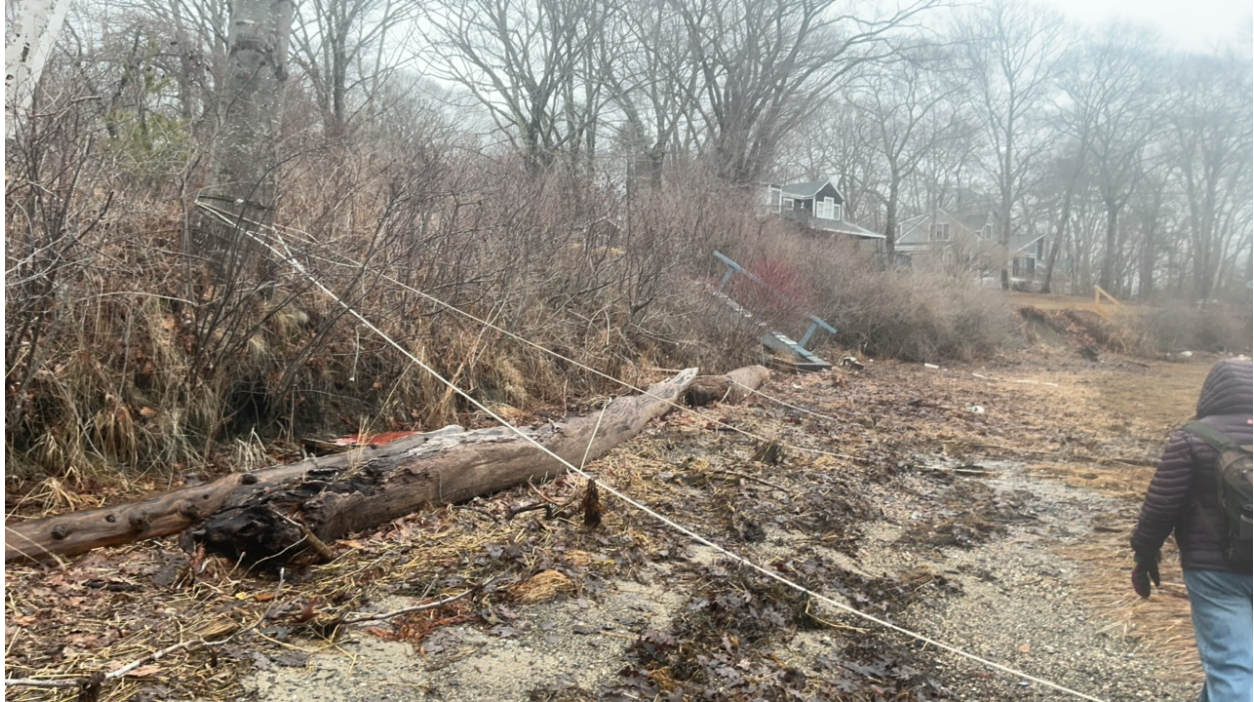
Signs of toe erosion are visible on the bank across the shoreline of Bishop Healy Woods and the private property. Some undercutting of the bank is present. On the private property's shoreline, a gully is also present (Fig. 8), indicating that flow of overland water is contributing to erosion and bank instability.

**Figure 2:** Photograph of the site shoreline facing north. Toe erosion including mild undercutting is visible on the bank.

| <b>Toe Erosion</b> | Moderate - Moderate toe erosion, beginning to slump |

Similarly to the burlap bag method described above, coir logs can be staked in place using live stakes or hardwood stakes to provide protection to the toe of the bank where erosion impacts are concentrated. The coir log should be positioned to have good soil contact with the eroding edge of the bank, pushing it underneath any areas of undercut as necessary.

Densely planting live stakes on and in front of the toe slope will also provide stability and protection. This will be most effective along areas of the bank that are above the highest astronomical tide line and are not regularly submerged in salt water. For toe protection, the OUR SHORE guide recommends placement of live stakes approximately one inch apart. This

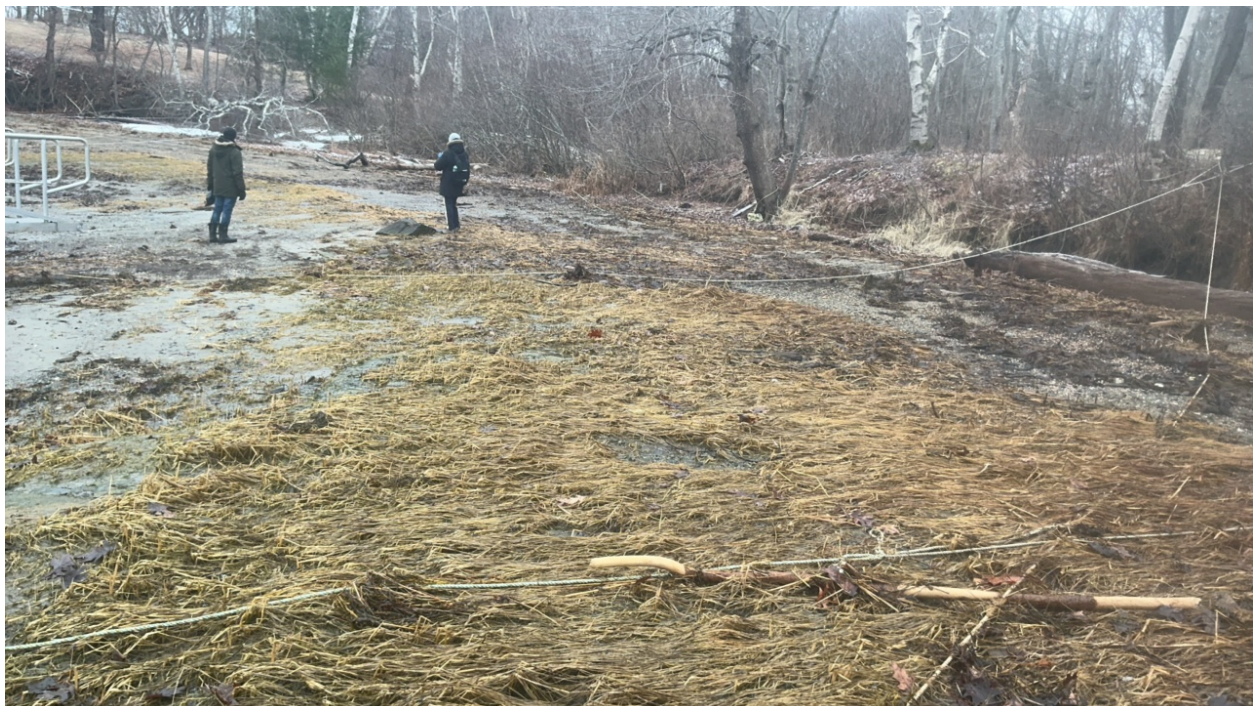
**Figure 3:** Photograph of the site shoreline facing south, including salt marsh vegetation.

Salt marsh systems provide protection to coastal banks by reducing the energy of oncoming waves before they reach the shore. The presence of patches of salt marsh vegetation in the coastal wetland at this site indicate the possibility of salt marsh protection and enhancement as a nature-based strategy at this site. This strategy can be approached through no-cost sustainable management practices, or through active marsh restoration and enhancement.

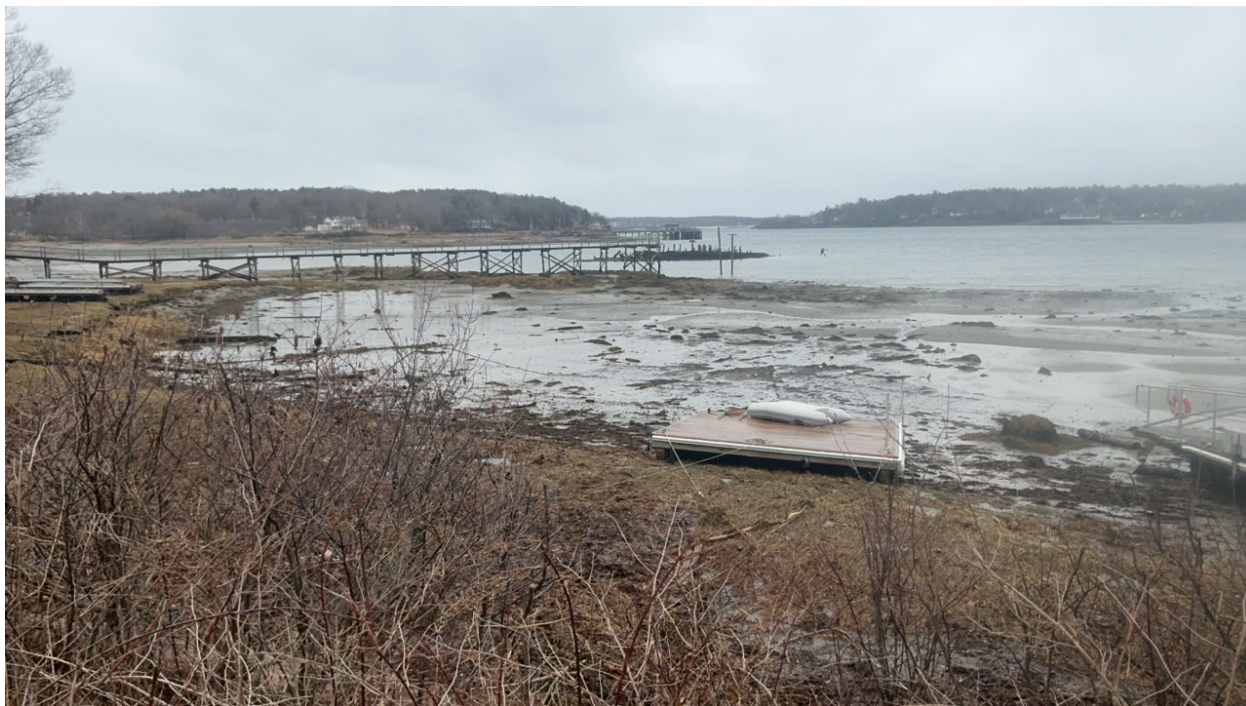
**Figure 4:** Photograph of the coastal wetland from the bank showing seasonal storage of docks.

To protect existing areas of marsh vegetation, avoid storing docks and floats on top of the marsh. Best practice is to store docks away from the entire coastal wetland and bank so vegetation in these areas is not shaded or crushed. If this is not feasible, select areas of the shore that do not have salt marsh vegetation to store docks.

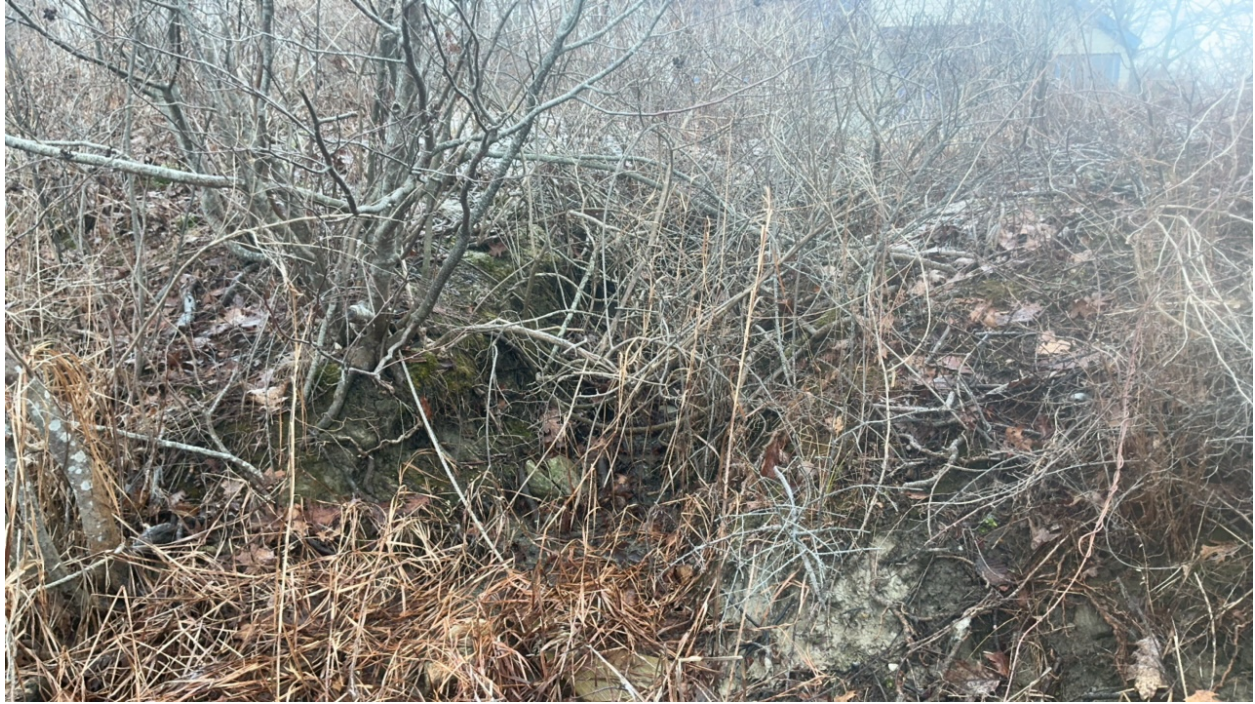
**Figure 8:** Photograph of a gully in the bank indicating surface water contributions to erosion.

The presence of a gully on the bank at the site indicates that concentrated flows of surface water are contributing to bank instability. Managing overland flows to reduce or prevent surface erosion will also increase overall bank stability and reduce wave and storm damage.

Management of overland flow at the site should incorporate the extension of the vegetated buffer on and near the bank, as well as targeted flow diversion and interruption to stabilize the gully that has already formed.

To stabilize the gully that has already formed, biodegradable slope interruptions can be installed to slow water moving through this area. While coir logs are often used, for a smaller gully like the one at this site, burlap bags filled with mulch are a cost-effective option (Fig. 10). Starting at the top of the gully, the bags should be placed in rows perpendicular to the slope and staked in place. The gully should be revegetated in combination with slope interruption practices for long-term stabilization. Using live stakes to secure the bags is recommended, as they will add additional protection and stability as the plants grow in, but untreated hardwood stakes or a combination of hardwood and live stakes may be used.

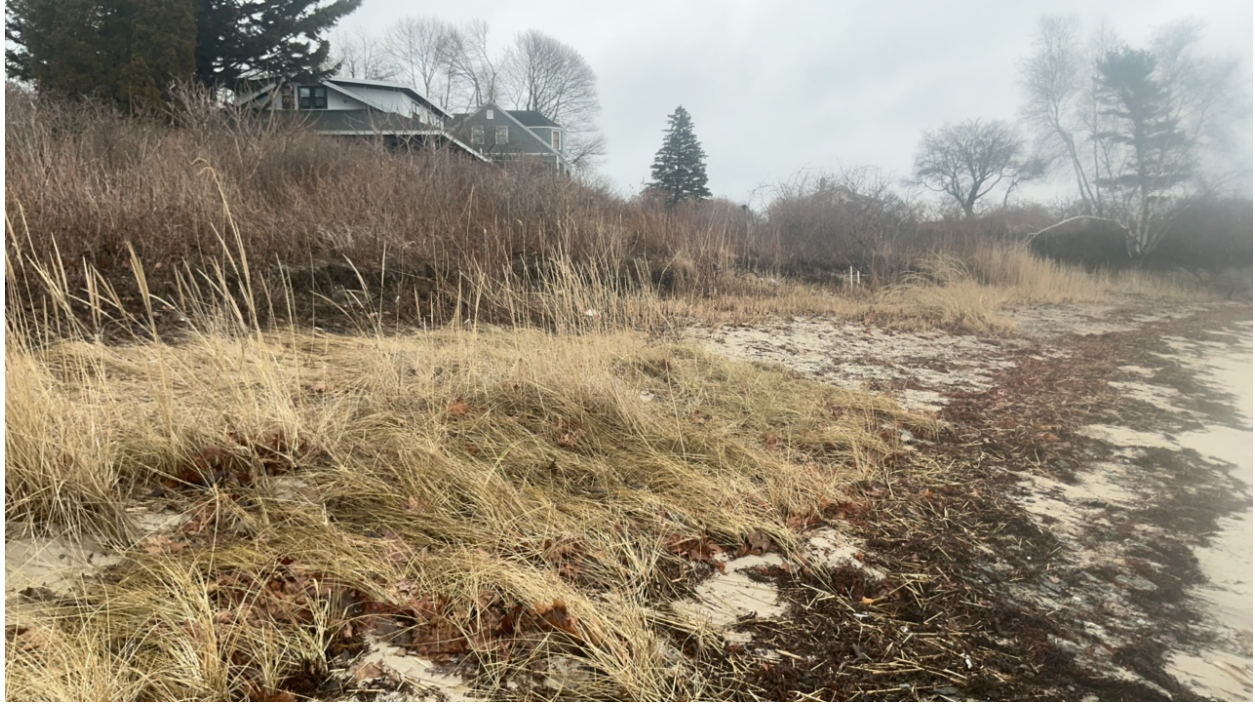
**Figure 1:** Northwest section of West Shore Beach with a low bank.

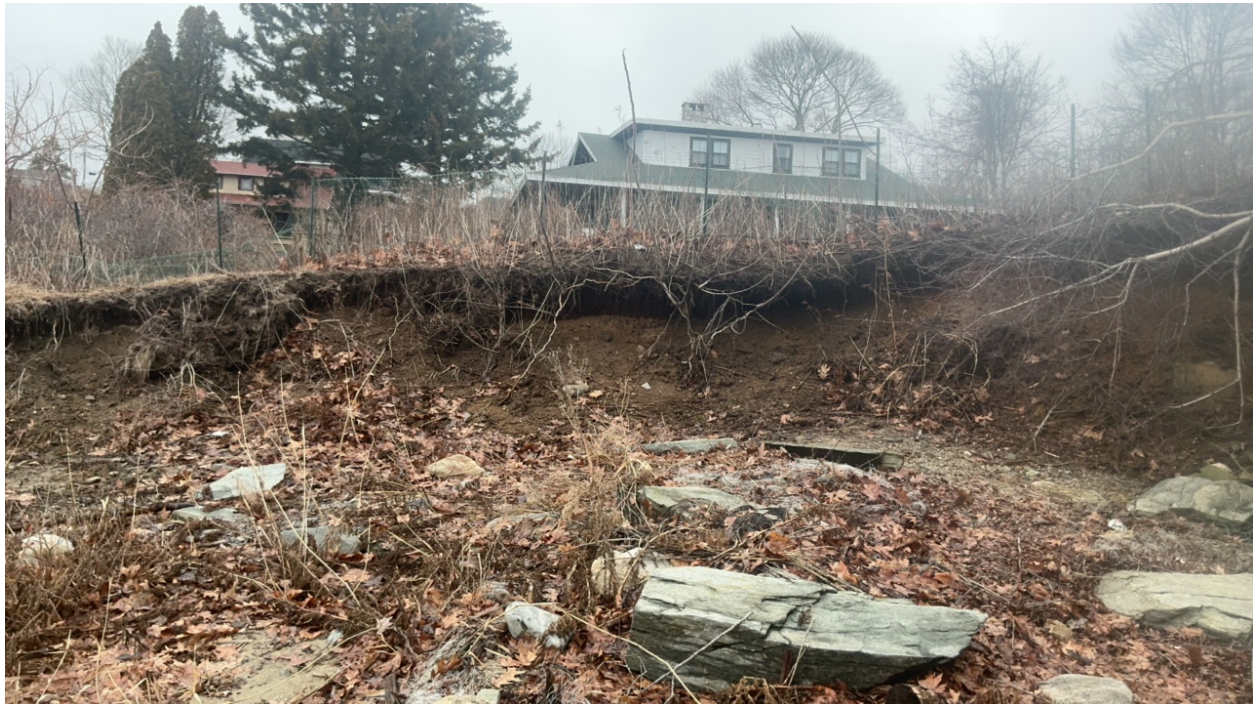
**Figure 2:** Southeast section of West Shore Beach with a taller, steeper coastal bluff.

Bioengineering options for this section of shoreline include encapsulated soil lifts or a living crib wall. Natural fiber blankets and coir logs can be used to establish and protect the toe of a series of terraces called soil lifts (Fig. 7). Vegetation is then planted in the flat areas of each terrace for long term stability. For coastal areas, a double layer of fiber blankets around each soil lift is recommended to prevent damage if debris hits the lifts during a storm. Encapsulated soil lifts, also called engineered bank cores, are considered suitable for high energy coastal environments.

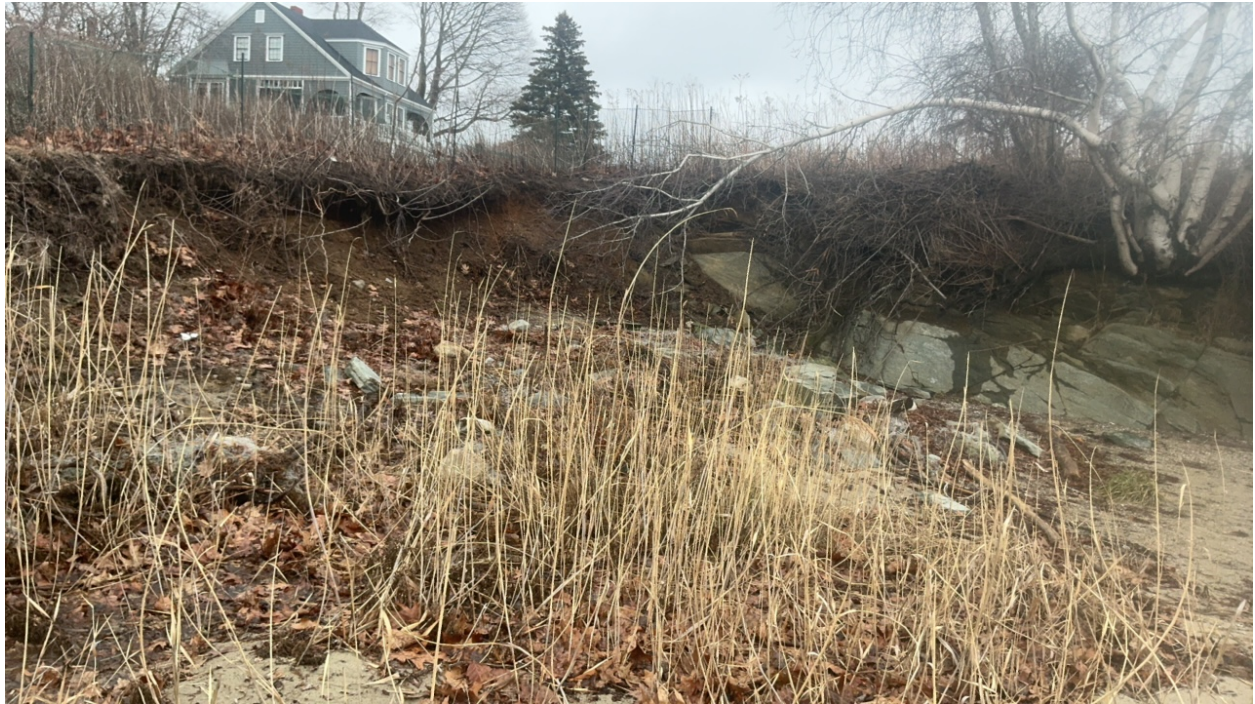
Some toe erosion is present across the length of the assessed site, but the primary area of concern is the southeast end where the higher bluff meets ledge. In this area, toe erosion is more pronounced, with a significant undercut bank and signs of slumping. Erosion in this area is likely exacerbated by waves deflected from the ledge towards the bare sediments of the bluff.

**Figure 3:** Southeast section of West Shore Beach where the sediment bluff meets bedrock.

A vegetated riprap stone toe could also be considered in the most severely eroded section. Planting within the riprap with live stakes or container plants is important to increase the structure's durability in storm conditions, and to attenuate wave energy so it is not deflected to neighboring sections of shoreline. If riprap is used, OUR SHORE principles recommend minimizing this intervention to the most impacted section of shoreline, and using nature-based stabilization on the remainder of the bank.

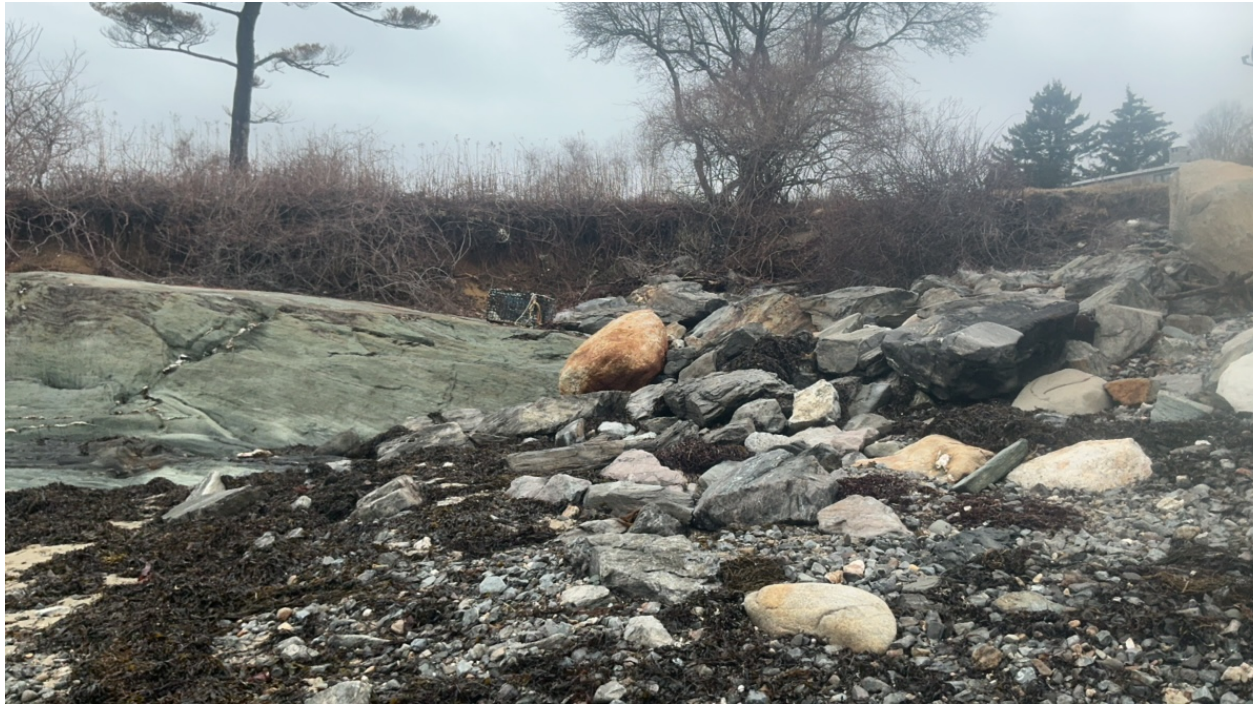
The property owners have noticed erosion of the bank, especially during the winter storms in 2024. The edge of the bank has retreated several feet inland towards the porch of the cottage. Rocks which were previously positioned against the edge of the bank have also been shifted away from the bank and down the beach by wave action in storms.

**Figure 1:** Photograph of the easternmost section of the shoreline at the site.

A structural approach to shoreline stabilization such as a riprap revetment is recommended at this site given the cottage's location near the eroding bank edge. When riprap or other hardened structures are necessary, the OUR SHORE program recommends several design considerations to increase the structure's resilience to storms and minimize negative impacts to neighboring properties and shoreline habitat.

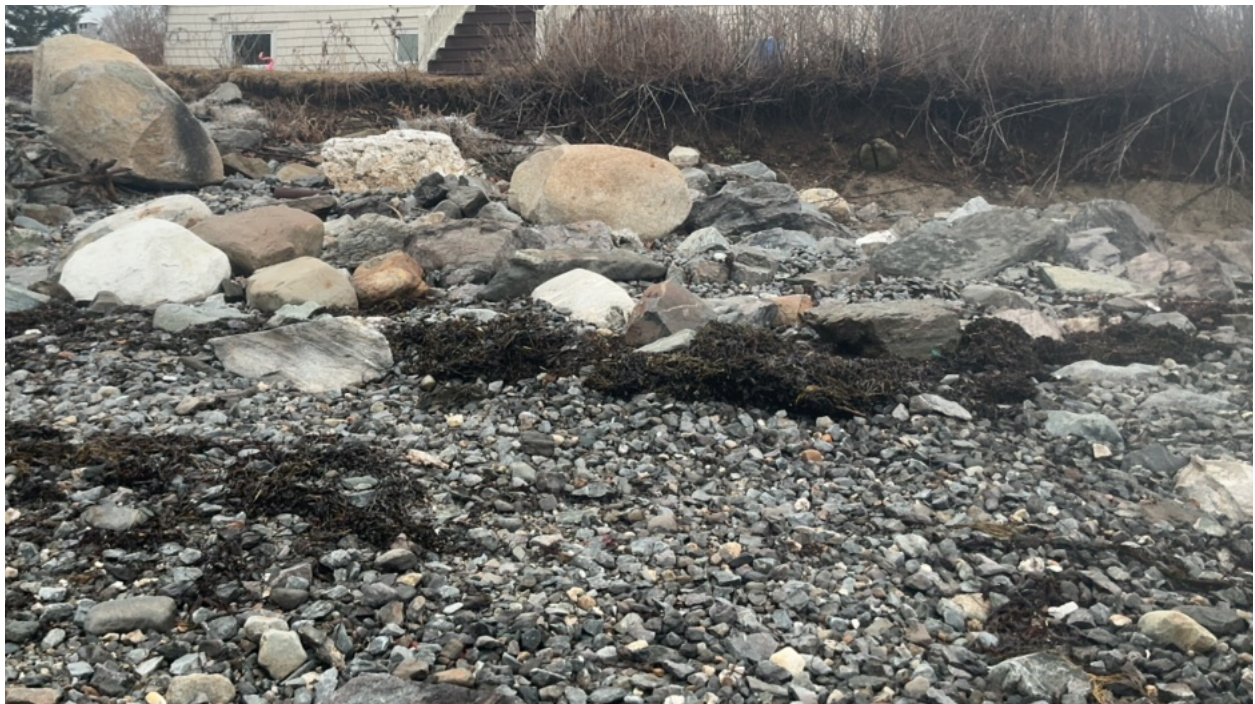
**Figure 2:** Photograph of the central section of the shoreline at the site.

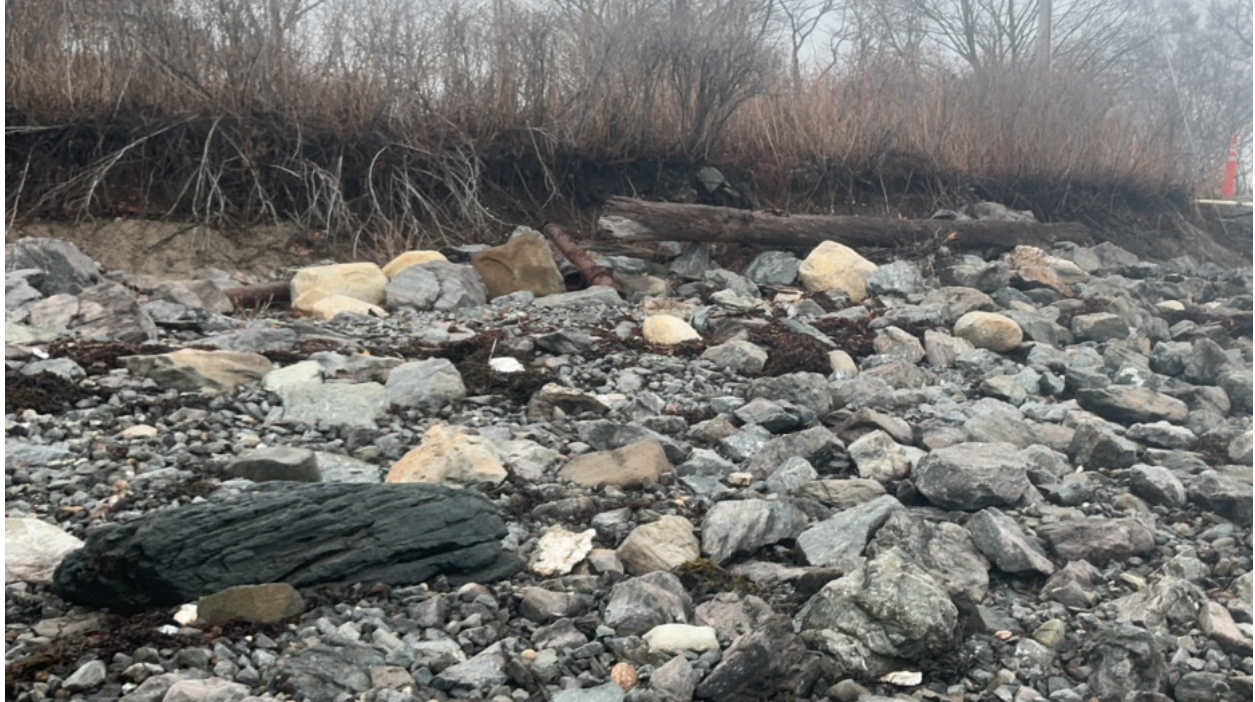
**Figure 3:** Photograph of the westernmost section of the shoreline at the site.

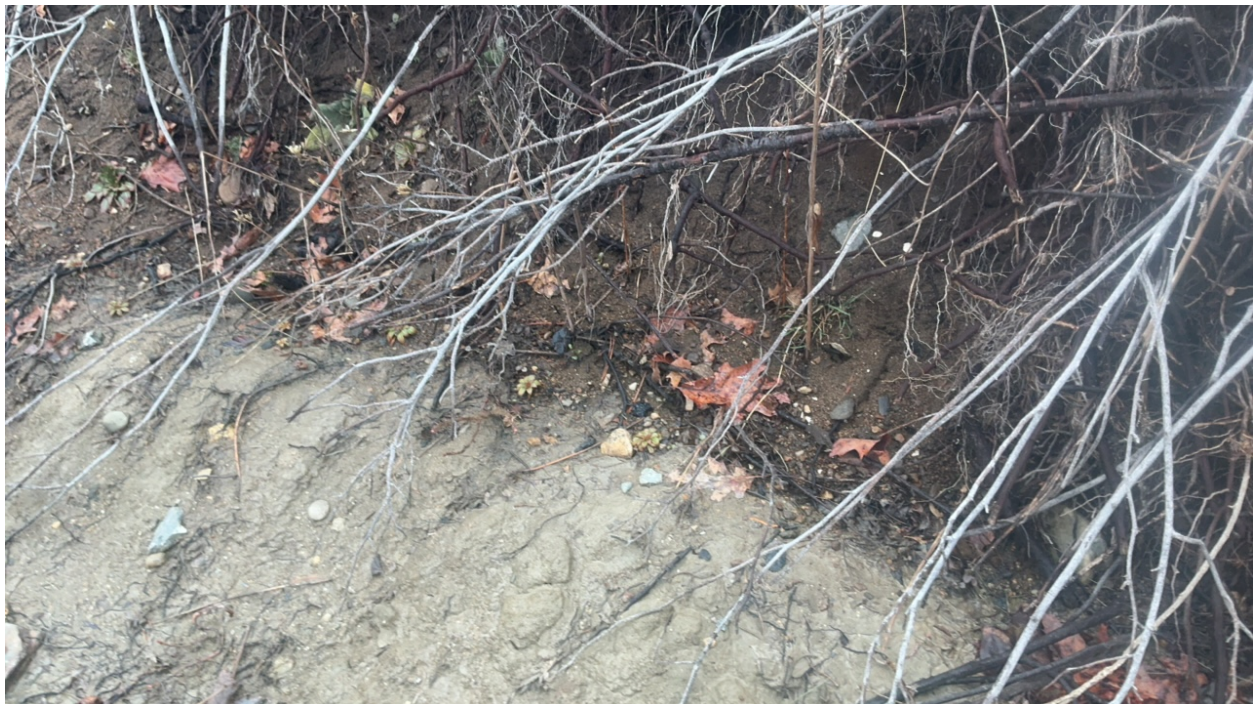
**Figure 4:** Photograph showing the two distinct soil layers of the coastal bank at the site. Small eroded channels called rills are visible in the bottom clay layer where groundwater is exiting the bank and running downslope.

Groundwater seeps were visible on the bank during the site visit. This is common when a subsurface clay layer is present in the soil, since groundwater infiltrates very slowly into the clay, causing pooling and horizontal movement above this layer of the soil. A saturated bank is more vulnerable to slumping and erosion by waves. When groundwater seeps are present, integrating an appropriate filter layer into riprap designs is critical.

Excess groundwater saturation can also be managed through land use decisions. Large, deep rooted plants are able to take up more water from the soil than turf grass, leading to decreased soil saturation and improved bank stability. Replacing as much lawn area as possible near the bank with densely vegetated buffers will enhance the stabilization provided by riprap. A buffer of 10-15 ft in width at minimum across the entire shoreline is recommended for shoreline stabilization benefits.
