# OUR SHORE Coastal Erosion Assessments and Site Reports: Long Island

Emma Polhemus, Shore Corps Steward, Maine Conservation Corps & Island Institute  
May 2026

## **OUR SHORE Coastal Erosion Assessments and Site Reports: Long Island**

Alongside community partners and Island Institute staff, the Shore Corps Steward visited three coastal sites on Long Island in April 2026 to complete OUR SHORE Assessments of coastal erosion. The following report documents the results of these assessments along with recommended erosion management actions that align with OUR SHORE guidelines and prioritize nature-based and hybrid strategies.

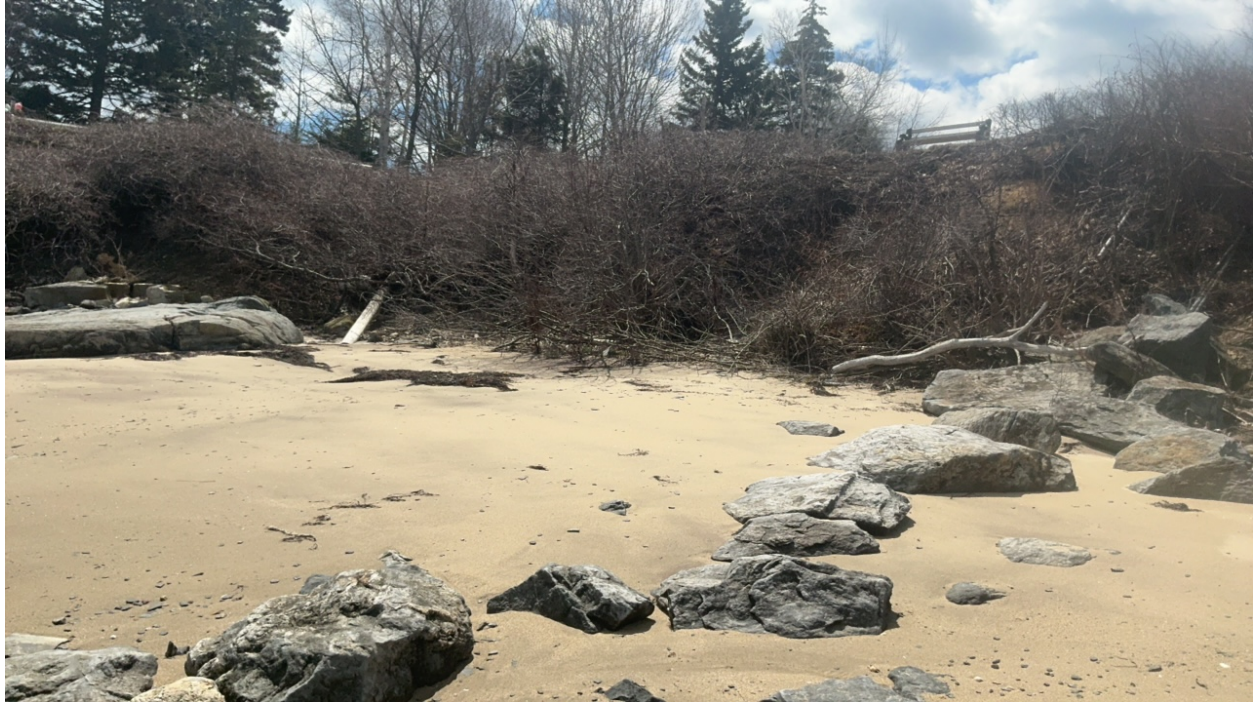
Indications of bluff erosion at the East End site include bare soil on the bluff face, and exposed, overhanging roots at the bluff crest from soil slumping. Signs of groundwater saturation included observable groundwater seeps and soil with pooling water. This extensive groundwater saturation is likely contributing to erosion and instability of the bluff.

**Figure 1:** A section of the beach and coastal bluff at the East End site.

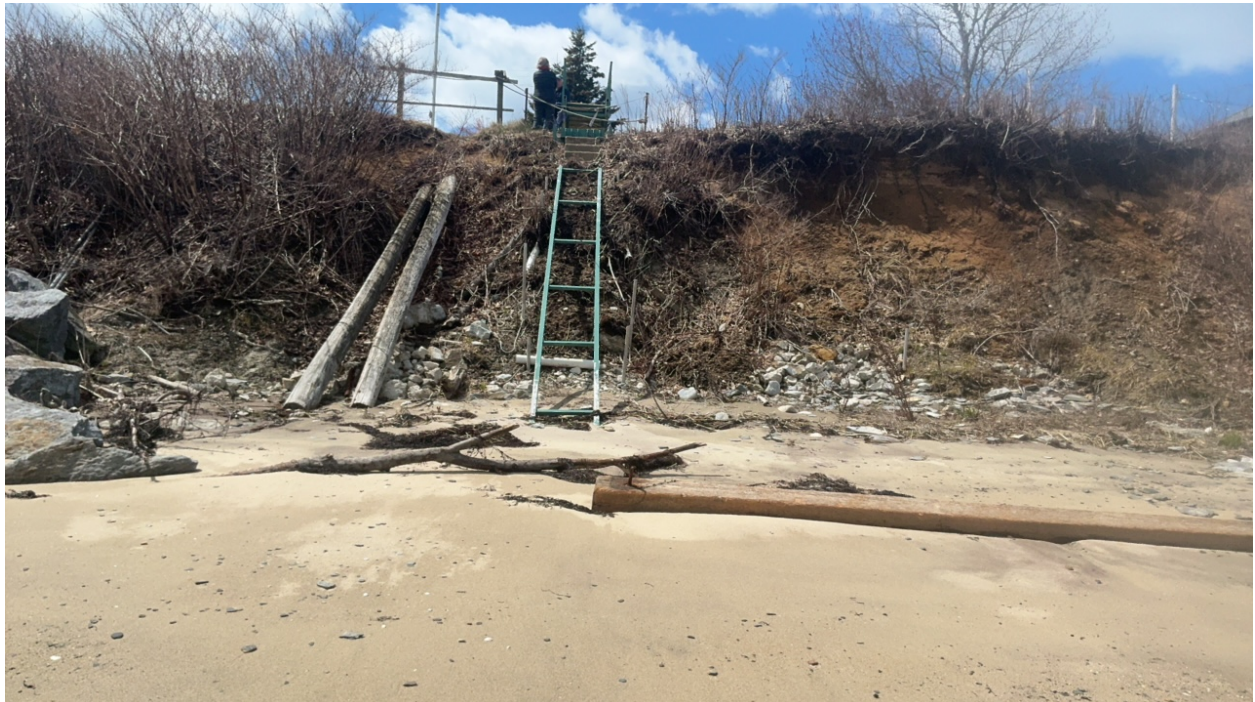
**Figure 2:** A section of the beach and coastal bluff at the East End site, including the access stairs.

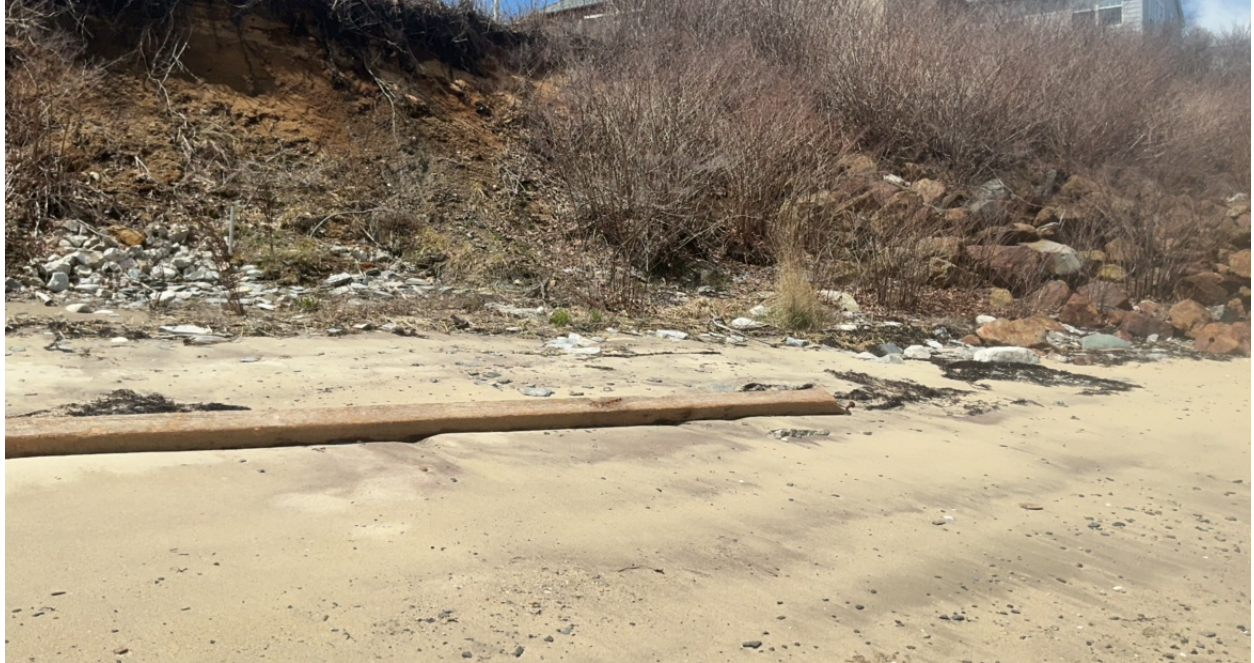
**Figure 3:** A section of the beach and coastal bluff at the East End site, including the transition to riprap stabilization of the bluff at the neighboring property line.

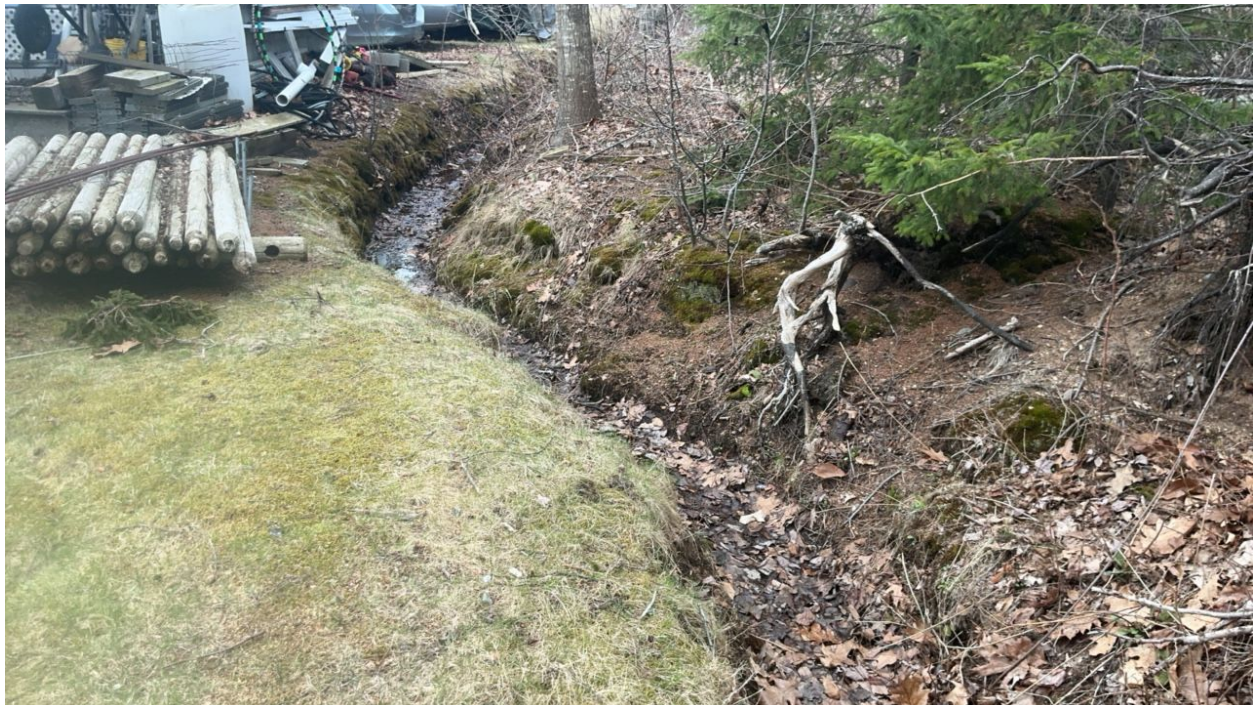
**Figure 4:** The drainage ditch bordering the East End site to the east.

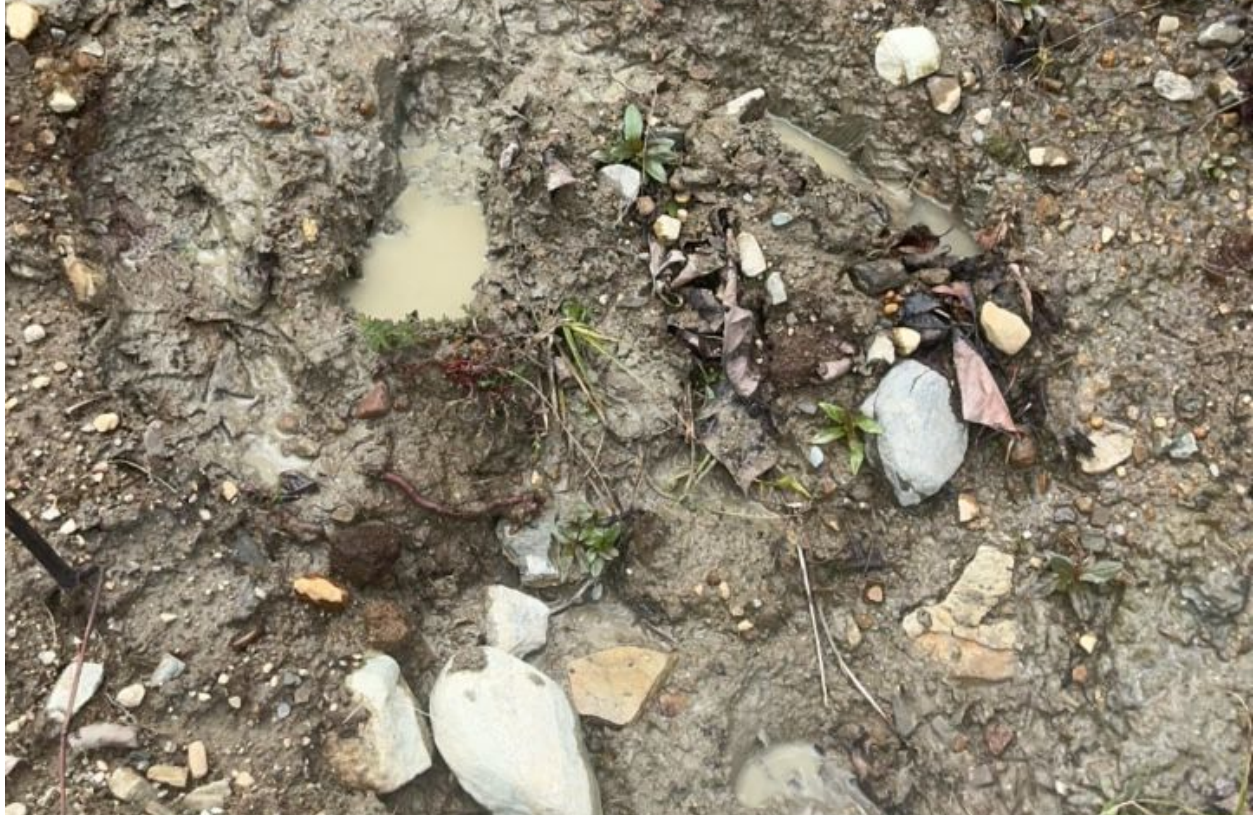
**Figure 5:** Saturated soil and pooling water observed on the bluff face.

| <b>Groundwater</b> | High - Groundwater is severely impacting the stability of the slope |

Banks that are oversaturated with groundwater are less stable and more vulnerable to erosion. Signs of groundwater saturation like shimmery soil and standing water were visible at the site. Some groundwater saturation is caused by land uses, and can therefore be more easily mitigated than saturation due to natural hydrology. Common causes of groundwater oversaturation include septic systems and overwatered lawns or gardens. Aging or undersized septic systems can release more water into the soil than intended, so ensuring that septic systems are maintained and pumped following a septic professional's recommended schedule will benefit bank stability. Watering lawns or gardens as little as possible is also a beneficial management practice.

Another common contributing factor to groundwater saturation is a lack of vegetation on the property and shoreline. Deep rooted vegetation, especially larger woody plants like shrubs or trees, take up significant amounts of water from the soil. When properties are primarily covered by structures and lawns, this water uptake is significantly reduced. Adding a vegetated buffer to the shoreline in place of lawn areas can improve groundwater uptake, and thereby increase overall bank stability.

After land use contributions are addressed, groundwater management methods on the bank can be considered if groundwater oversaturation persists. One OUR SHORE recommended option is a live pole drain. This technique uses bundled live branch cuttings installed in trenches into the face of the bluff, providing a path for groundwater to drain from the bank (Fig. 10). The live cuttings will root and grow over time, helping to revegetate the bank and provide additional groundwater uptake.

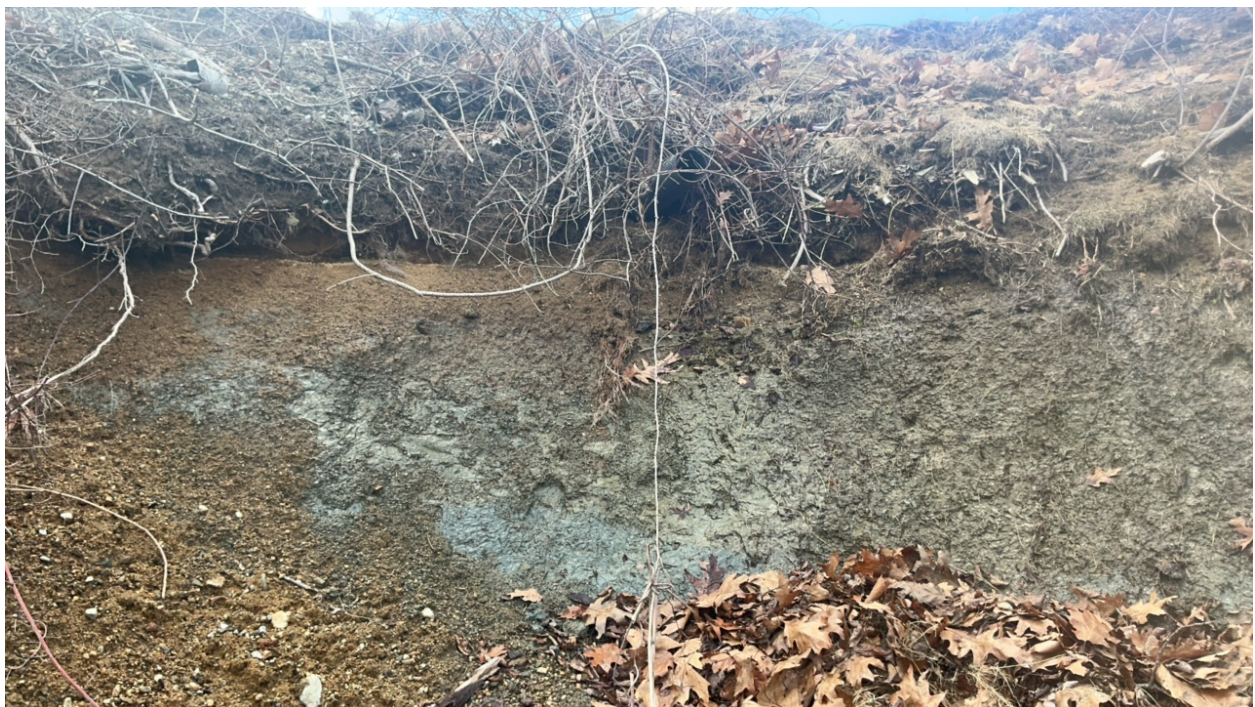
**Figure 6:** Dark and shimmery soil indicative of groundwater saturation near the top of the bluff face.

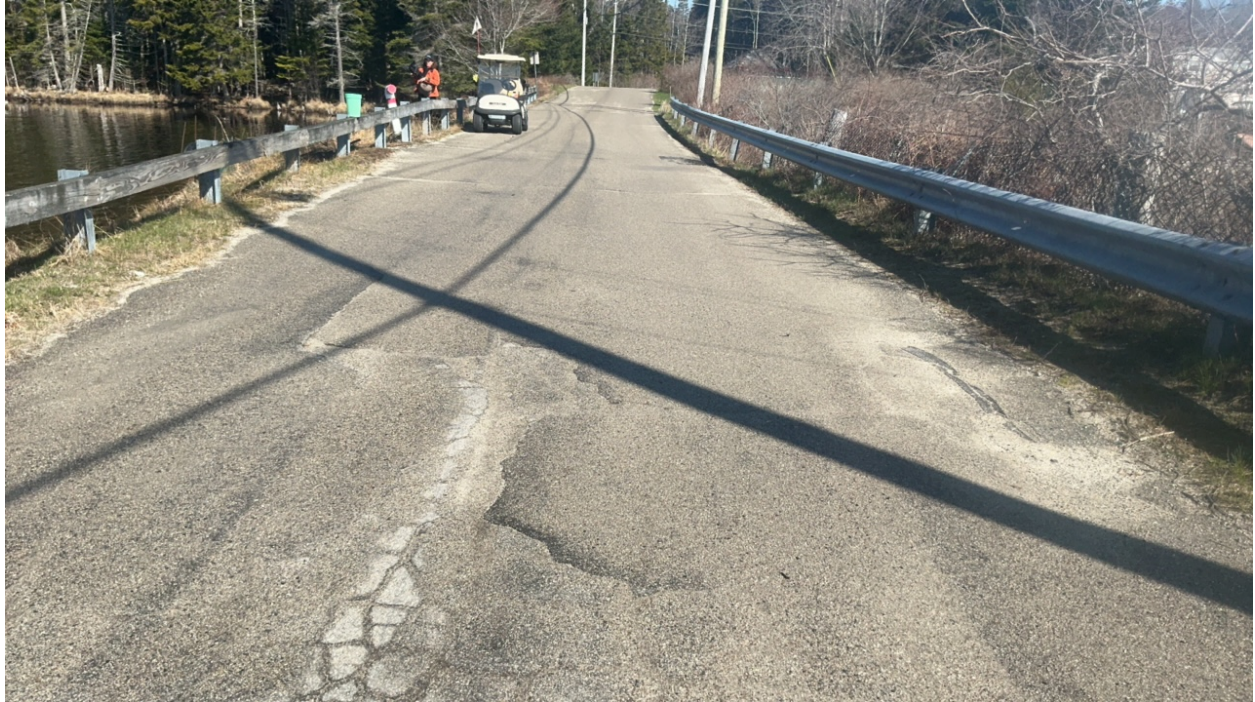
The shorelines at the Fern Ave site experience a combination of surface water and wave erosion. Runoff from the road has formed gullies on both sides of the road, worsened in areas where vegetation has been degraded by human and beaver foot traffic. While the riprap stone prevents wave erosion under normal tide and weather conditions, the coastal bluff was eroded during the 2024 winter storms, contributing to undermining and damage of Fern Ave. Federal Emergency Management Agency (FEMA) funds have been designated for repair and future hazard mitigation of this section of Fern Ave.

**Figure 1:** The assessed section of Fern Avenue facing northwest. The freshwater pond is to the left of the photo and the tidal shoreline to the right.

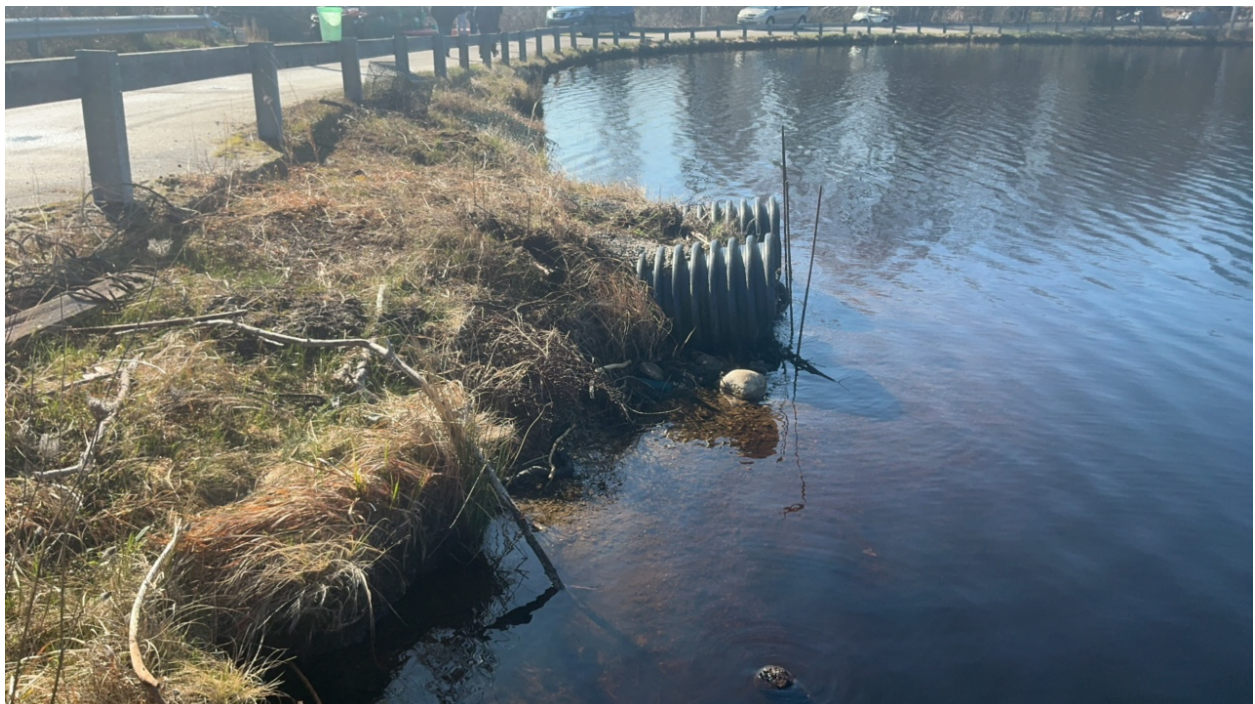
The culvert under Fern Ave is constructed of two plastic pipes that allow water to drain from the pond. The outlets of the pipes are above the high tide elevation, and the Maine Tidal Restriction Atlas identifies the culvert system as a tidal restriction. Beavers reside in the pond and have repeatedly attempted to block the culverts, creating a need for ongoing management to remove these blockages.

**Figure 2:** The shoreline of the freshwater pond and the inlets to the culvert underneath Fern Avenue.

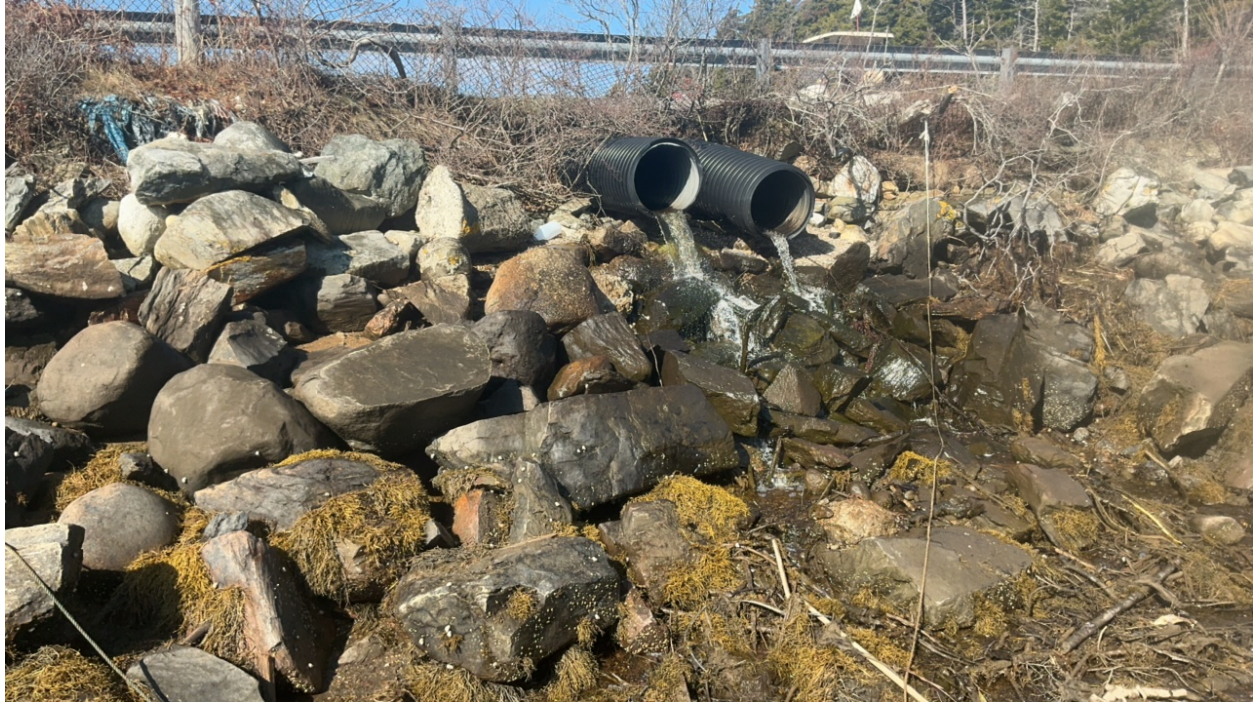
**Figure 3:** The tidal shoreline adjacent to Fern Avenue and the culvert outlets.

The coastal bluff is eroding despite existing riprap stone placement. The top of the bluff, above the riprap, has eroded during storms. The culverts and road surface also showed signs of shifting and damage during the January 2024 winter storms, which may indicate that soil behind the riprap is being washed out through gaps in the stone. Older riprap designs did not always have a filter layer installed underneath the riprap stone to prevent soil washout, and there did not appear to be a filter layer incorporated into the riprap at the Fern Ave site.

Adding vegetation and considering options to add a filter layer are recommended to make the existing riprap design more effective and more resilient to future storms. The structure and root systems of plants growing within riprap help hold the stones in place on the soil of the bank. This will limit movement and downward slumping of the stones that could leave higher areas of the bank exposed. The roots also act as a filter layer to help trap sediment and prevent soil from being washed out. Live staking is a simple and effective method of adding vegetation to existing riprap, as the stakes can be pushed through gaps in the stones into the underlying soil (Fig. 9). Salt tolerant plants should be used, especially in areas that may experience salt spray or tidal inundation. Adding vegetation may not be possible on lower sections of the bank that are frequently submerged at high tide. Adding a filter layer like fine gravel or a natural fiber erosion control blanket is also beneficial for increasing riprap's durability, but can be difficult to add riprap that is already in place. If modifications to the riprap are made during FEMA-funded repairs, the full OUR SHORE guide provides information on selecting filter layers that support vegetation and long-term resilience.

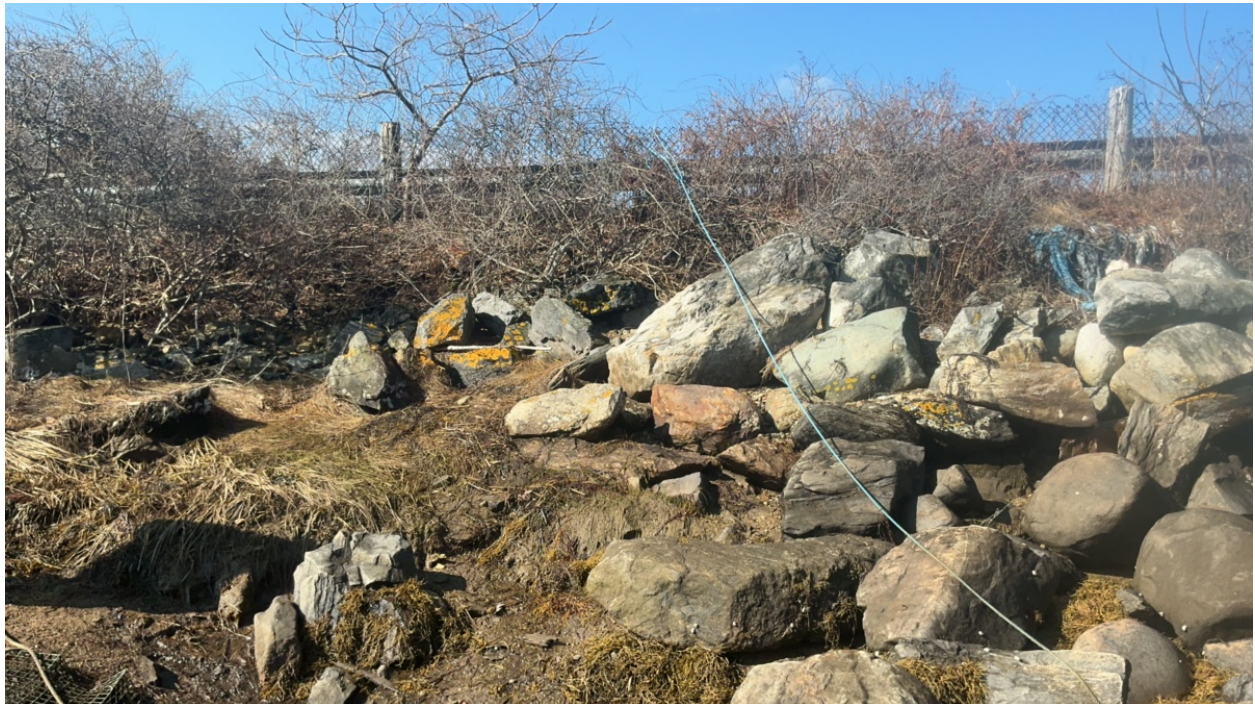
**Figure 4:** The tidal shoreline to the left of the culverts showing the transition from placed stones to salt marsh vegetation.

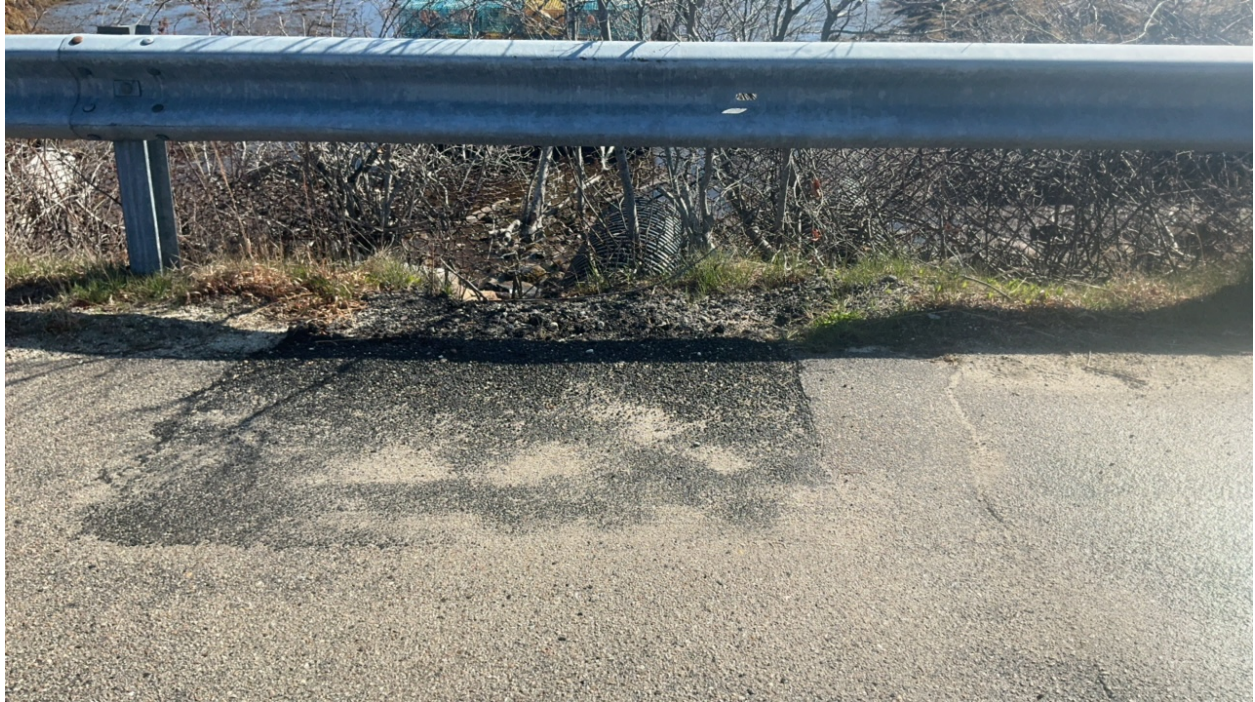
**Figure 5:** This section of Fern Ave above the culvert had to be patched after it was undermined and damaged during the 2024 winter storms.

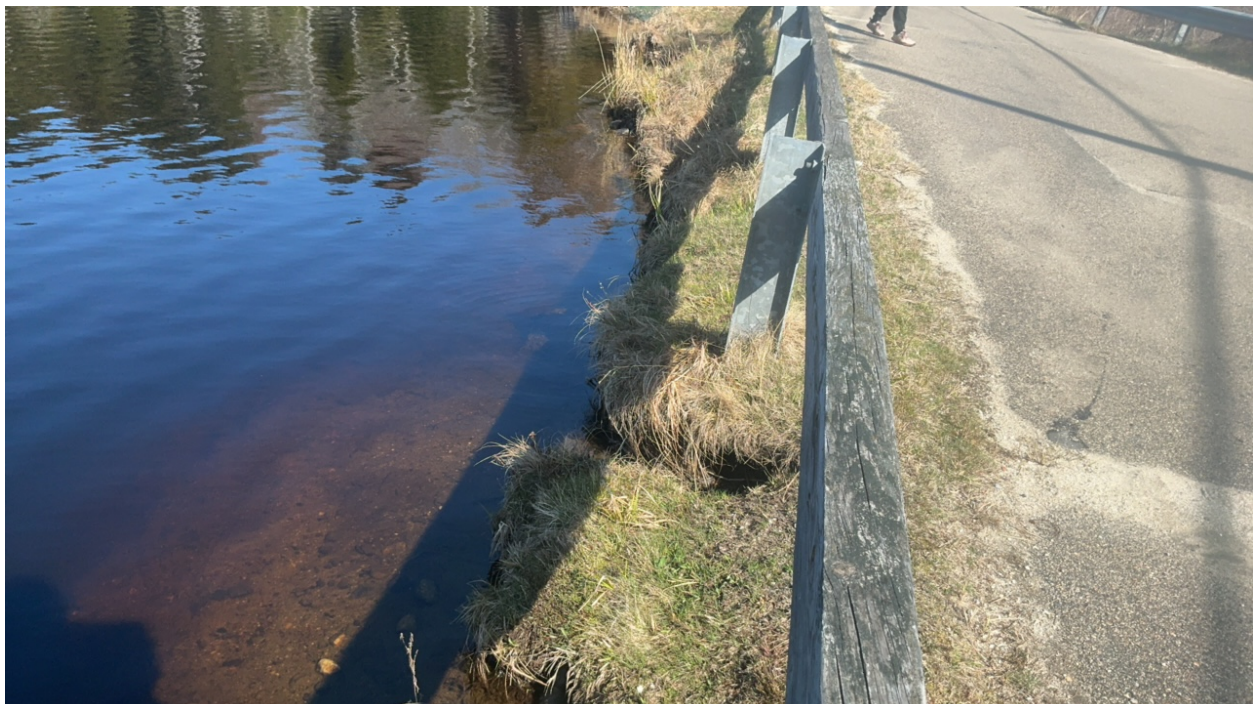
**Figure 6:** Runoff from the road has carved gullies into the pond shoreline.

| <b>Surface Water Flow to Bank</b> | High - Concentrated or channelized flow is directed down the embankment with rills and gully erosion. No protection is in place |

Since the bank is narrow and showing signs of erosion, choosing planting methods that minimize soil disturbance is recommended. For shrubs, live staking would be effective for this bank area. Live staking uses branch cuttings from certain quickly-rooting shrubs, which are pushed into the soil to sprout and grow new plants. For shrubs that cannot be live staked and herbaceous plants, using bare-root plants or plugs and planting with a bulb auger or by slit planting is preferable to digging holes for larger potted plants.

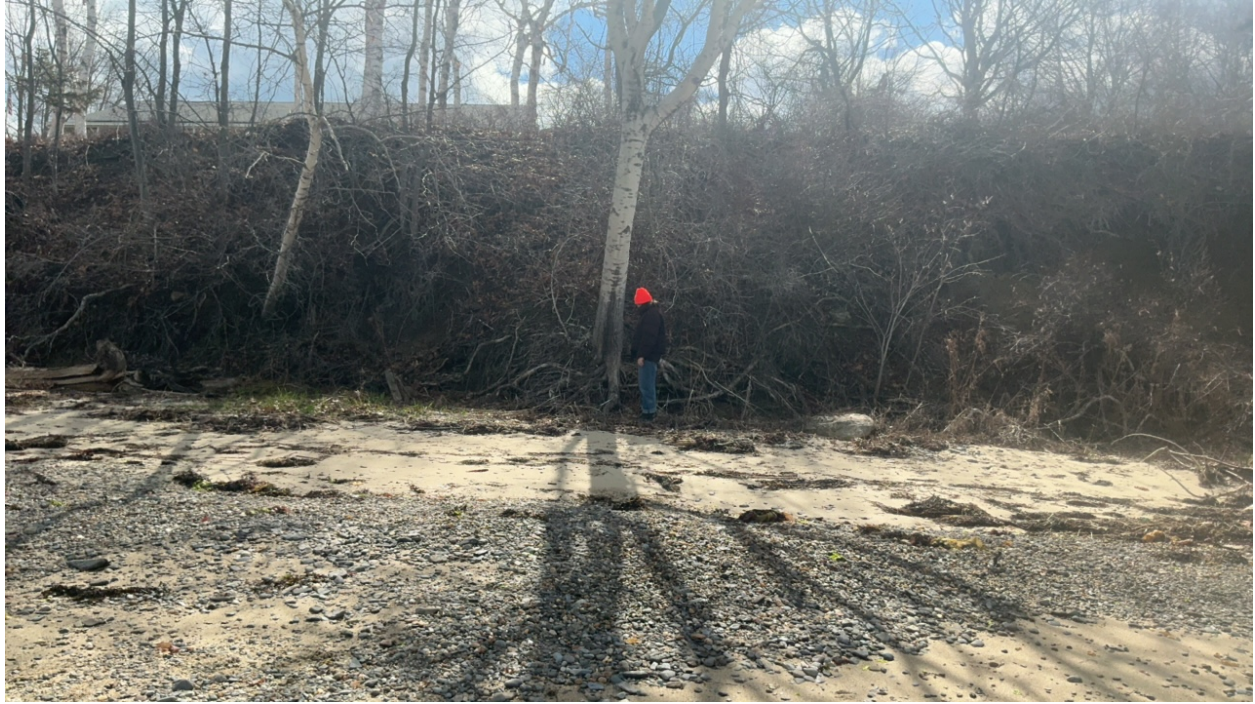
The coastal bluff at the VFW Hall is mapped as Unstable by the Maine Geological Survey. Signs of bluff erosion seen at the site include bare soil on the bluff face and leaning trees indicative of bluff slumping. Dark and saturated soil on the bluff face suggests that groundwater is contributing to bank instability at the site. A gully caused by surface water runoff has formed underneath the shoreline access stairs, leading the property manager to place riprap stone protection.

**Figure 1:** A section of the beach and coastal bluff at the VFW Hall.

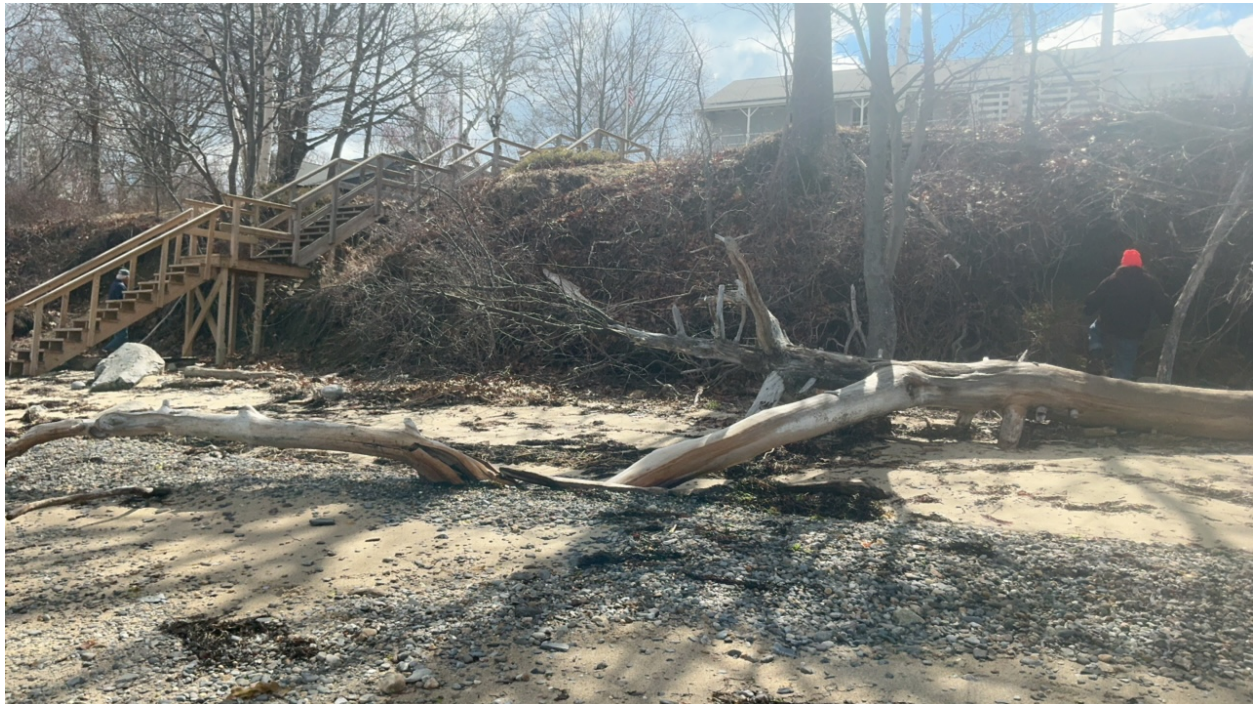
**Figure 2:** A section of the beach and coastal bluff at the VFW Hall including the shoreline access stairs.

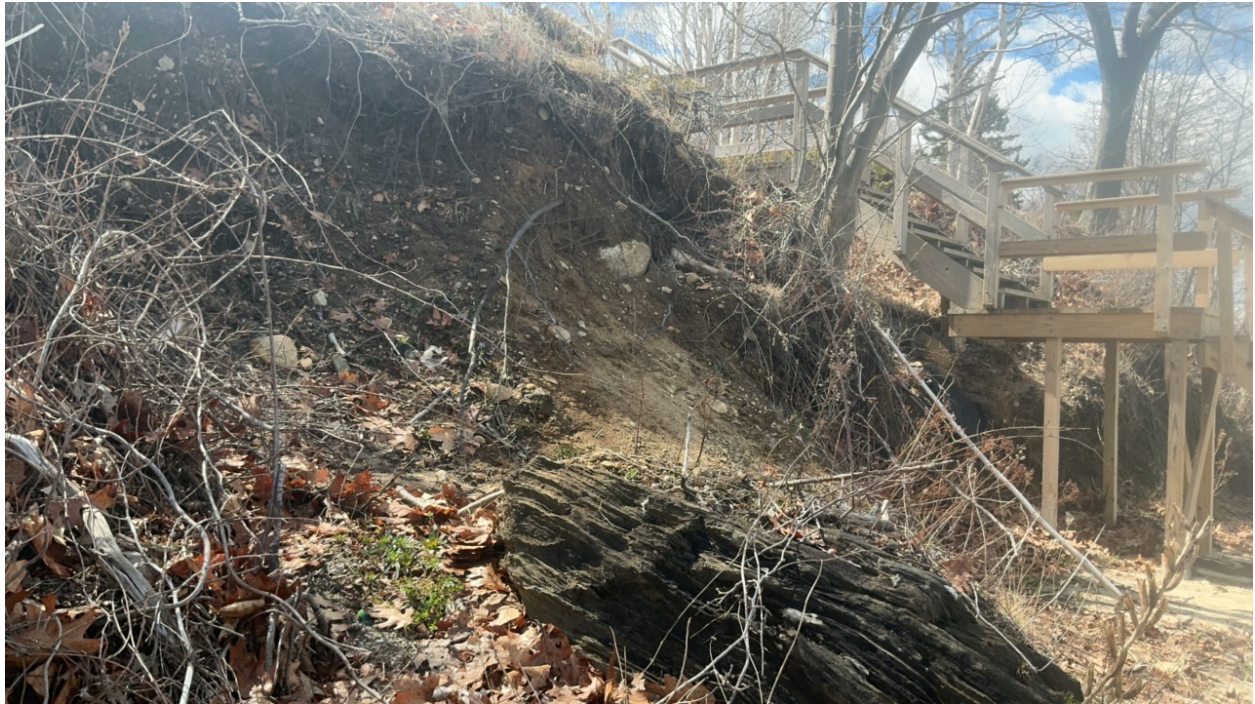
**Figure 3:** Bare soil and bluff erosion on the shoreline of the VFW Hall site.

A vegetative buffer provides many functions in a shoreline stabilization project. The deep, fibrous root systems of native plants help hold soil in place, and aboveground plant material slows surface runoff and can help buffer wave energy during storms. For slopes with groundwater oversaturation, like the VFW Hall site, vegetated buffers can also help reduce groundwater saturation because the plants will take up more water from the soil than shallow-rooted turf grass. Planting a vegetated buffer of at least 10-15 ft in width from the top of the bluff is recommended at the VFW Hall. A functional buffer for erosion control should include densely planted native plants, including a mix of shrubs, grasses, and groundcover

A riprap stone toe combined with vegetation is another alternative. Stone is placed only at the base of the bluff subject to most frequent wave energy and erosion, which minimizes the cost and environmental impact of the project. Above the stone toe, dense native vegetation is used as the primary method of bank stabilization. OUR SHORE recommends vegetating riprap whenever possible. This increases connectivity between the stones and underlying soil through plant root systems, making the entire structure more durable and reducing maintenance requirements. To allow for vegetation to grow within riprap, replacing the plastic geotextile layer used in standard riprap designs with either a layer of gravel and small stones or a natural fiber blanket is recommended. Plants should be installed directly into the riprap during installation, either using gaps between stones as planting pockets for container plants, or by installing live stakes, which are branch cuttings of quickly-rooted shrubs that are planted into the soil.

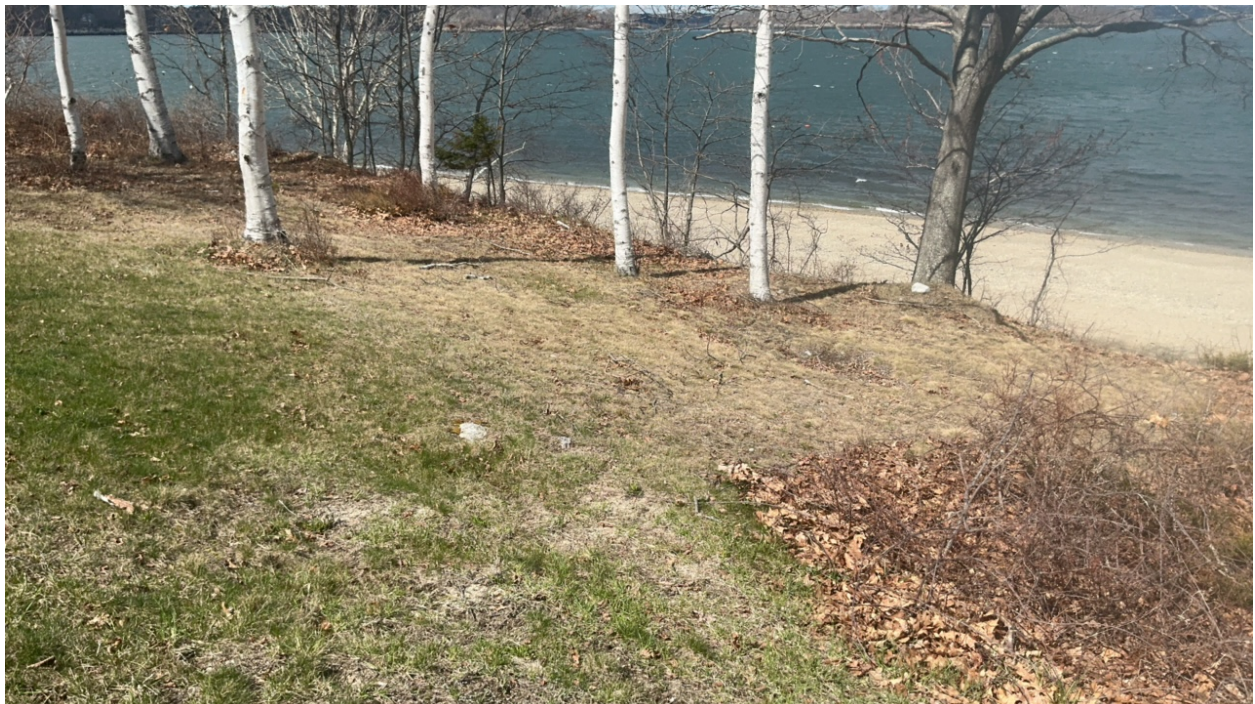
**Figure 4:** Bluff crest and upland areas at the VFW Hall.

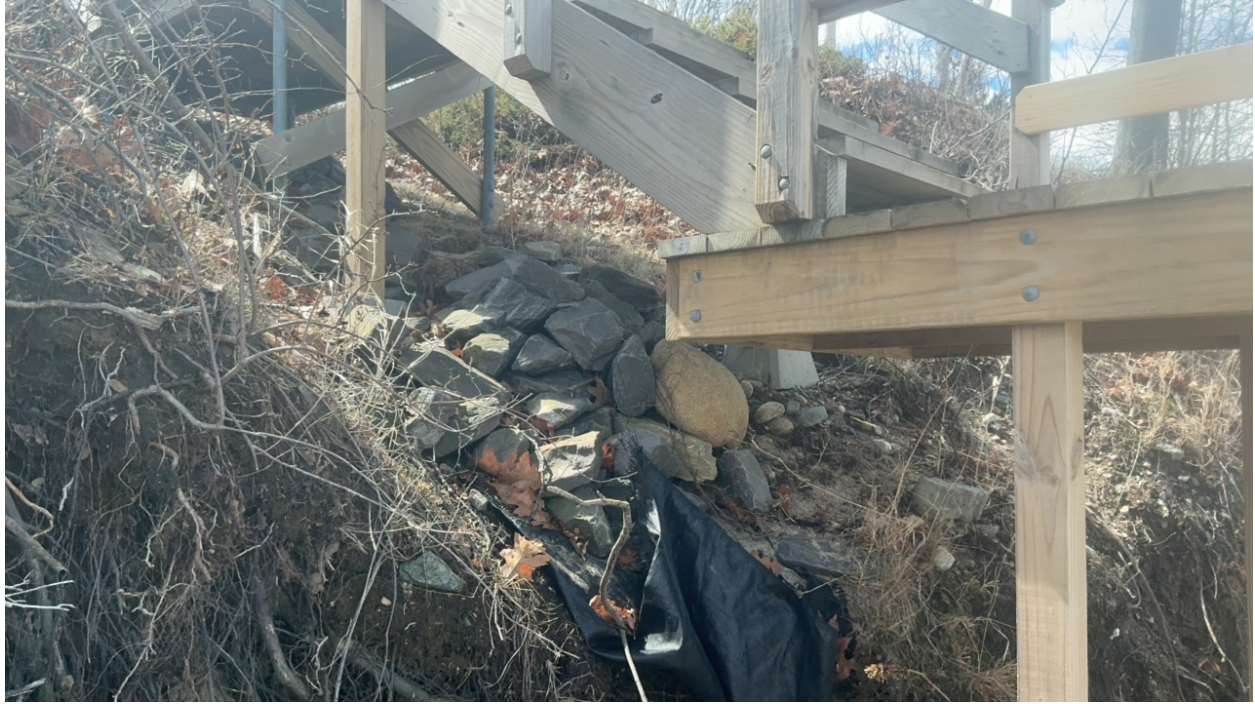
**Figure 5:** Gully beneath the shoreline access stairs and stone placed to prevent further erosion.

While adding vegetation underneath a structure can be challenging due to low light conditions, shade tolerant plants can often be successful in these areas. Looking at what plants are growing in similar nearby areas is a helpful tool in plant selection. For example, property owners also on the west end of Long Island reported blackberry shrubs successfully growing under similar staircases. The geotextile fabric currently placed under the stones will prevent plants from growing into the underlying soil, so it will need to be removed to install vegetation. An erosion control blanket made of biodegradable materials that will allow plant growth could be used as a replacement, if desired. For small areas, like the section of bank beneath the stairs, the thick burlap bags used by coffee roasters make an effective alternative to purchased erosion control blankets, and can often be sourced for free from local companies. The current riprap stones can be replaced after the geotextile is removed for additional surface protection while vegetation establishes.

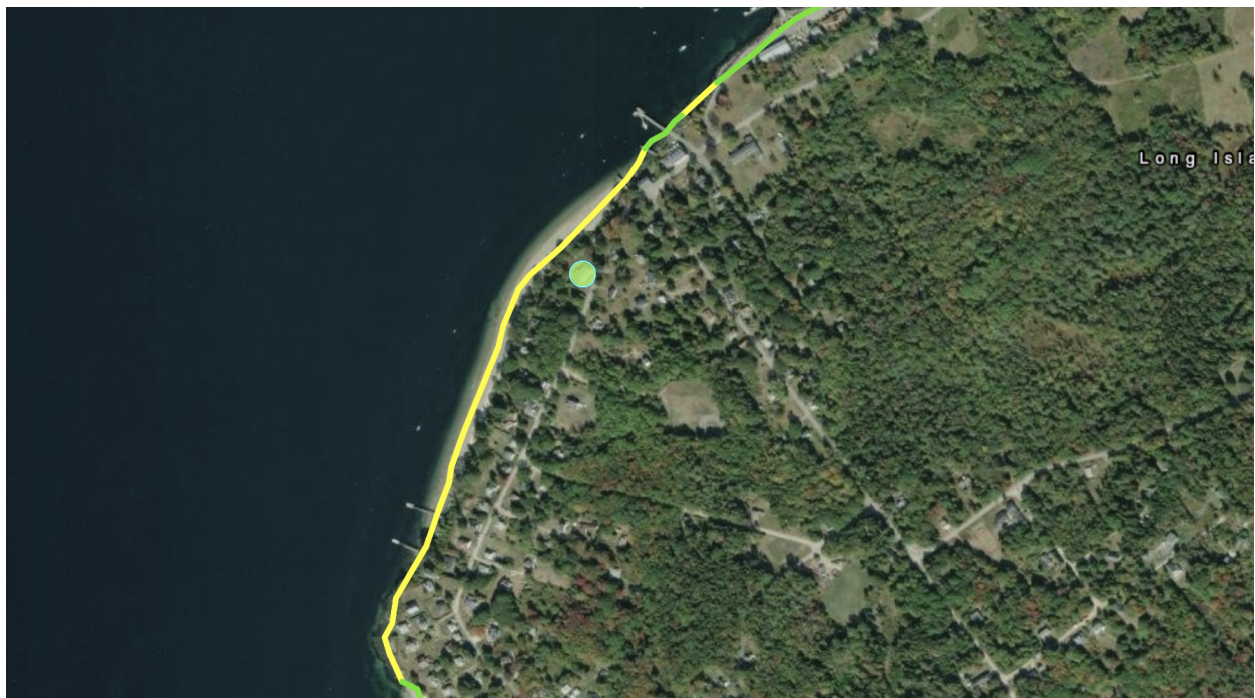
**Figure 8:** Maine Geological Survey Coastal Bluff map of the VFW Hall site. The yellow line indicates that the bluff was mapped as Unstable.
