# OUR SHORE Coastal Erosion Assessments and Site Reports: Peaks Island

Emma Polhemus, Shore Corps Steward, Maine Conservation Corps & Island Institute  
May 2026

**OURSHORE Quick Assessment: Boat Ramp**  
**Centennial St, Peaks Island, ME**

**OURSHORE Quick Assessment: Ferry Beach**  
**Welch St, Peaks Island, ME**

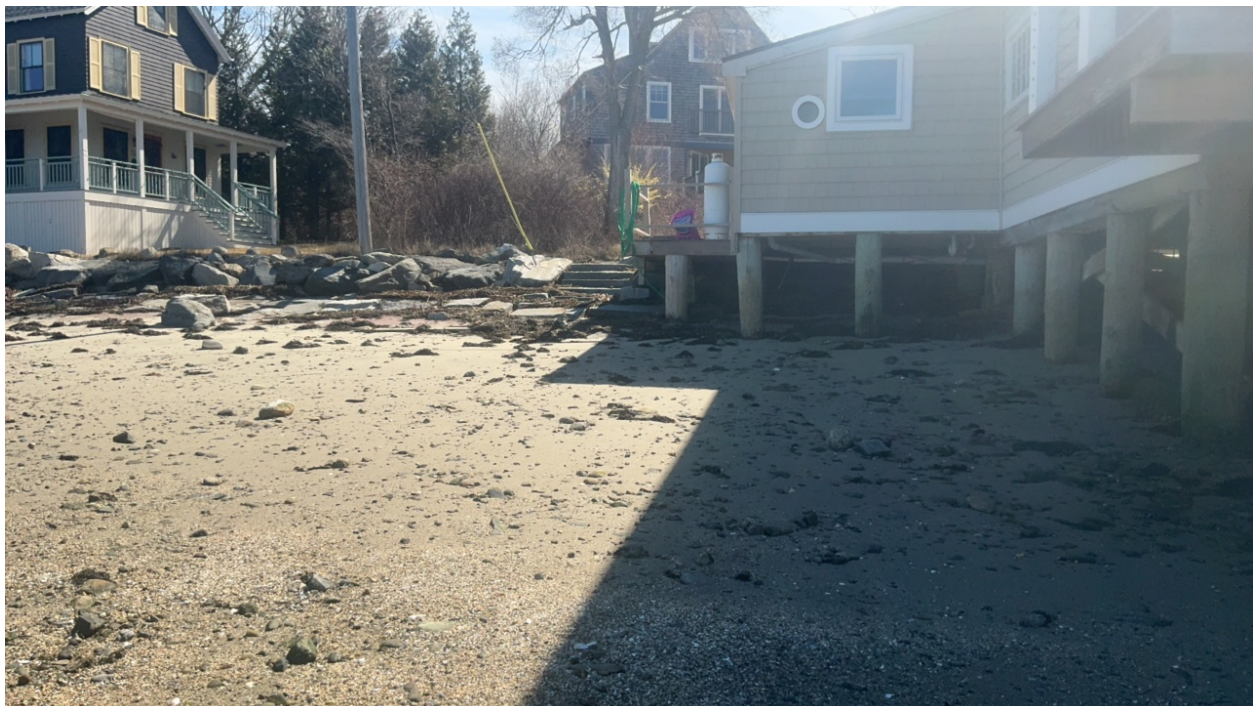
**Figure 2:** Photograph of the beach and shoreline of the neighboring private property to the east of Centennial St.

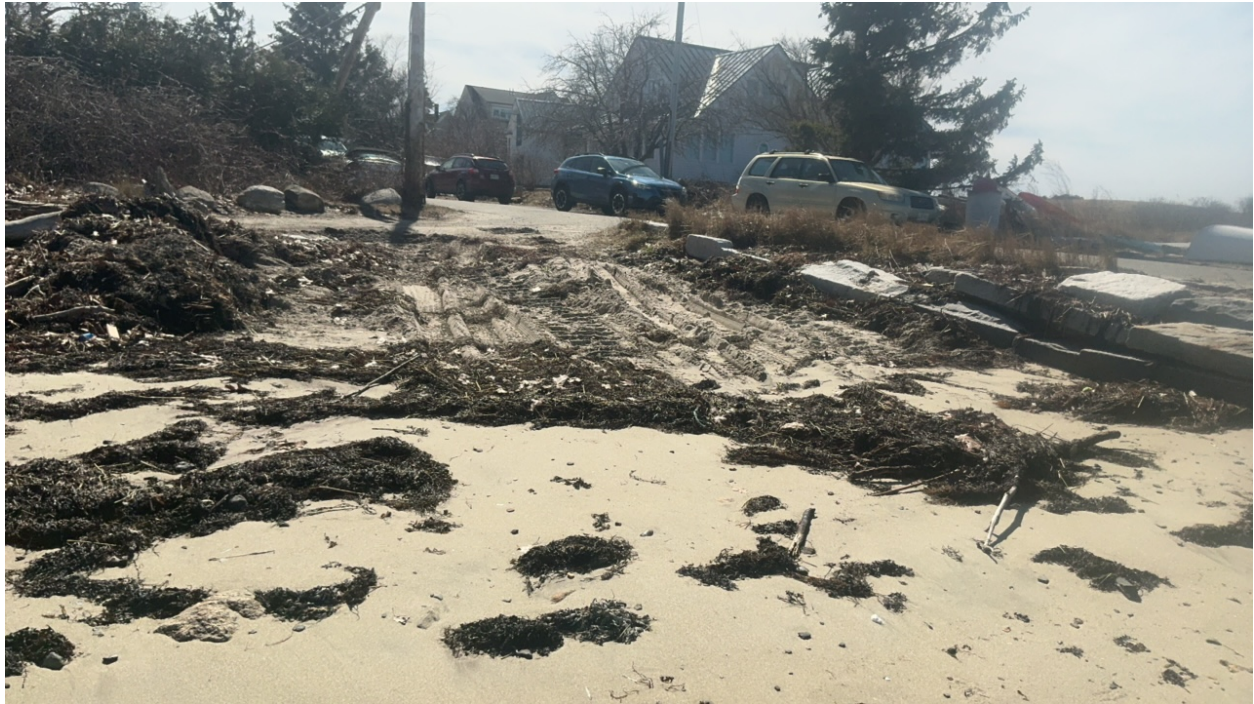
**Figure 3:** Photograph of the east side of the Centennial St boat ramp and boat ramp parking.

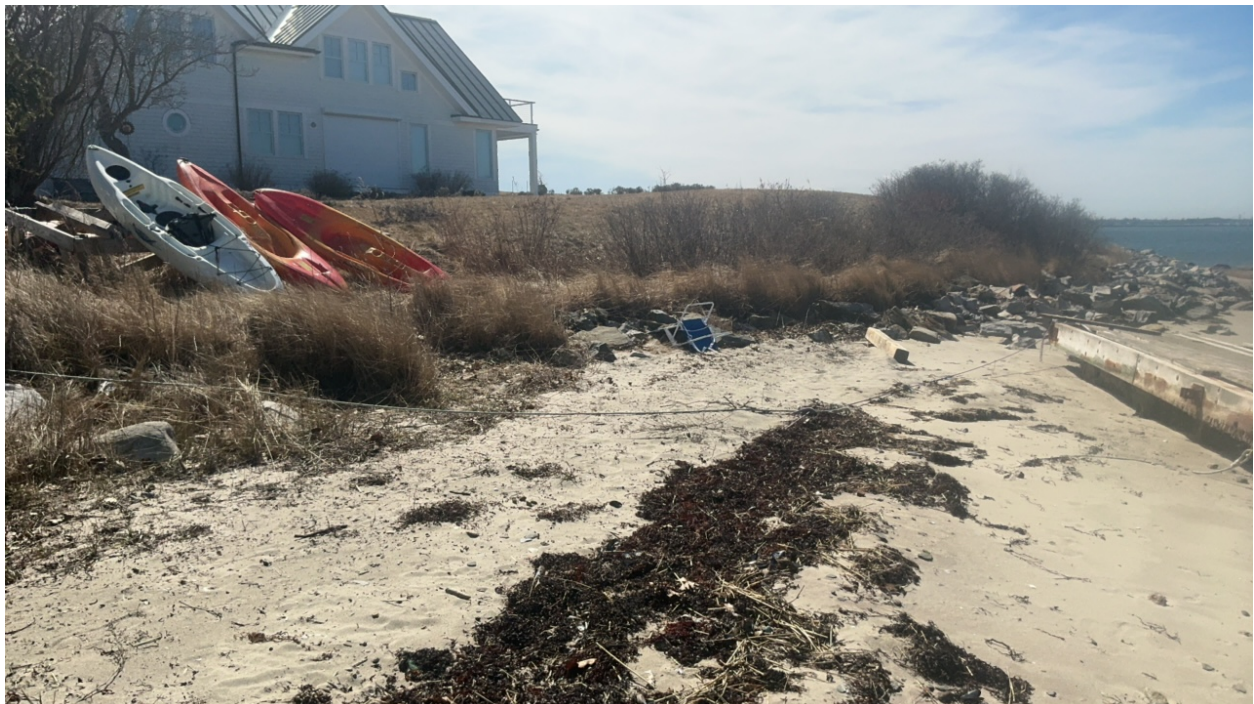
**Figure 4:** Photograph of the beach and shoreline of the neighboring private property to the west of Centennial St.

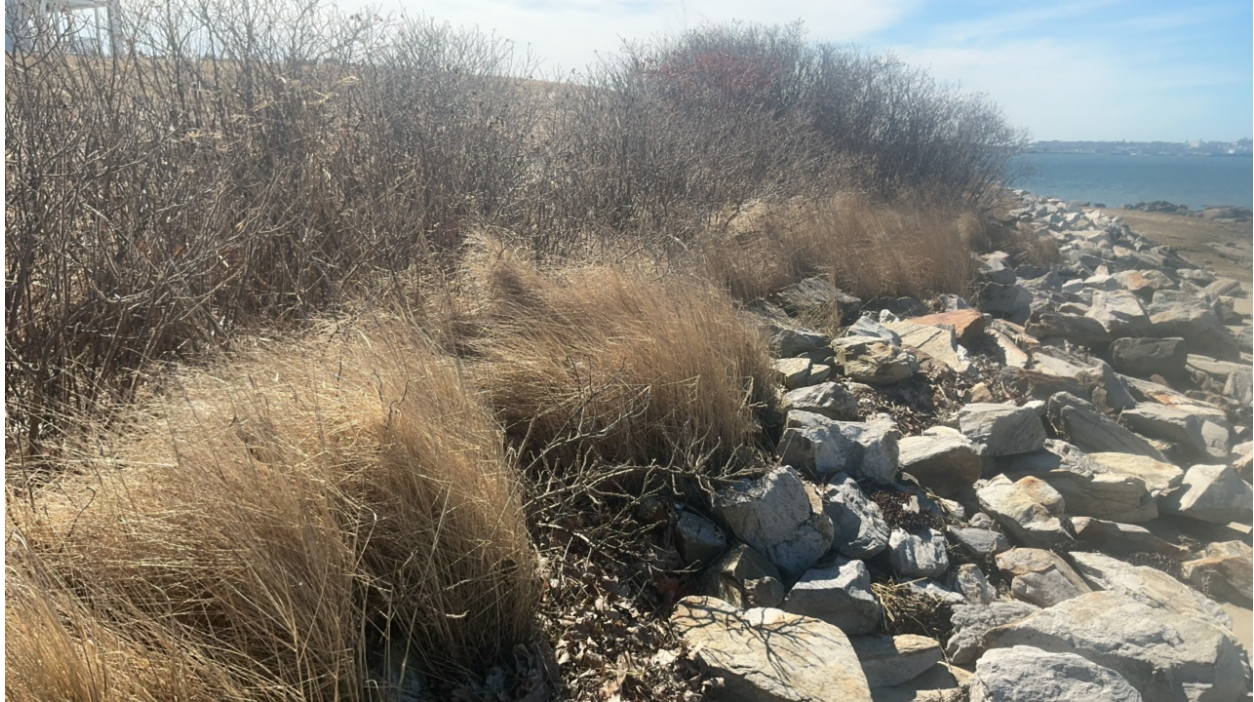
**Figure 5:** Photograph of existing riprap stabilization on a private property adjacent to the Centennial St boat ramp.

Adding vegetation to an existing riprap design can enhance the shear strength and durability of the structure while improving shoreline habitat quality. Some riprap structures have plastic geotextile fabric installed underneath the stone. This fabric prevents plant roots from reaching the underlying soil or growing within the riprap, so a structure with geotextile fabric will require specific techniques to add vegetation. Live stakes, or branch cuttings of easily rooted shrubs, can be pushed directly through gaps in the stone into the underlying soil (Fig. 9). If the stakes aren't able to puncture through the filter fabric, a hole can be cut into the fabric, or a piece of rebar and a mallet can be used to first create a pilot hole for the live stake. Installing potted plants into existing riprap is also possible, but it requires more disturbance of the existing riprap design, since stones will have to be moved to create gaps large enough to place the plants.

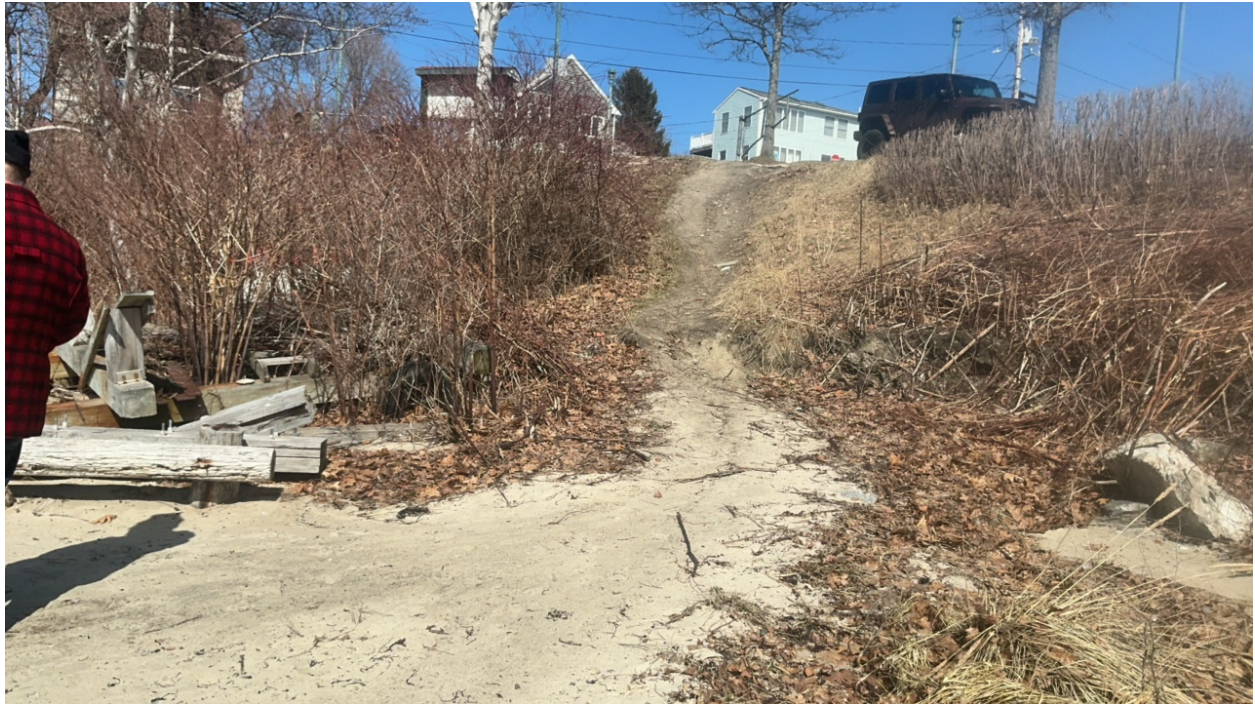
As a frequently used public beach, erosion at Ferry Beach is highly visible to the community. The two key erosion issues at the site are toe erosion, worsened by severe winter storm events, and erosion from surface water on the footpath and on both sides of the wooden stairs.

**Figure 1:** Photo of a section of the Ferry Beach bank including the footpath.

At this site and areas with similar slopes, preventing surface erosion on dirt paths is difficult and requires regular maintenance, especially when there are roads and other impervious surfaces nearby. Since the stairs provide a stable point of access to the beach, ceasing use of the footpath and revegetating this area will be the most effective method of preventing overland erosion of this area. Temporary slope interruption techniques, which prevent water from taking a direct path down the slope, will limit erosion and speed up the revegetation process. Slope interruption methods for this site could use placement of coir logs or mulch-filled "socks" horizontally across the slope (Fig. 7). Native vegetation should also be installed in the footpath area for long-term protection. Because there are nearby populations of invasive species, mature plants purchased from a nursery will be more likely to successfully establish before the knotweed or bittersweet than seeds or seedlings. Lastly, after slope interruptions and native vegetation have been installed, any remaining areas of bare soil should be covered with erosion control mix (ECM), a specialized mulch that is effective at providing long-term soil protection.

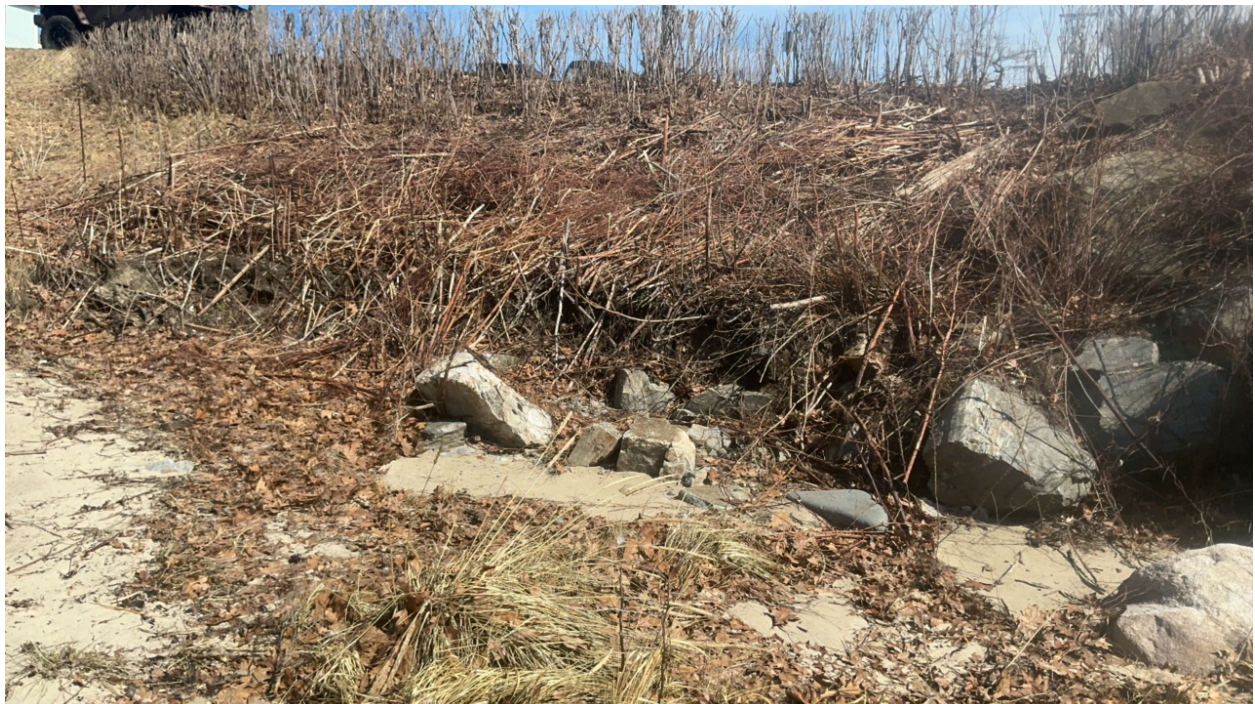
**Figure 2:** Photo of a section of the Ferry Beach bank between the footpath and access stairs.

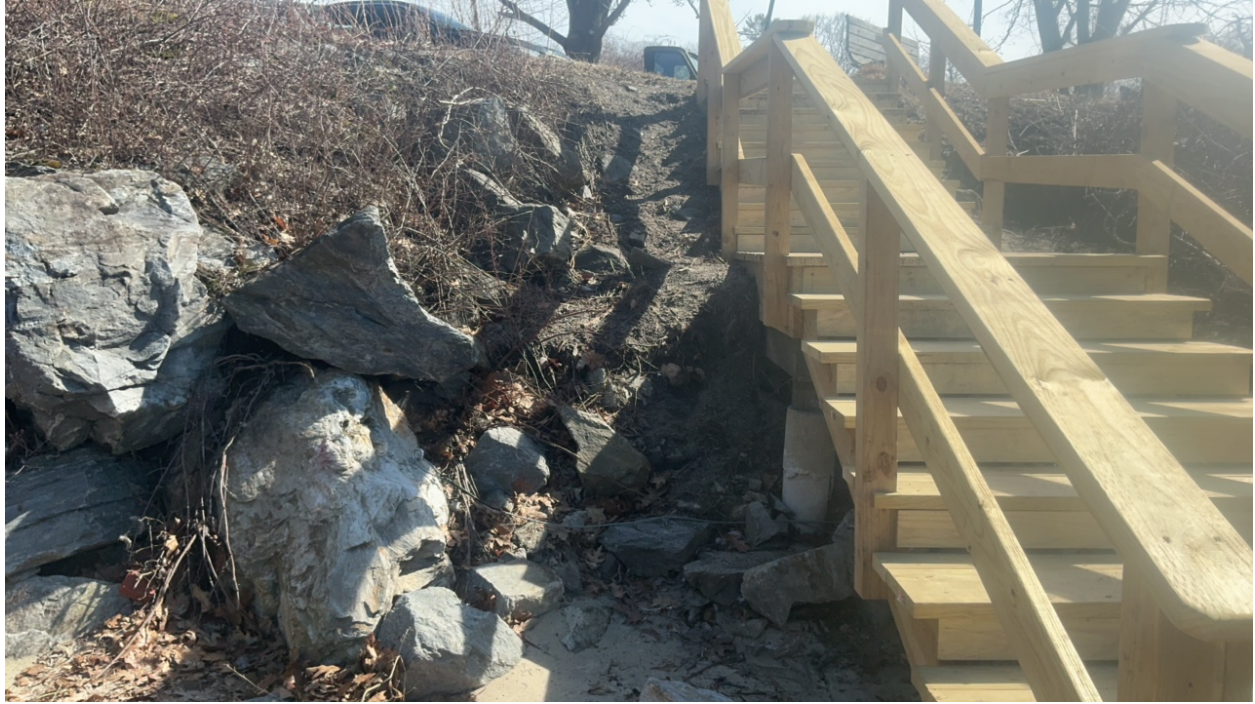
**Figure 3:** Photo of the new access stairs at Ferry Beach.

Similar techniques can be used to mitigate erosion alongside the wooden stairs. Slope interruptions, such as coir logs, should begin at the top of the stairs to prevent water from traveling down the areas of exposed soil near the stairs. Additional coir logs could be used to enhance the natural terraced areas visible next to the stairs. The flat surfaces of these terraces slow the movement of runoff and increase the amount of water that infiltrates into the soil rather than continuing down the slope. Care should be taken that any slope interruption techniques direct water away from the footprint of the stairs, rather than towards. This can be accomplished by placing the slope interruptions at a slight angle so the end of the coir log or sock next to the stairs is at a higher elevation than the far end. The coir log or sock should also extend underneath the footprint of the stairs, so runoff does not create a new channel along the side of the structure. As with the footpath, native vegetation should be installed in all areas showing signs of surface erosion, then any bare areas of soil should be mulched with ECM.

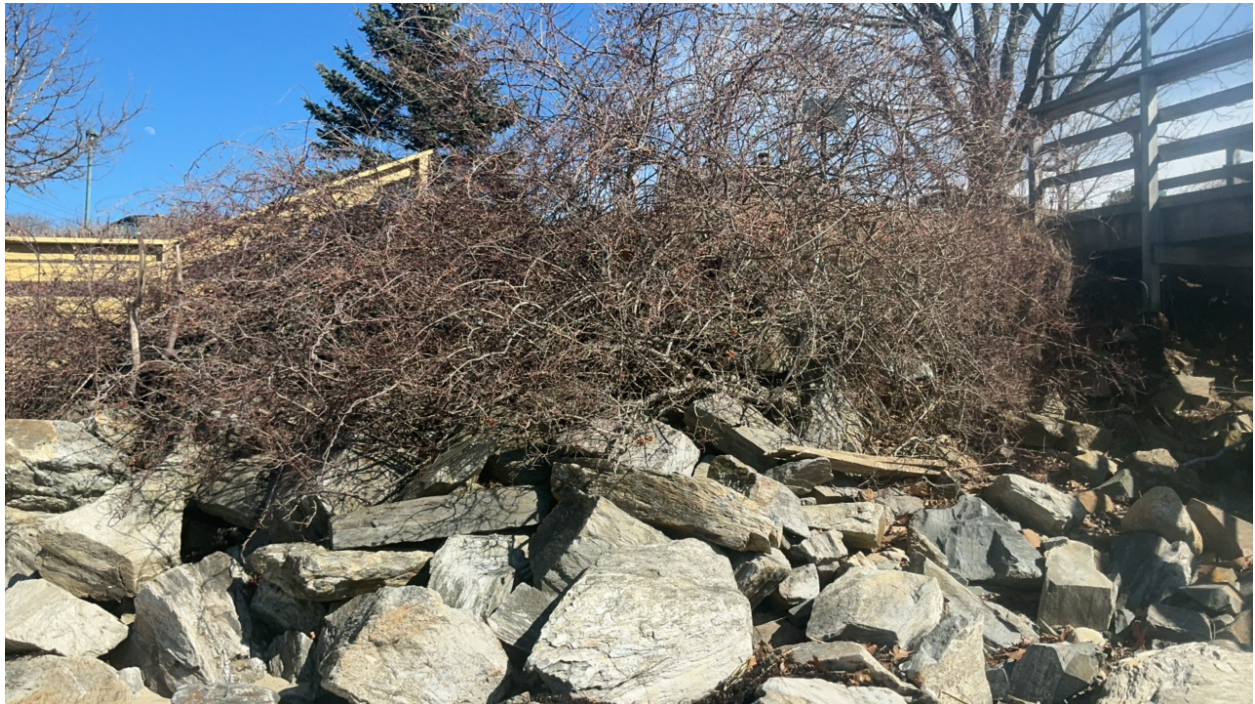
**Figure 4:** Photo of a section of the Ferry Beach bank between the access stairs and southern end, including the existing stone revetment.

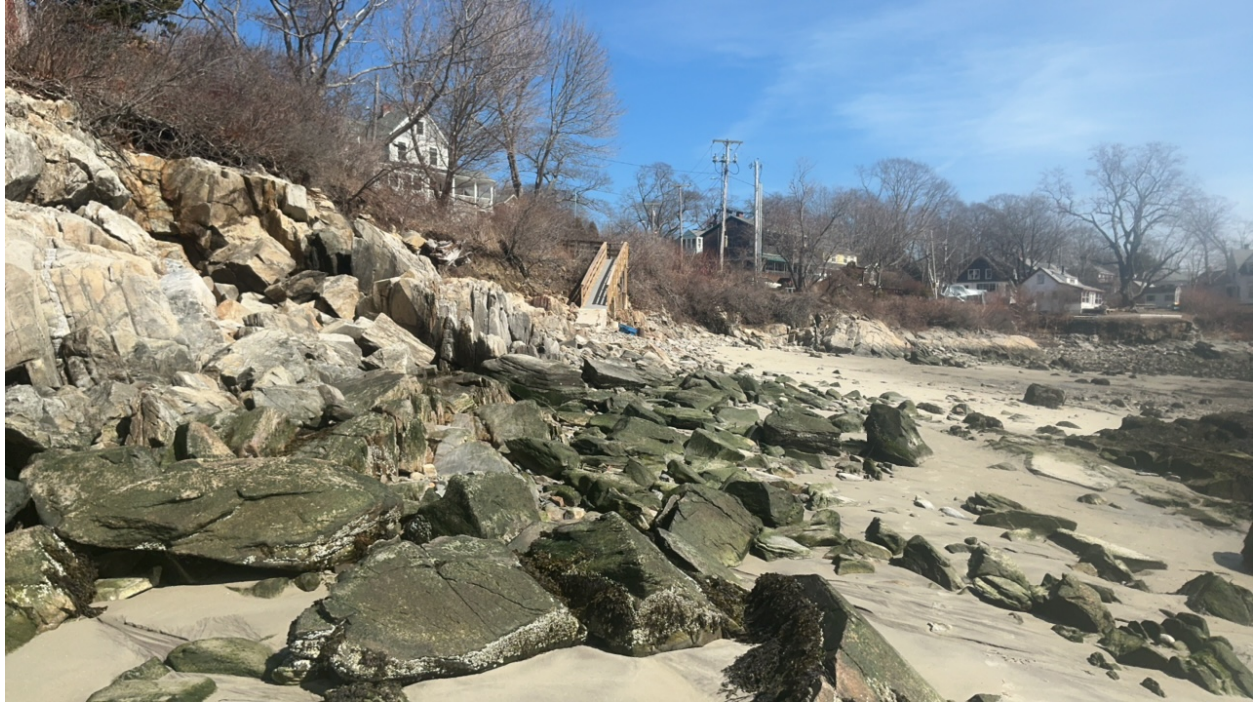
**Figure 1:** Photograph of Sandy Beach facing east, including the Torrington Ave access stairs.

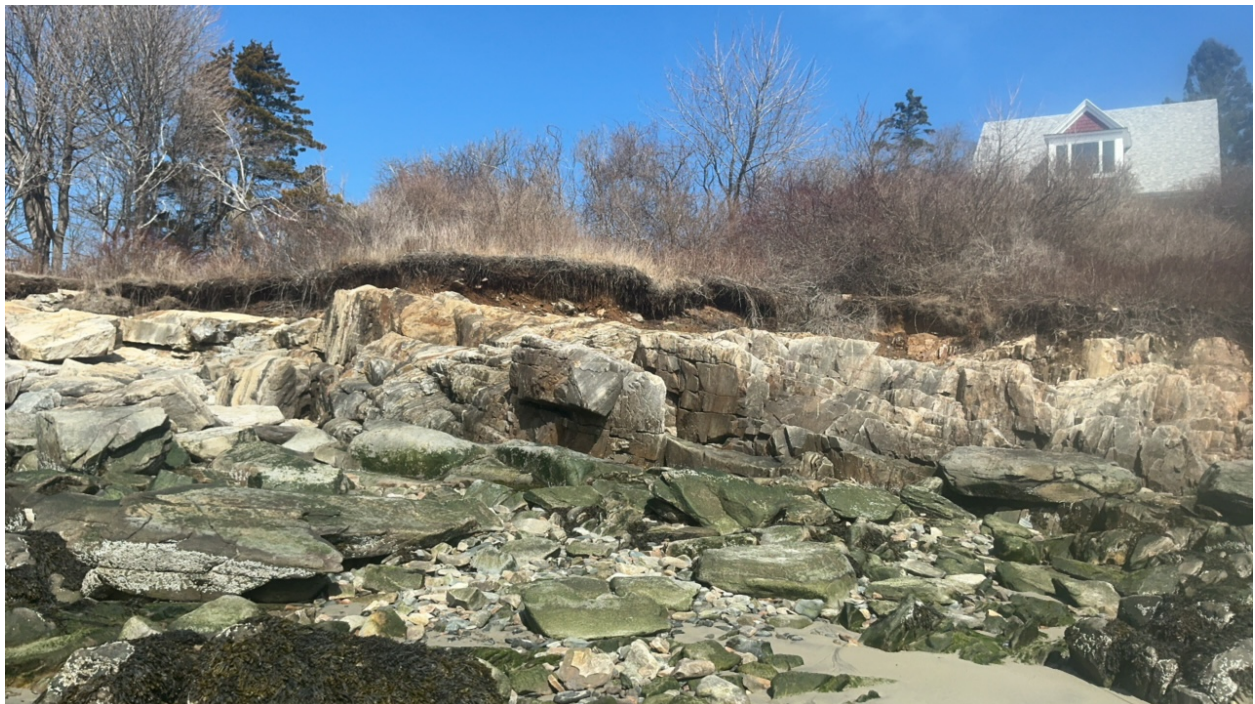
Waves do not reach the sediment portions of the bank at Sandy Beach under normal tidal and weather conditions. In large storms, waves can reach and erode the upper bank. Signs of erosion are visible, including areas of bare soil and undercutting.

**Figure 2:** Photograph of the bank of the focus area of Sandy Beach. Undercutting of the soil layer above the bedrock is visible.

Areas of bare soil that were exposed during storms are more vulnerable to future erosion by waves and surface runoff. A protective cover of vegetation should be restored to mitigate further erosion. Plants that are resilient to storm damage can be selected to create a “self-healing” system that will be able to more quickly recover from future storms. Cumberland County Soil and Water Conservation District’s Coastal Planting Guide indicates which of the listed plants are most resilient to varying and extreme weather and water conditions.

Since most of the eroding areas only receive wave action during storms, planted vegetation will likely have enough time to successfully establish before it needs to resist wave energy. However, there is some risk that if a large storm hits during the first few growing seasons, the new plantings will be damaged. While not necessary, if additional short-term protection is desired, a biodegradable fiber roll, such as coconut coir, can be installed on the bank just above the ledge to protect the soil and support newly planted vegetation. The coir log should be anchored in place against the soil using stakes and biodegradable rope. For secure placement and enhanced vegetation, using a combination of standard hardwood stakes and live stakes is recommended (Fig. 7).

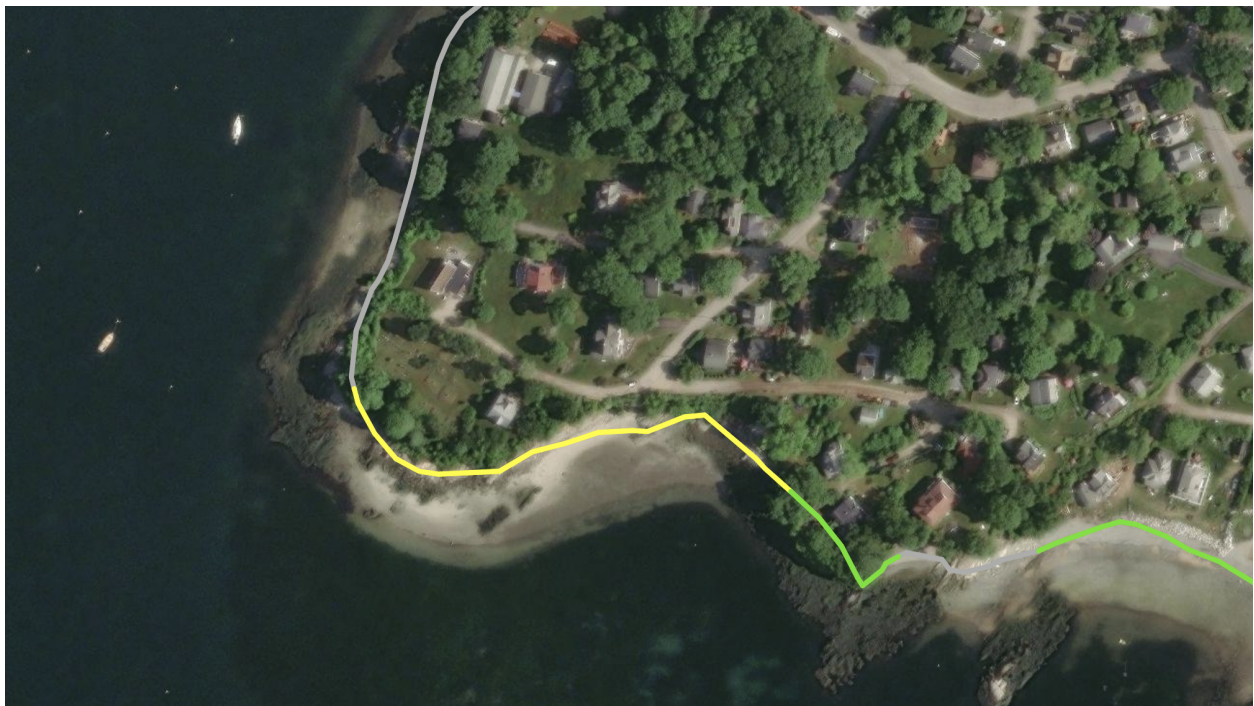
**Figure 6:** Coastal Bluff map of Sandy Beach from the Maine Geological Survey. The yellow line indicates areas of bluff mapped as Unstable from erosion.
