# OUR SHORE Coastal Erosion Assessments and Site Reports: Chebeague Island

Emma Polhemus, Shore Corps Steward, Maine Conservation Corps & Island Institute  
January 2026

## **OUR SHORE Coastal Erosion Assessments and Site Reports: Chebeague Island**

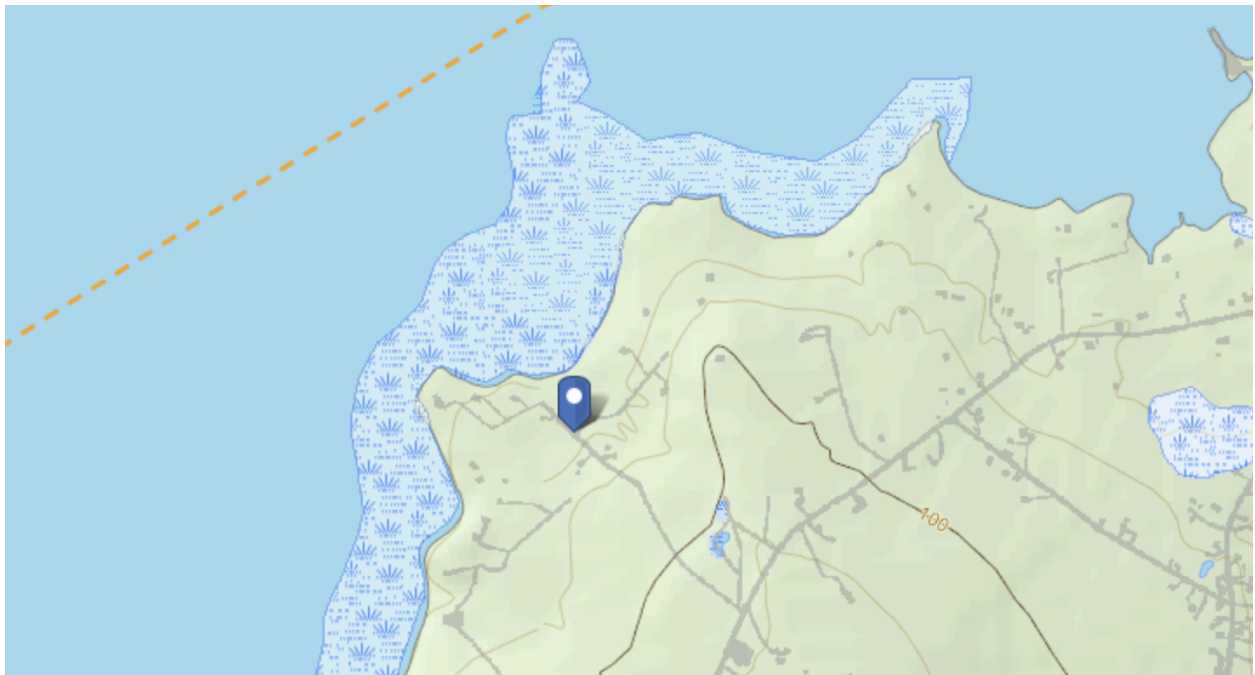
**Figure 4:** Beginning with Habitat map of National Wetland Inventory areas (white and blue pattern).

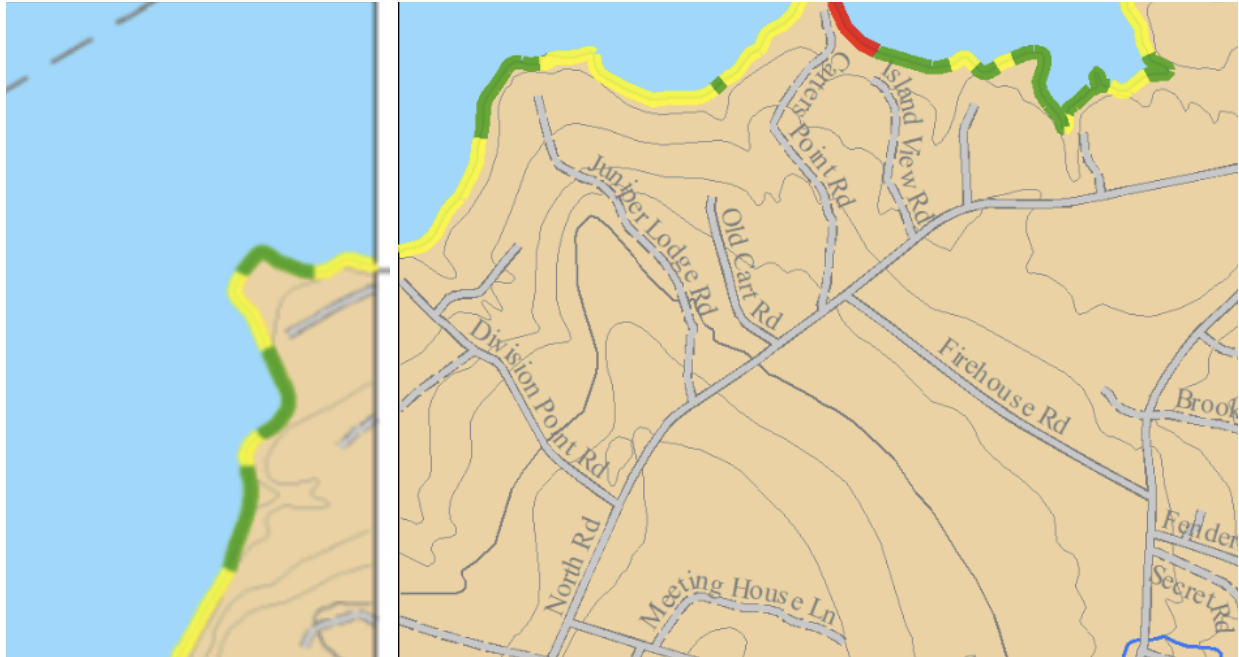
In 2020, MGS evaluated the bluff at the Division Point ROW as unstable, with a gently sloping to steep slope, some areas of exposed soil on the bluff face, and bent or tilting trees present (Fig. 7). The site is an area of concern for the town, since the access stairway is at risk as the underlying bluff recedes from erosion.

**Figure 7:** Maine Geological Survey Coastal Bluff Maps from 2020 including the Division Point ROW. Green indicates a stable bluff, and yellow indicates an unstable bluff.

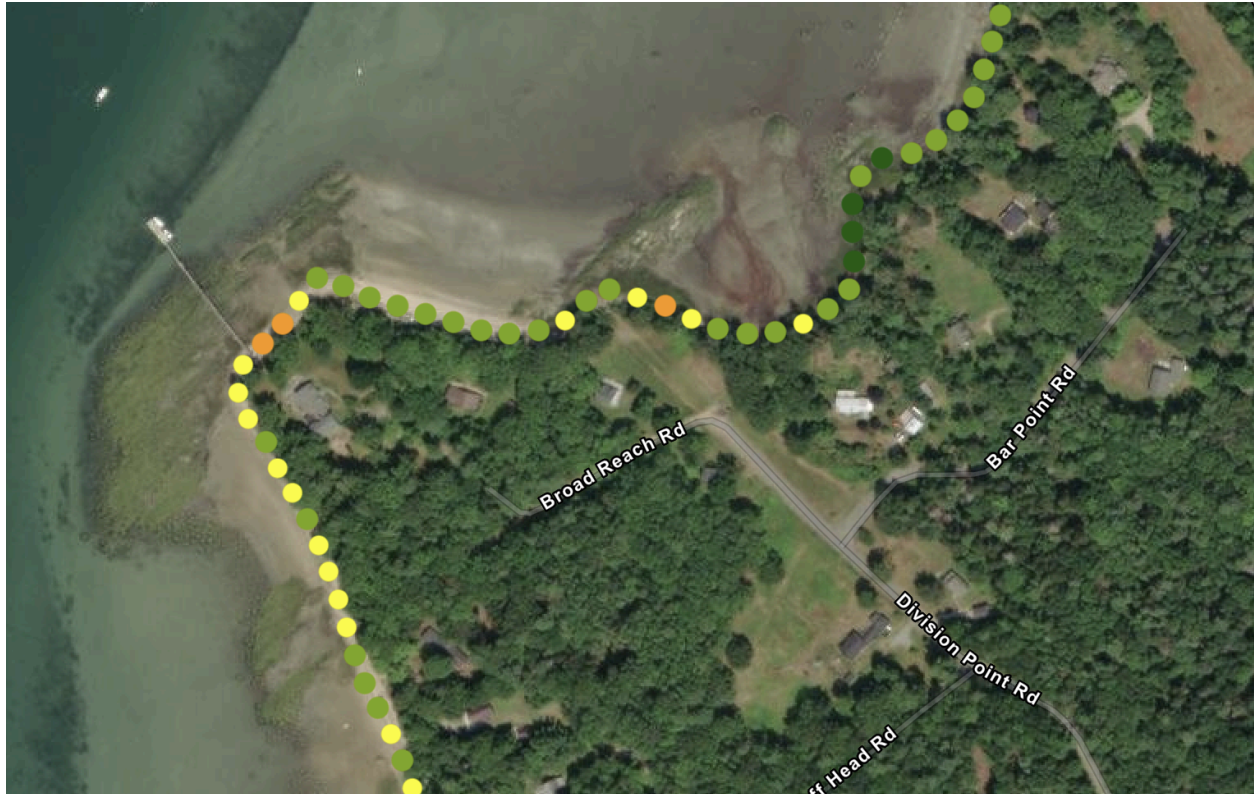
**Figure 8:** Maine Geological Survey Living Shoreline Decision Support Tool. The light green points along the Division Point ROW shoreline indicate moderate suitability for a living shoreline.

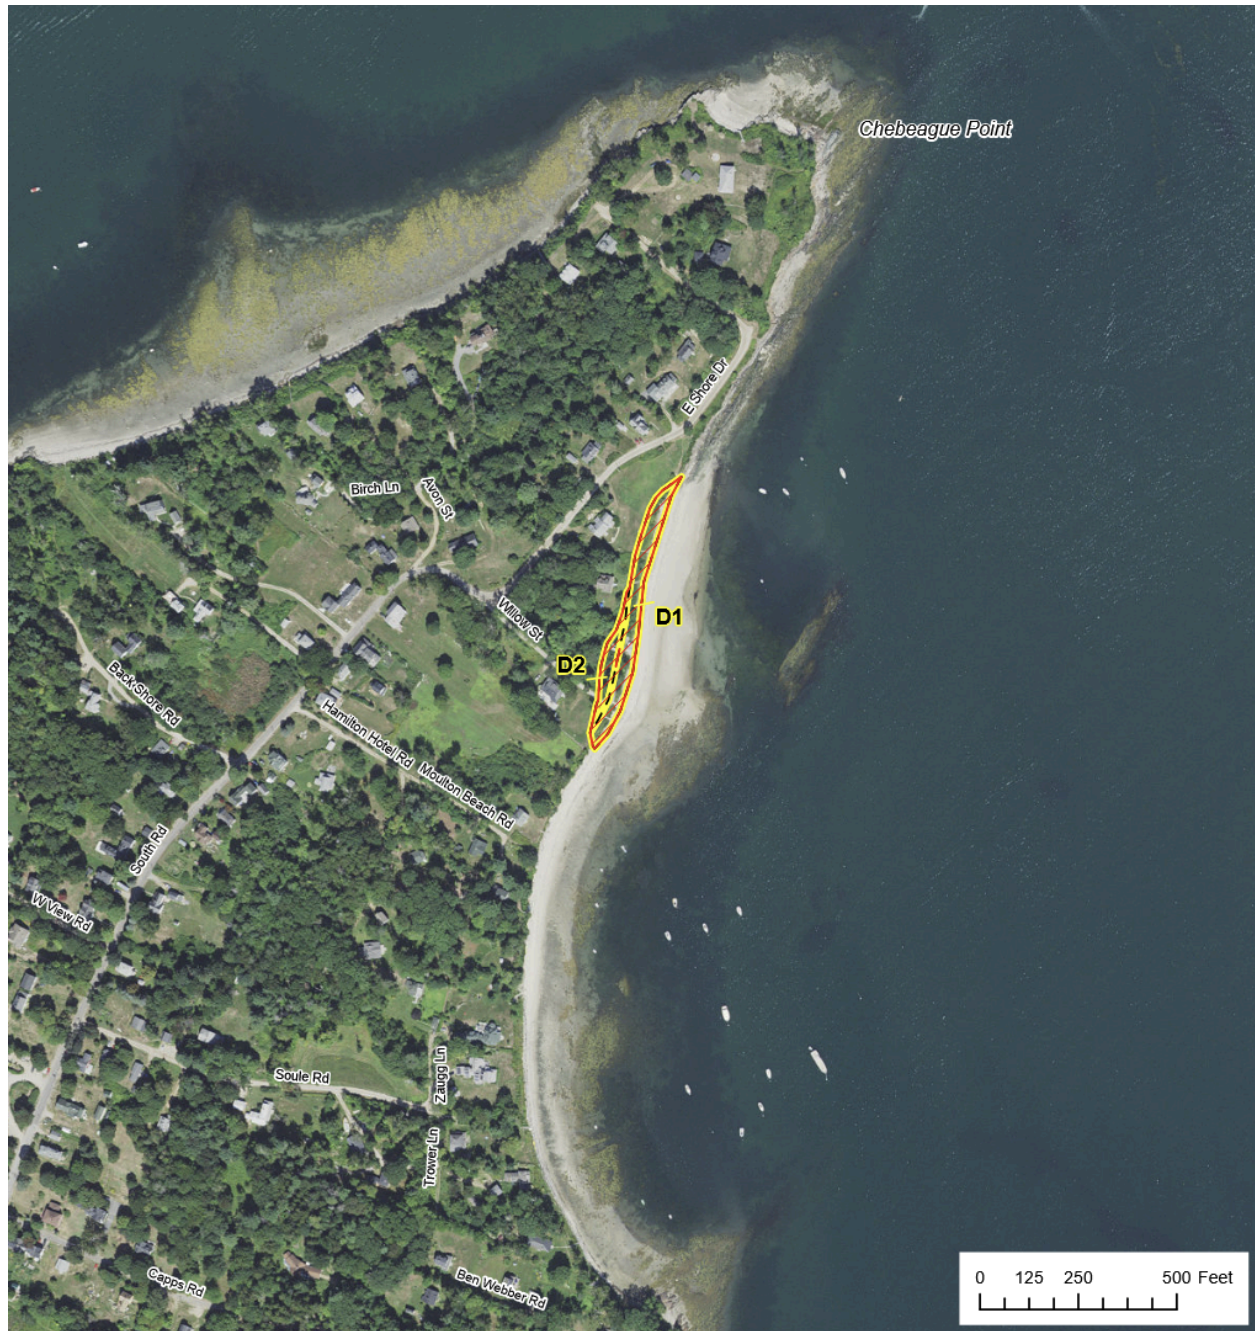
**Figure 5:** Coastal Sand Dune Geology of Chebeague Point including Hamilton Beach (MGS). Yellow lines delineate areas of sand dune, and red lines indicate areas at risk of erosion based on predicted sea level rise.

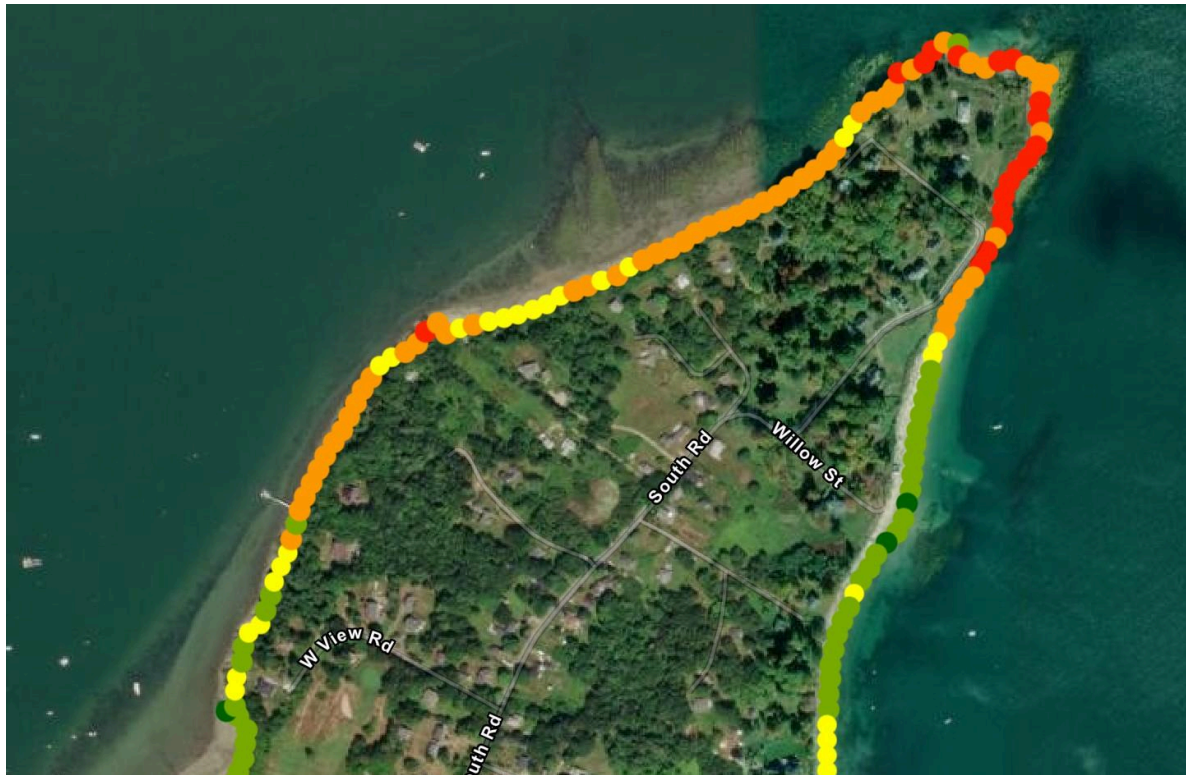
The Maine Geological Survey Living Shoreline Decision Support Tool identifies Hamilton Beach as Moderately to Highly Suitable for a living shoreline design due to the low fetch, gradual slopes, and presence of sand dune and mudflat habitats (Fig. 6). Likewise, results of the OURSHORE Quick Assessment support the selection of a nature-based strategy (NbS) for this site while prioritizing management of overland water contributions to instability. The site has a lower slope failure risk because of the low bank height and shallow grade. These factors also increase the feasibility of successful vegetation establishment for NbS. OUR SHORE recommended management actions based on the Quick Assessment results include installing biodegradable toe protection, creating a vegetative buffer, and minimizing runoff from roads and parking areas. As a mapped sand dune system, there is also the potential to use sand dune restoration at the site as a nature-based erosion control tool.

**Figure 6:** Living Shoreline Decision Support Tool map of Chebeague Point including Hamilton Beach. Green points indicate scores of Moderately Suitable (light green) and Highly Suitable (dark green).

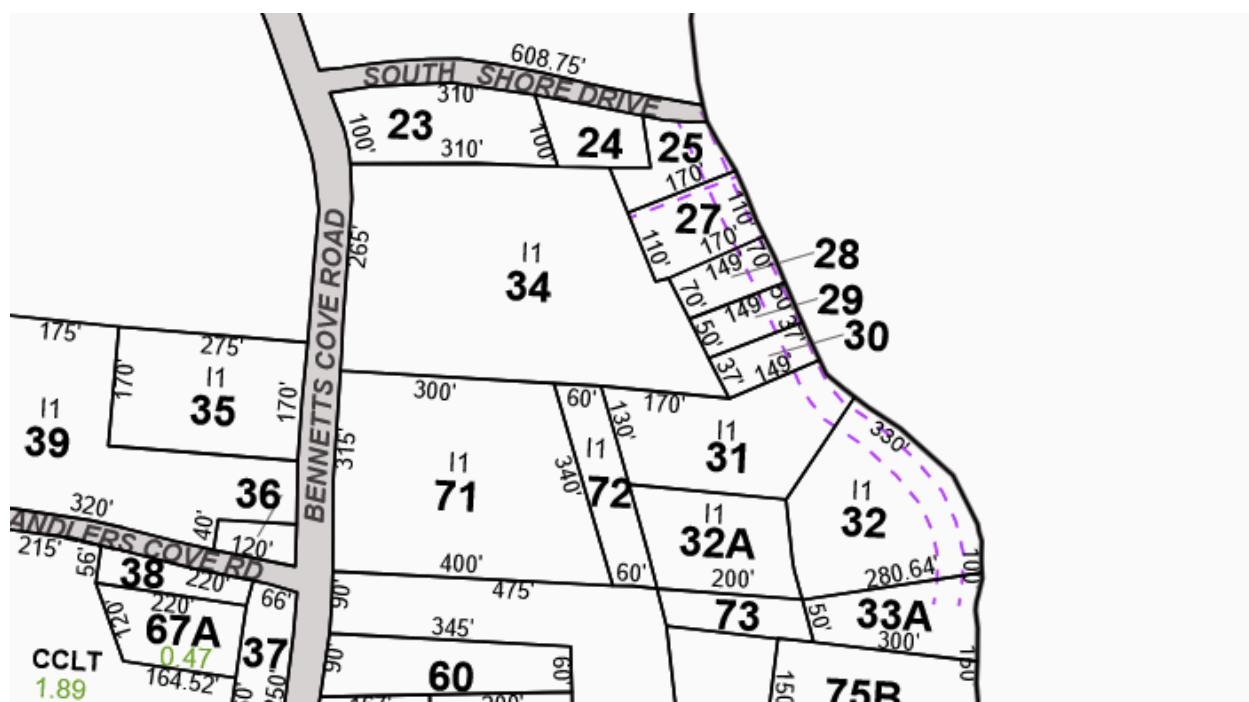
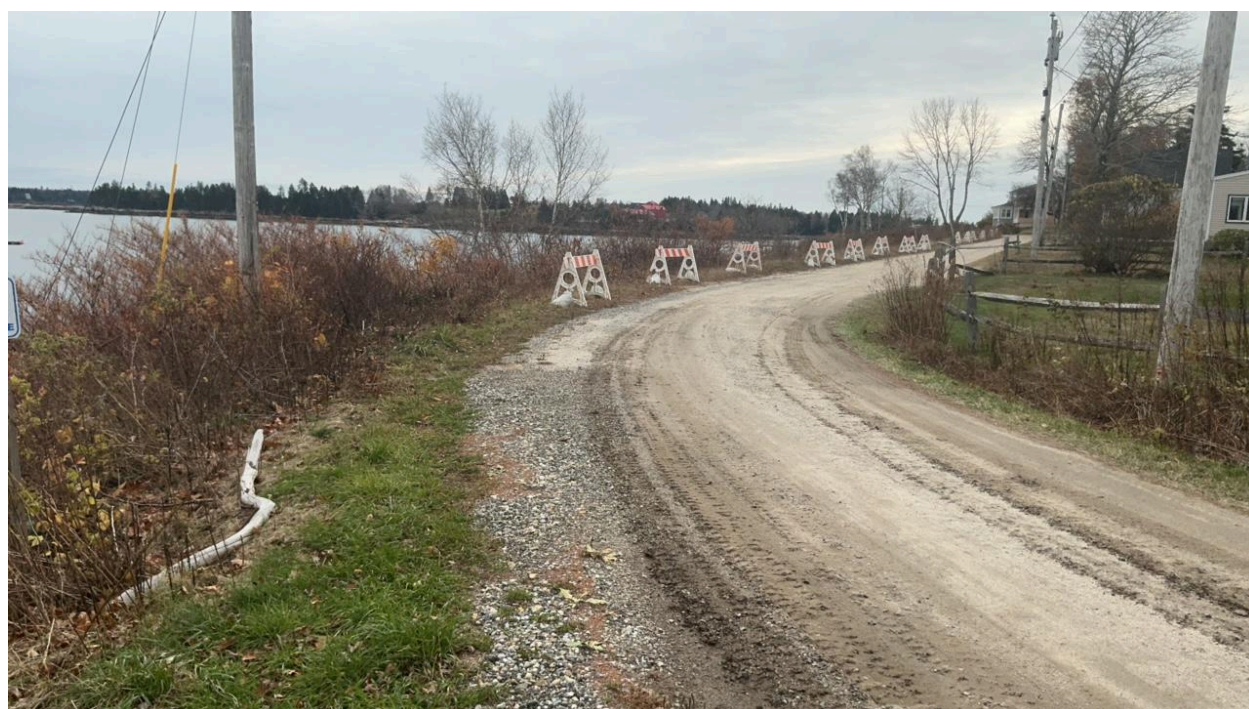
The bluff at South Shore Drive was damaged during the winter storms of 2024, exacerbating existing bluff erosion. The bluff slope has areas of bare soil, there are leaning trees indicating slope failure, and the bluff edge has receded closer to the existing road. This infrastructure risk led the Town to contract GEI Consultants, Inc. (GEI) to conduct a site assessment and provide conceptual design alternatives to stabilize the bluff. Two short-term alternatives were provided in the report: a toe stone riprap revetment with a vegetated upper bank, or a full slope riprap revetment. The goal of this report is to support the Town in selecting a stabilization option by providing information on how state OUR SHORE guidance may align with project design for South Shore Drive.

**Figures 3 & 4:** Photos showing sections of the bluff including access stairs, fallen and leaning trees, and rocks placed in a previous shoreline protection attempt.

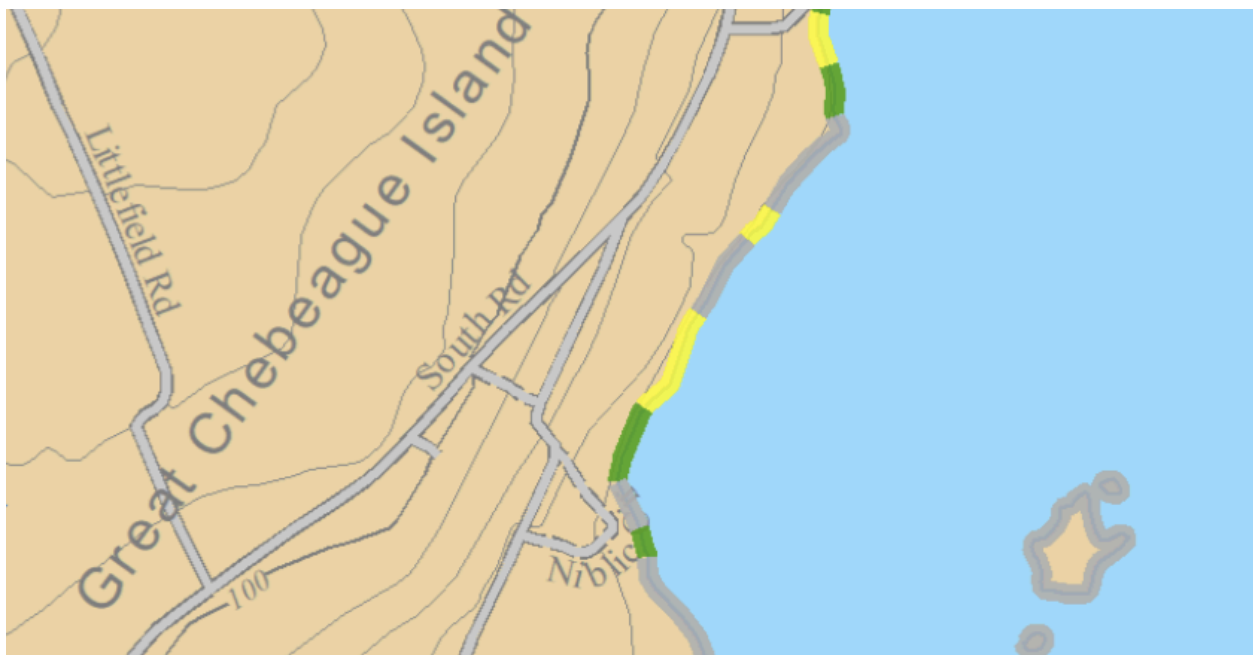
**Figure 6:** Maine Geological Survey Coastal Bluff Map of the assessed property and surrounding areas created in 2020. Yellow indicates Unstable bluffs and green indicates Stable bluffs.

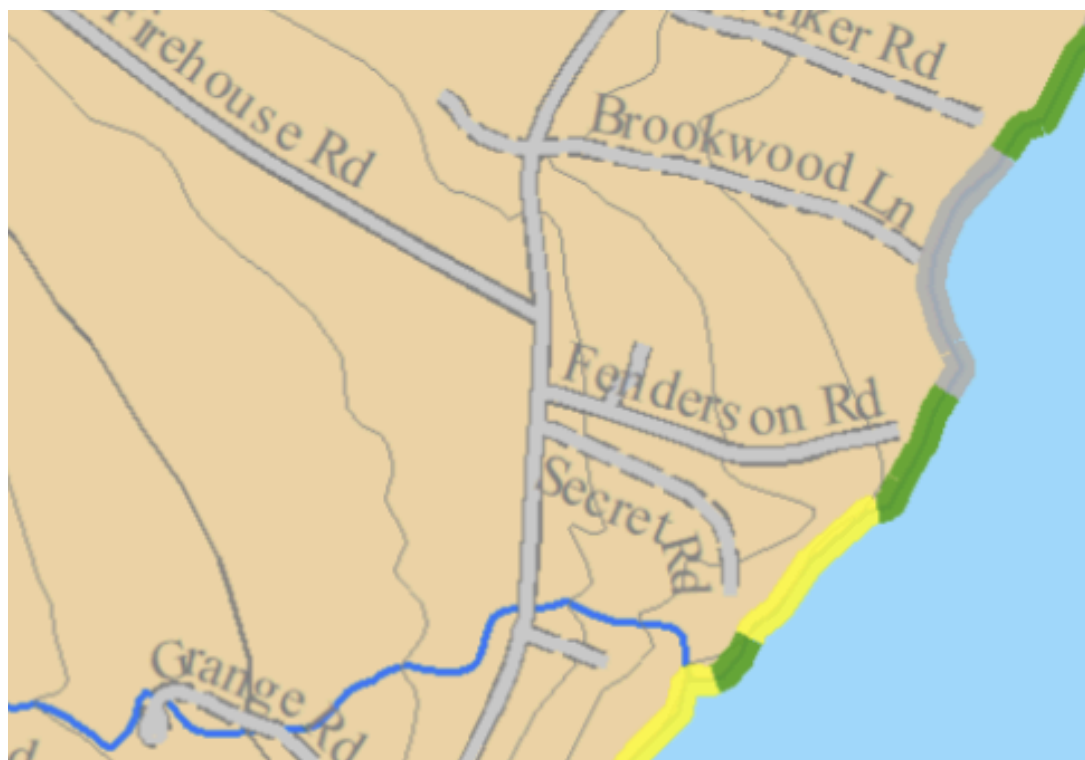
The coastal bluff at this property was mapped as stable in the northern section and unstable in the southern section in 2020 (Fig. 6). The bluff has been eroded and damaged during storms in the last several years, leaving signs of instability such as leaning trees, exposed sediment, and blocks of displaced sediment at the bluff base (Fig. 3). Erosion of the bluff is more severe near the drainage ditch on the north boundary of the property. The property owner at the site has hired a coastal protection contractor to install bank protection, and site plans are in development. The goal of this report is to provide options for hybrid green-gray stabilization options and overland water management strategies that can be integrated into the site design.

**Figure 6:** Maine Geological Survey Coastal Bluff Map of the site and surrounding areas created in 2020. Yellow indicates Unstable bluffs and green indicates Stable bluffs.
