# OUR SHORE Coastal Erosion Assessments and Site Reports: Cliff Island

Emma Polhemus, Shore Corps Steward, Maine Conservation Corps & Island Institute  
May 2026

## **OUR SHORE Coastal Erosion Assessments and Site Reports: Cliff Island**

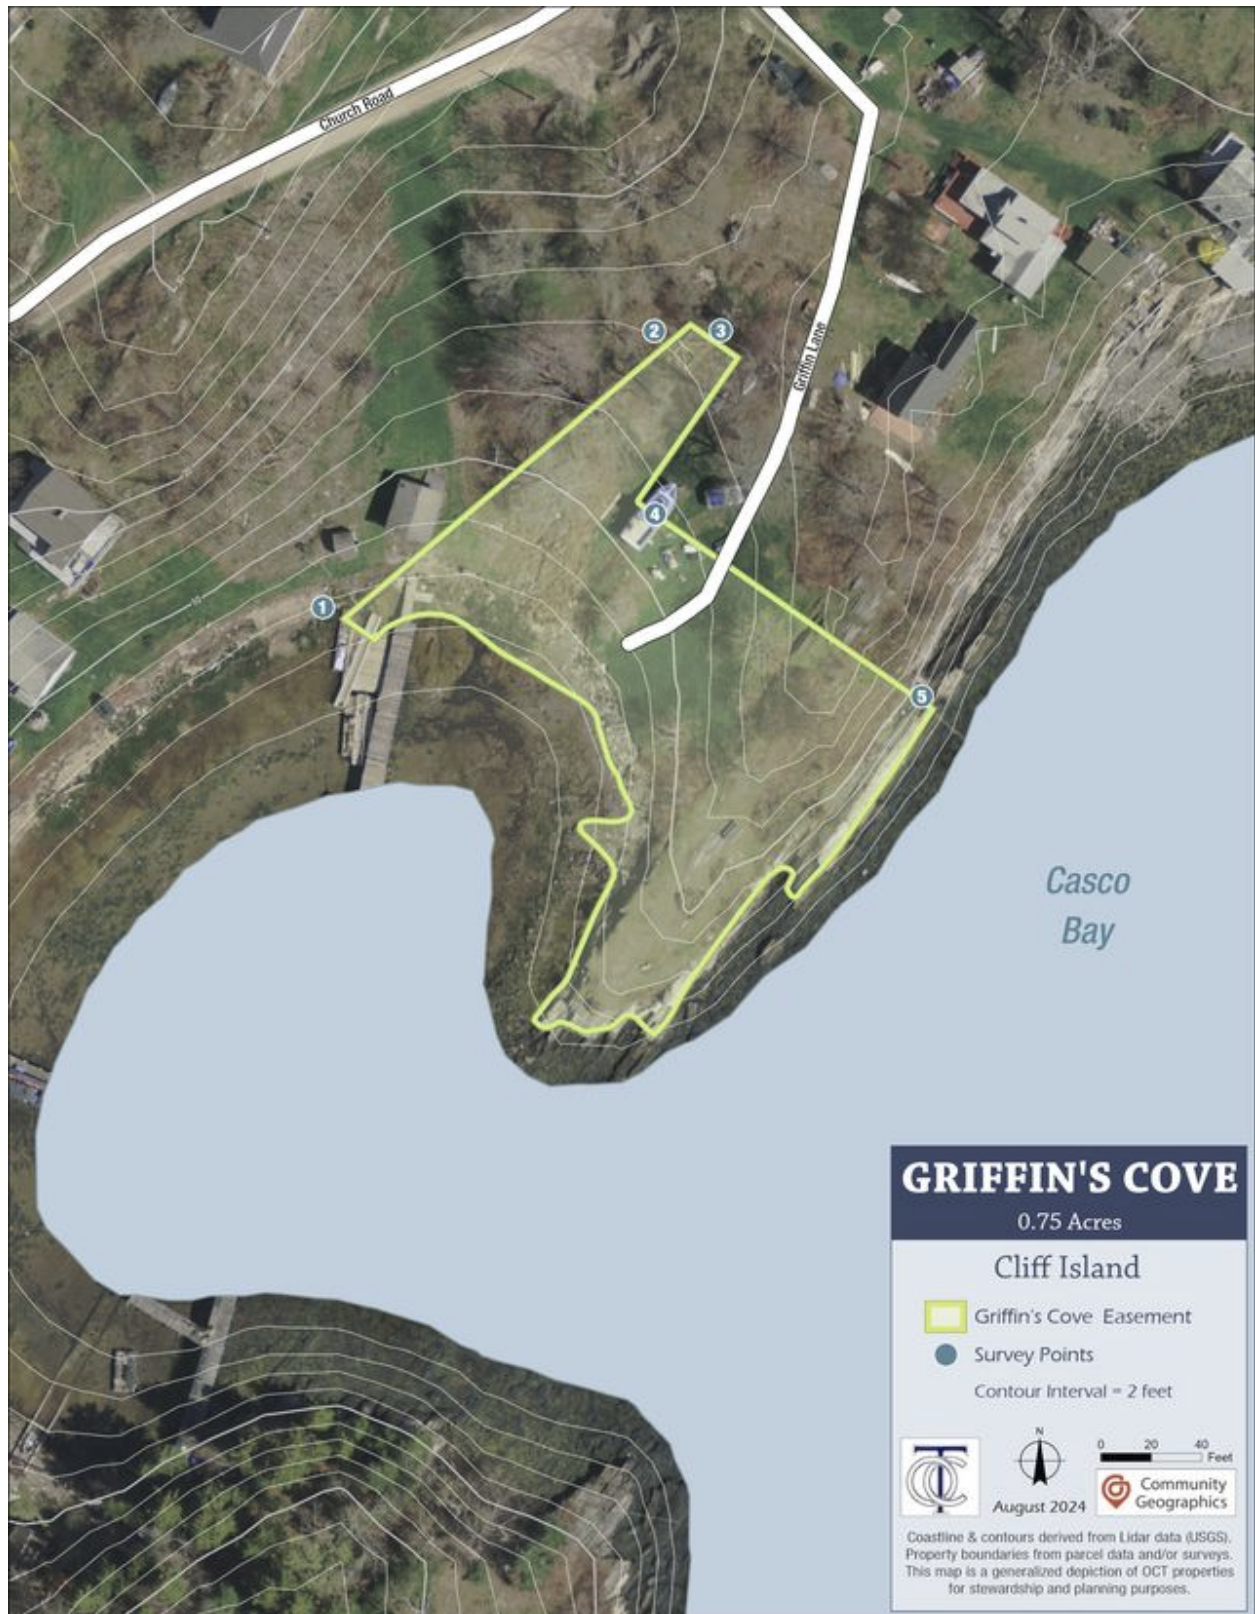
**Figure 1:** Map of the Griffin's Cove property owned by ACE with an easement held by Oceanside Conservation Trust of Casco Bay (OCT, 2024).

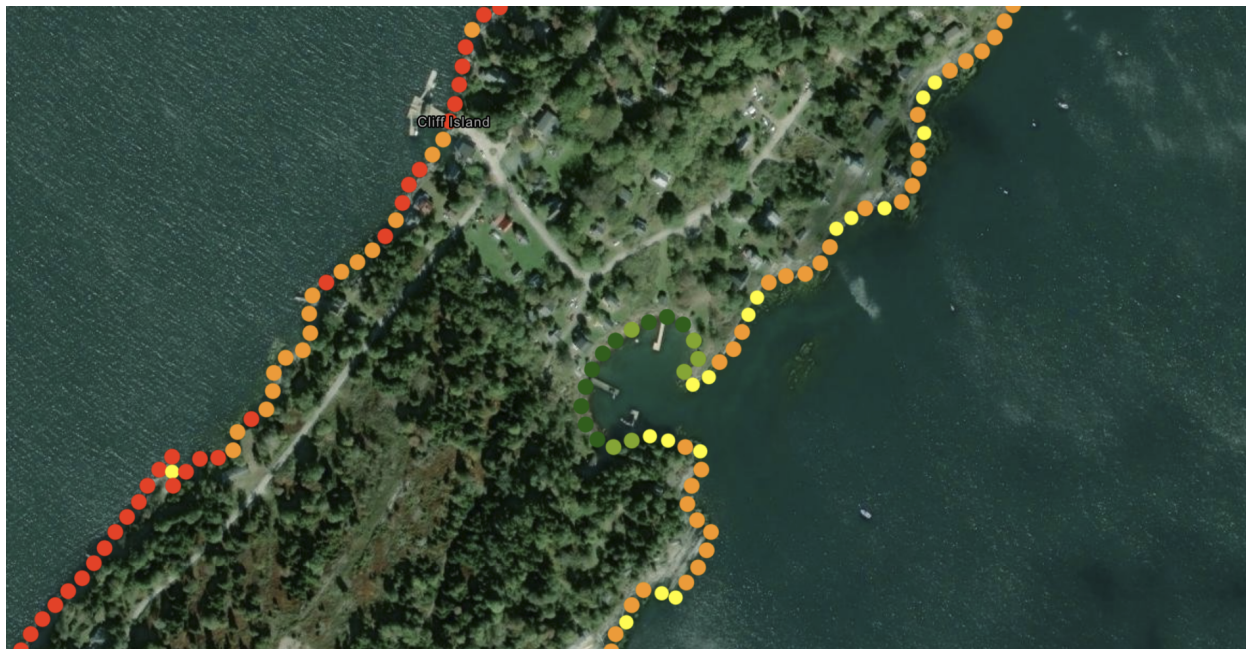
Based on site characteristics including the sheltered location, shallow beach, and gradual slope, Griffin's Cove is mapped as Highly Suitable for living shoreline approaches in the Maine Geological Survey's Living Shorelines Decision Support Tool (Fig. 4).

**Figure 4:** MGS Living Shoreline Decision Support Tool map of Griffin's Cove. Dark green points indicate Highly Suitable locations for living shoreline approaches and light green points indicate Moderately Suitable locations.

Living shoreline and nature-based techniques will likely be highly successful at Griffin's Cove based environmental conditions at the site. The addition of deeply-rooted native plants along the upper edge of the beach will help stabilize the bank and hold soil in place, supplementing the current stone protection. If suitable growing conditions are present and vegetation spreads into the riprap area of the upper beach, this will also help hold the riprap stones in place and enhance overall shoreline resilience. A vegetated buffer width of 10-15' is recommended at minimum to provide shoreline stability. This buffer should be made up of a variety of densely planted native plants including both woody plants like shrubs or trees and herbaceous plants like grasses, flowers, and groundcover plants.

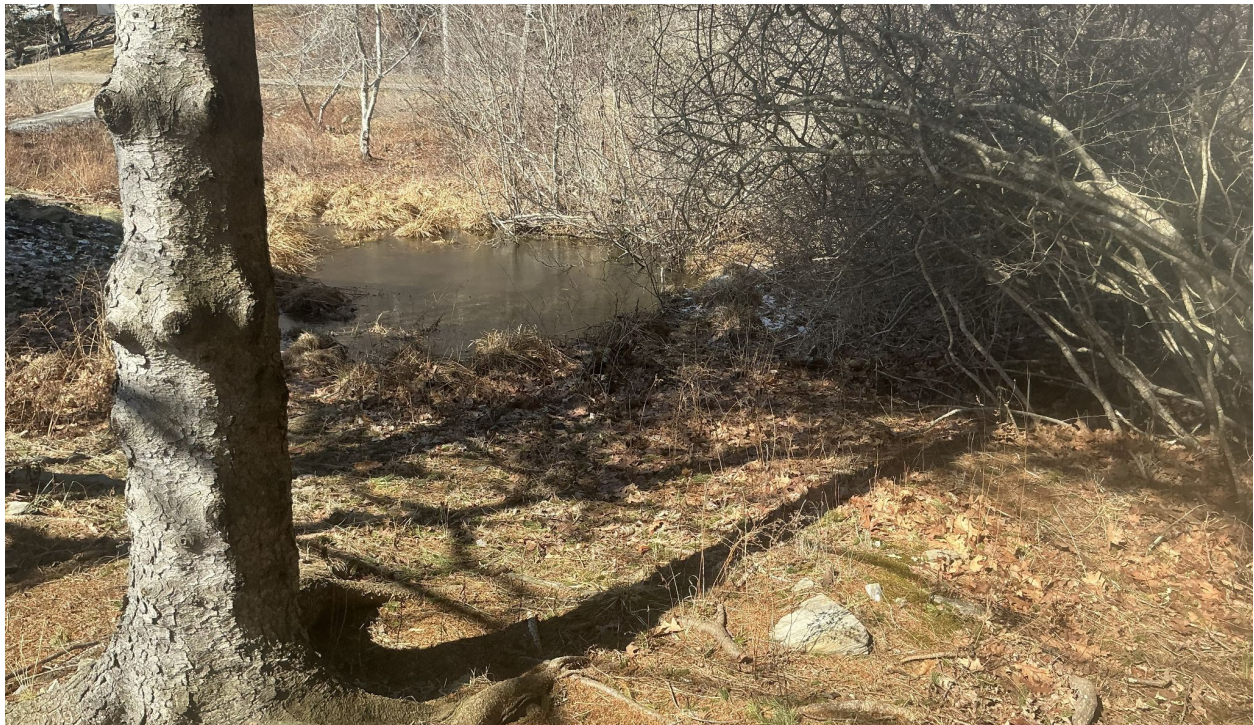
A drainage ditch passes between the two properties, fed by a culvert passing under Church Rd. A small freshwater wetland is located inland of the house on one of the properties. A groundwater seep was noted exiting the bank just above the bedrock layer.

**Figure 7:** The wetland area upland of one of the houses.

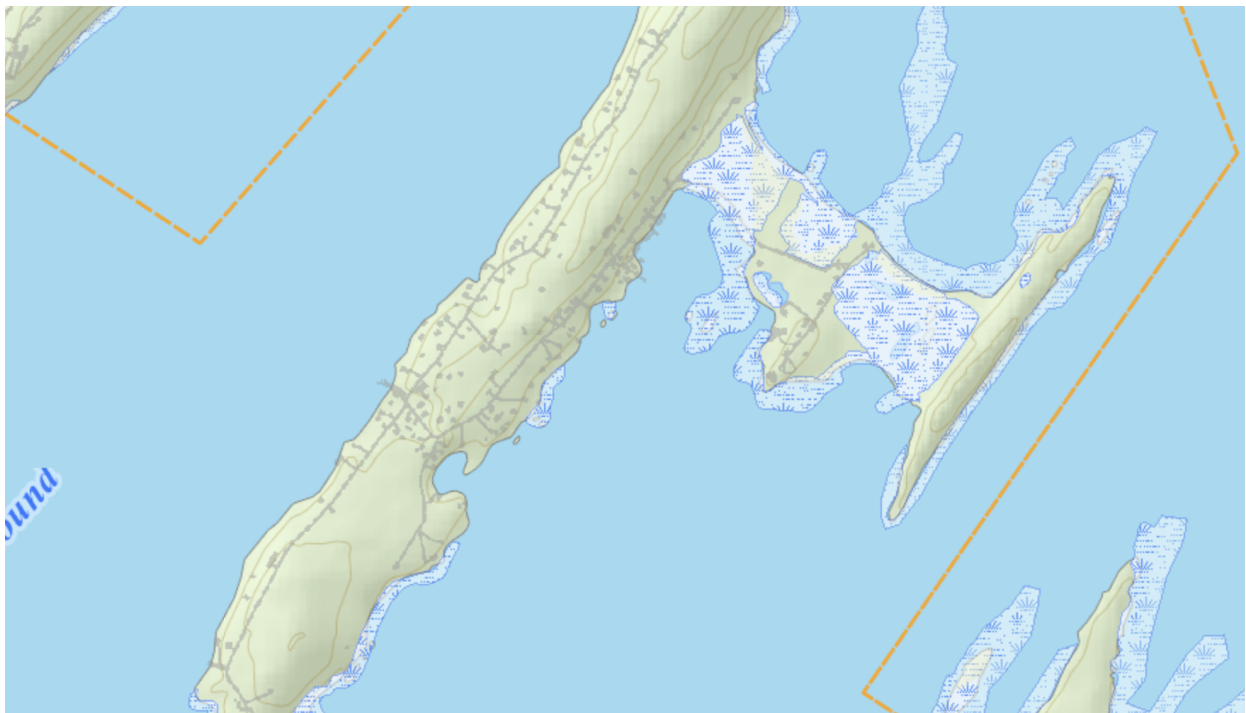
**Figure 8:** Beginning with Habitat map of the site showing National Wetland Inventory areas (white and blue pattern).
