# OUR SHORE Coastal Erosion Assessments and Site Reports: Great Diamond Island

Emma Polhemus, Shore Corps Steward, Maine Conservation Corps & Island Institute  
May 2026

Alongside community partners and Island Institute staff, the Shore Corps Steward visited three coastal sites on Great Diamond Island in April 2026 to complete OUR SHORE Assessments of coastal erosion. The following report documents the results of these assessments along with recommended erosion management actions that align with OUR SHORE guidelines and prioritize nature-based and hybrid strategies.

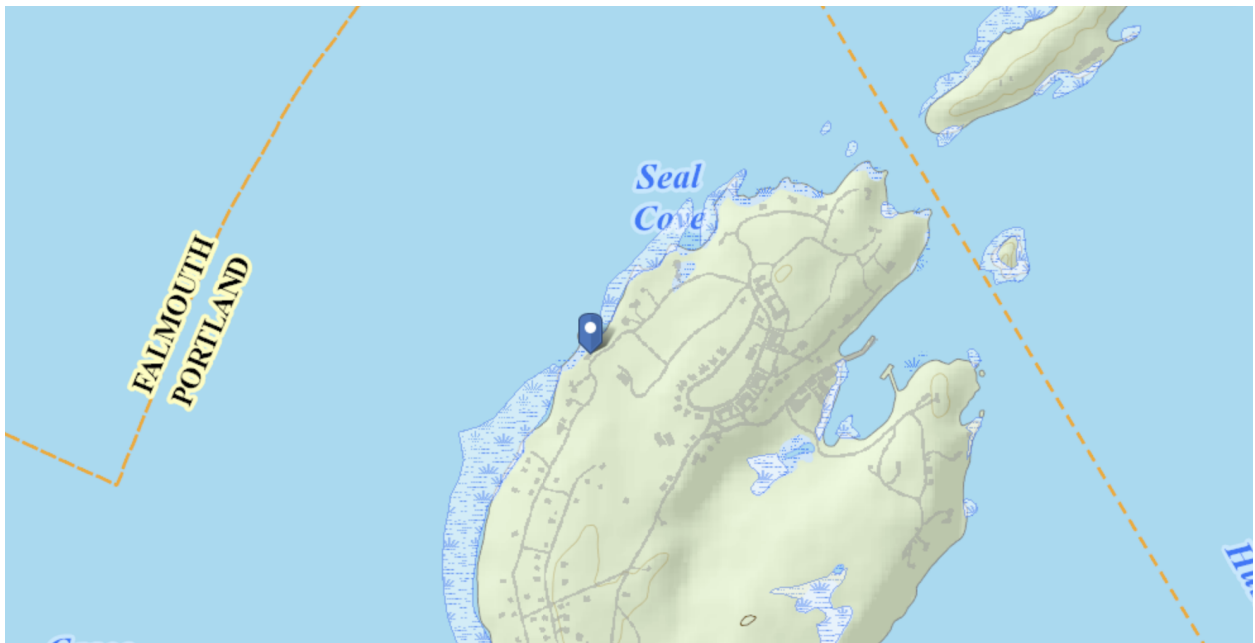
**Figure 6:** Beginning with Habitat map of the site showing National Wetland Inventory areas (white and blue pattern).

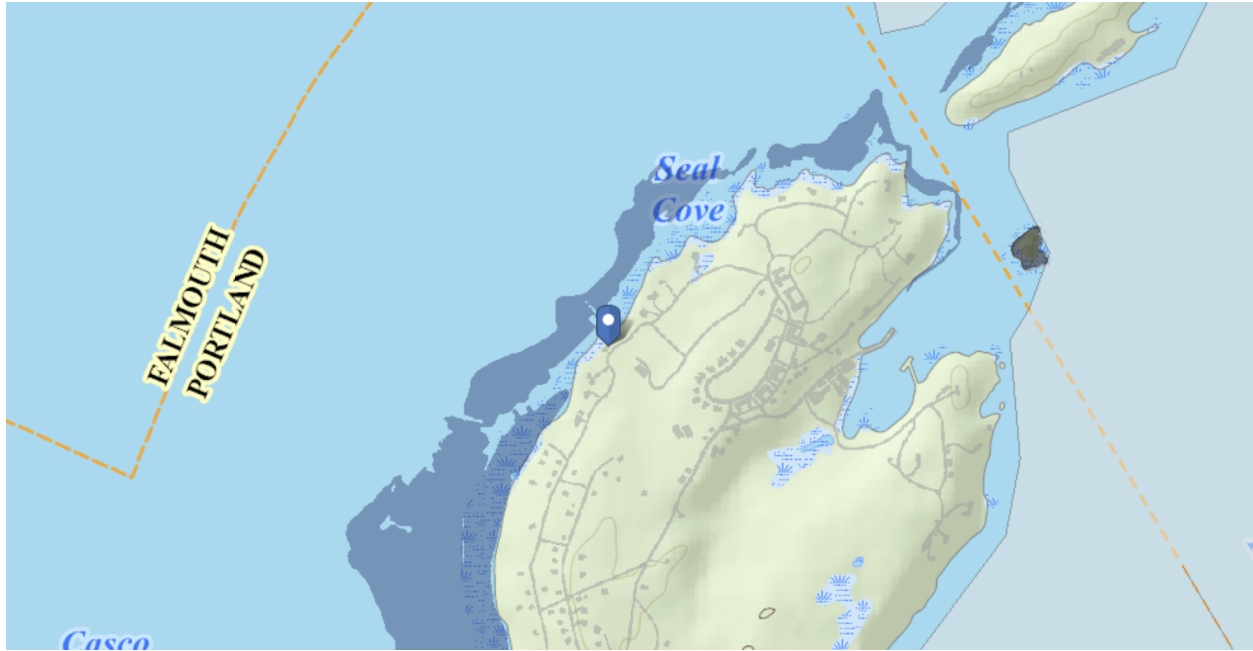
**Figure 7:** Beginning with Habitat map of the site showing high value Tidal Waterfowl and Wading Bird habitat (dark blue).

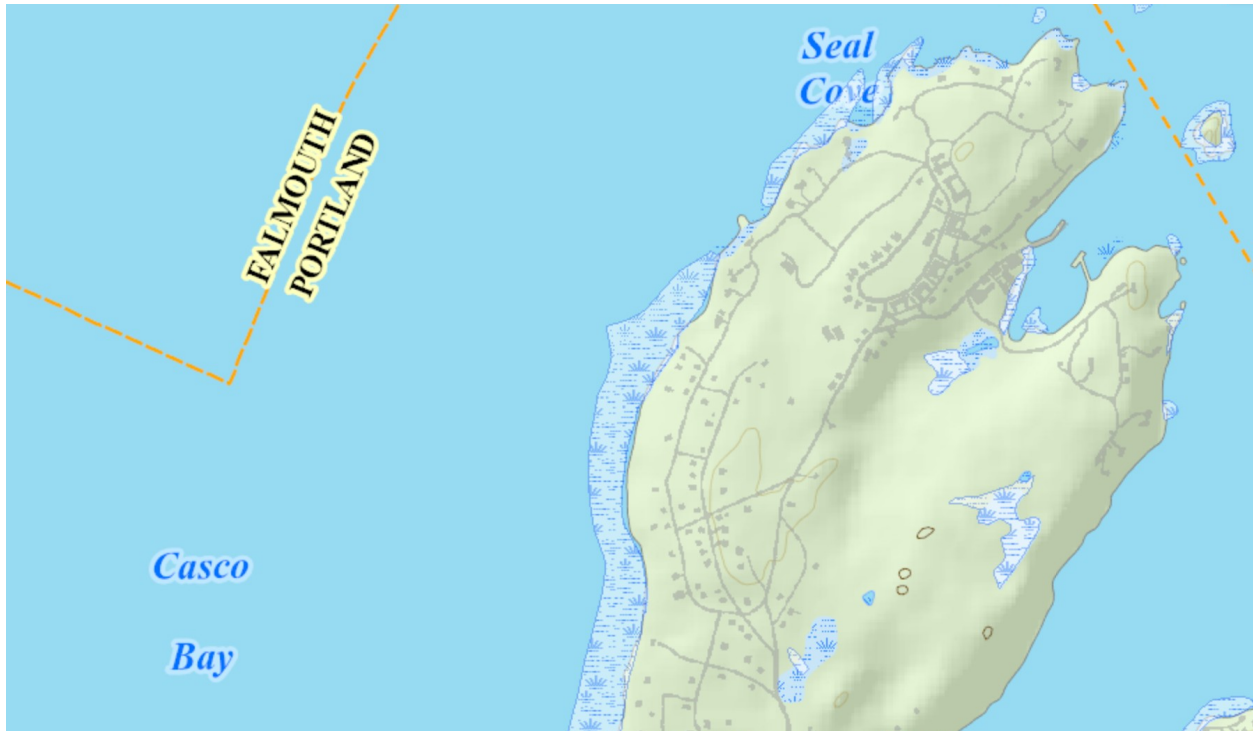
The intertidal zone in front of the property is mapped as a coastal wetland within the National Wetland Inventory (Fig. 5). The area is additionally mapped as high value Tidal Waterfowl and Wading Bird habitat (Fig. 6).

**Figure 5:** Beginning with Habitat Map of the site indicating National Wetland Inventory wetland locations (white and blue pattern).

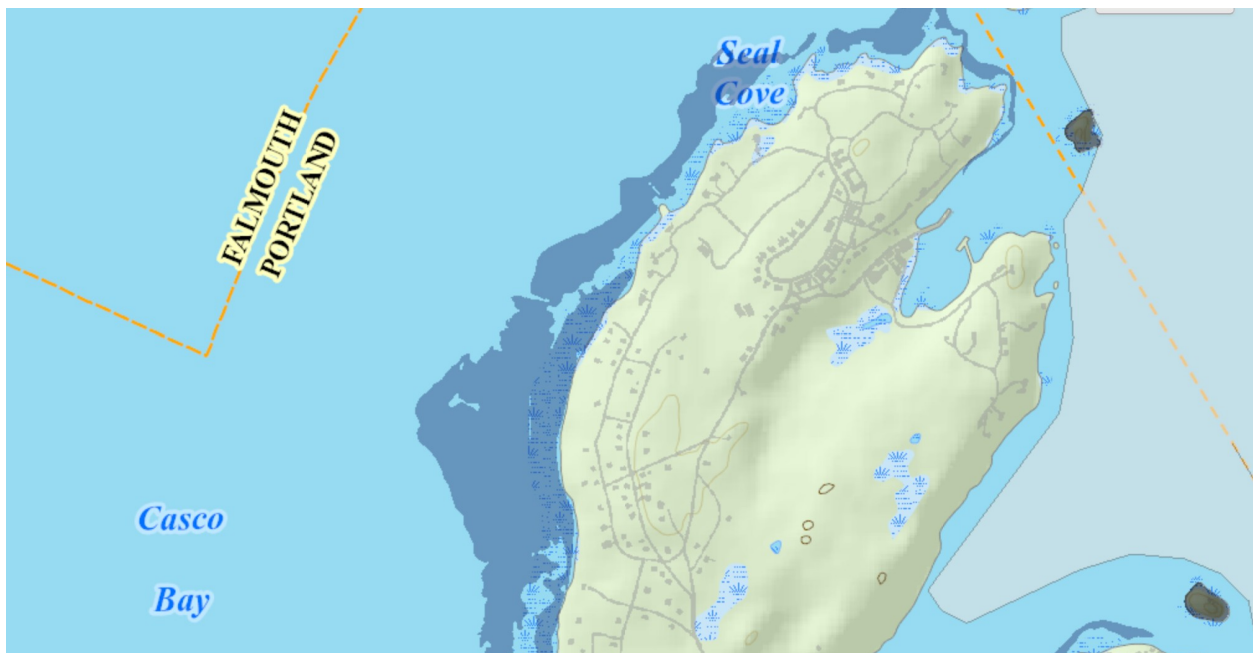
**Figure 6:** Beginning with Habitat map of the site indicating nearby high value Tidal Waterfowl and Wading Bird habitat areas (dark blue).

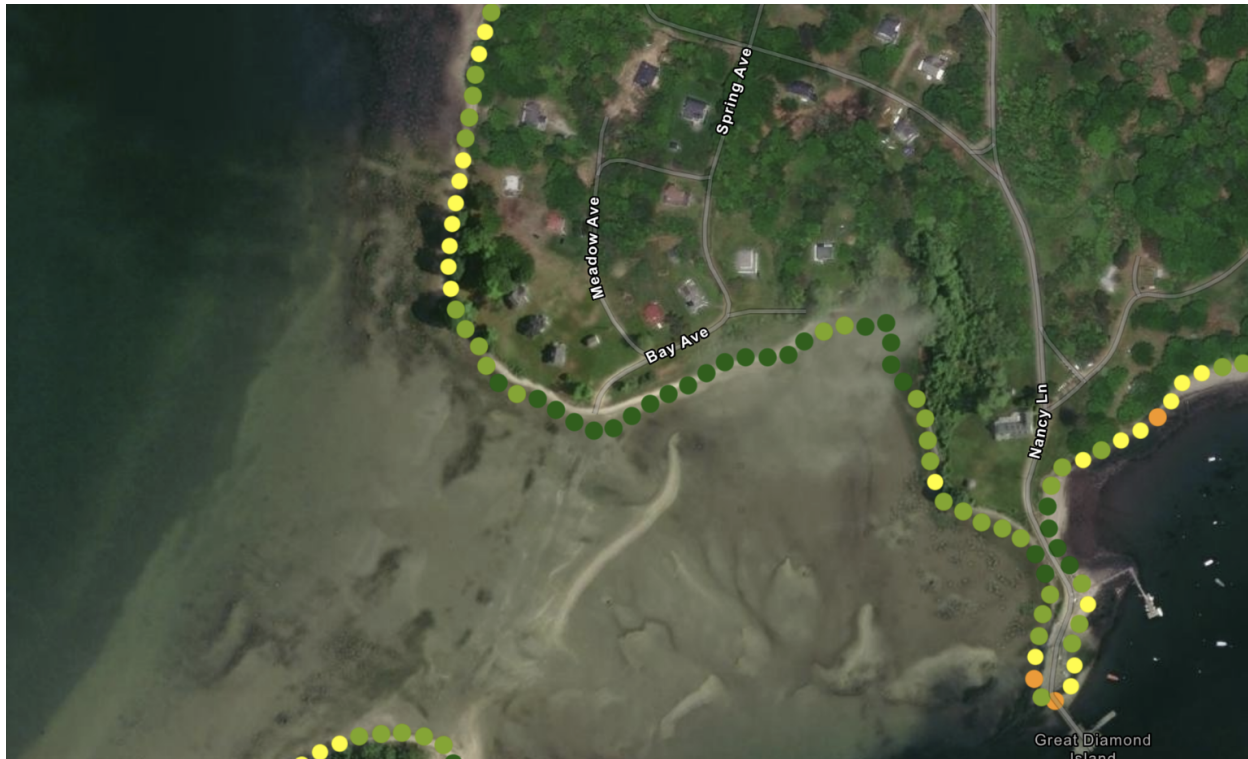
Maine Geological Survey's Living Shoreline Decision Support Tool ranks the site as Highly Suitable for living shoreline approaches (Fig. 6). Environmental factors like the shallow intertidal zone, low bank height, and low annualized fetch provide beneficial conditions to establish plantings in combination with bioengineering approaches.

**Figure 6:** Maine Geological Survey Living Shoreline Decision Support Tool showing the Lamson Cove area. Dark green circles indicate that a site is ranked Highly Suitable for a living shoreline.
