# OUR SHORE Coastal Erosion Assessments and Site Reports: Little Diamond Island

Emma Polhemus, Shore Corps Steward, Maine Conservation Corps & Island Institute  
May 2026

**OURSHORE Quick Assessment: Bishop Healy Woods**  
**Rockledge Ave, Little Diamond Island, ME**

**OURSHORE Quick Assessment: West Shore Beach**  
**Elizabeth Rd, Little Diamond Island, ME**

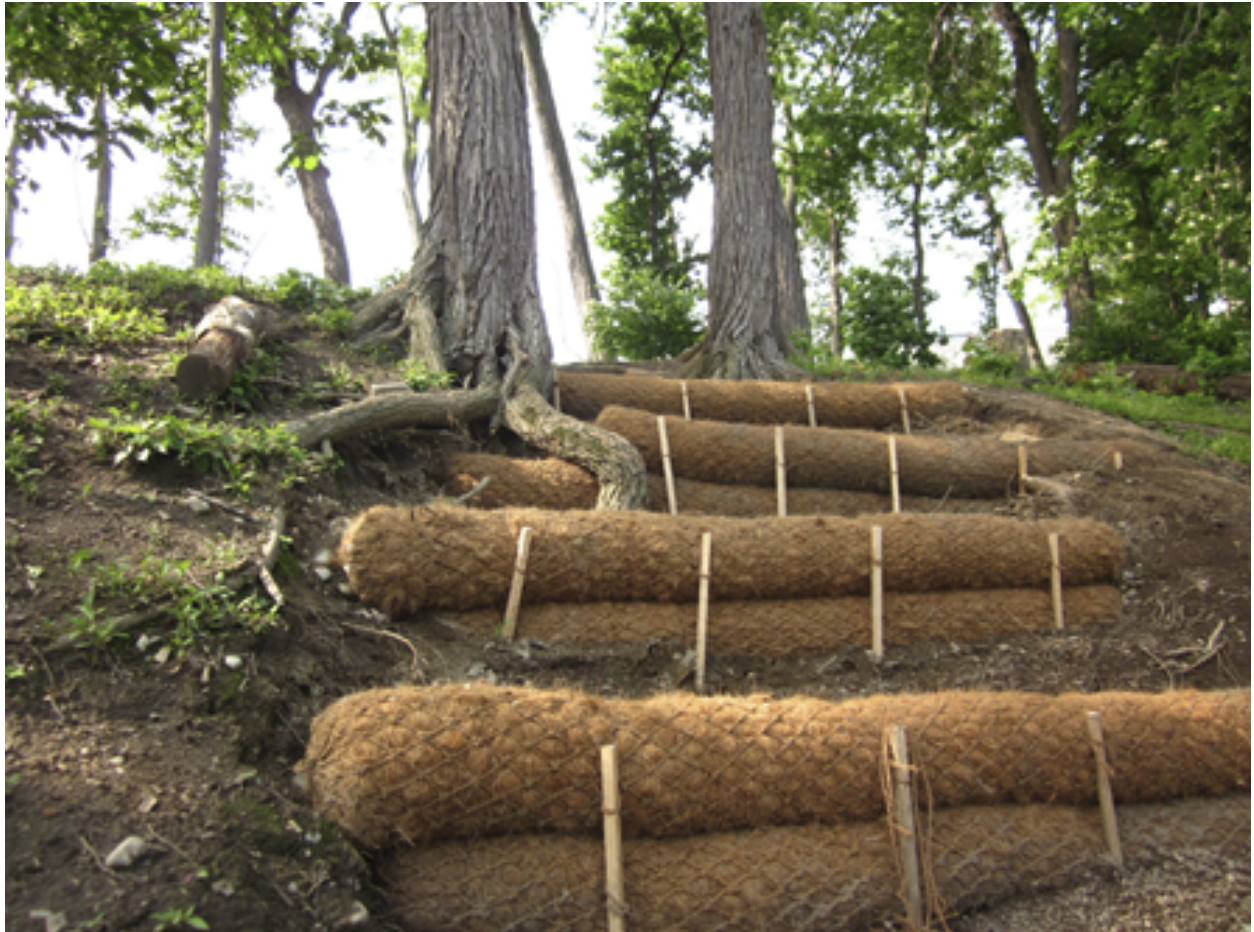
**Figure 10:** Coir logs used to divert water and repair a gully (Photo from Cambridge Water Department).

To stabilize the gully that has already formed, biodegradable slope interruptions can be installed to slow water moving through this area. While coir logs are often used, for a smaller gully like the one at this site, burlap bags filled with mulch are a cost-effective option (Fig. 10). Starting at the top of the gully, the bags should be placed in rows perpendicular to the slope and staked in place. The gully should be revegetated in combination with slope interruption practices for long-term stabilization. Using live stakes to secure the bags is recommended, as they will add additional protection and stability as the plants grow in, but untreated hardwood stakes or a combination of hardwood and live stakes may be used.

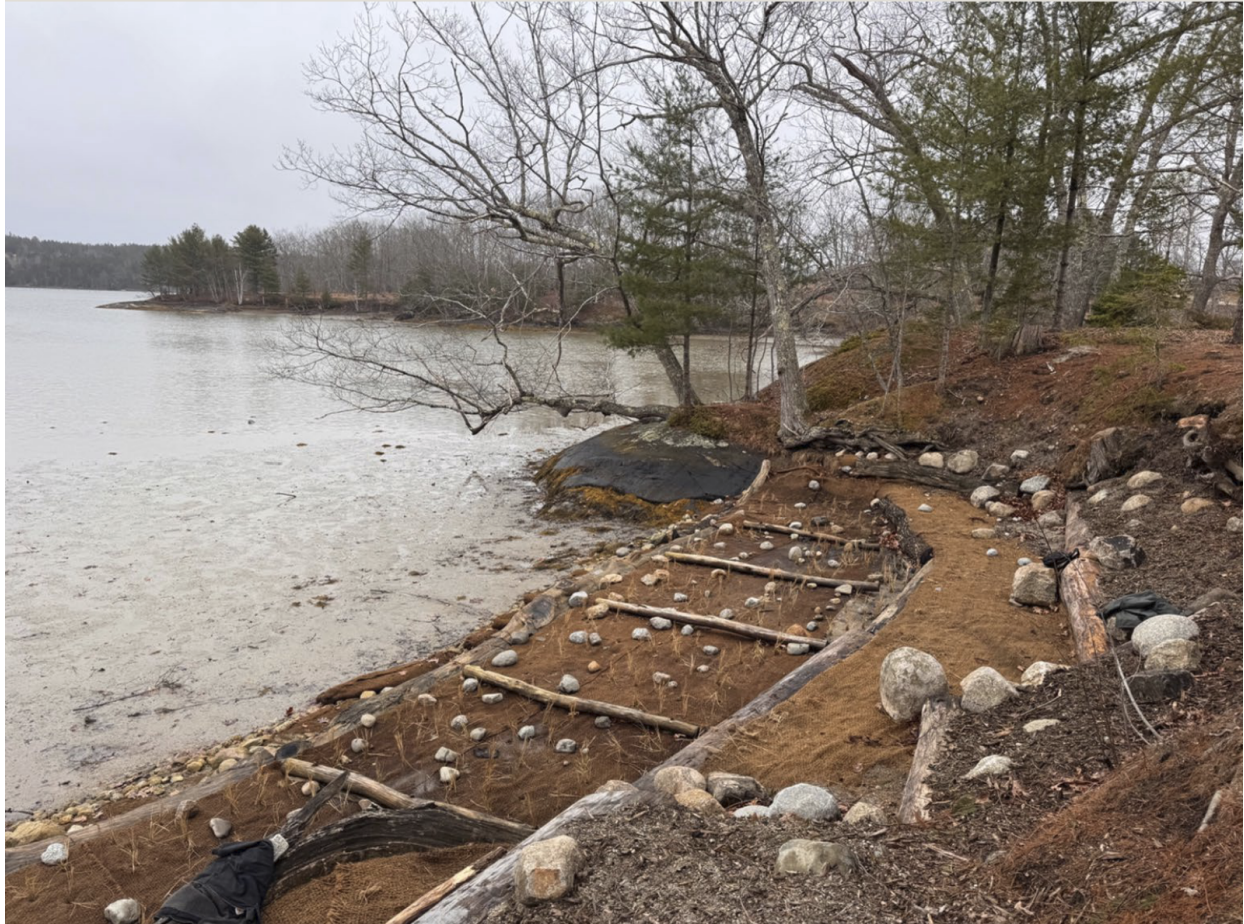
**Figure 11:** Example of a log sill installed for marsh restoration. (Photo from Treyball & Bernacki, 2025).

Expanding the area of salt marsh through active planting and restoration techniques would provide additional protection to the bank in addition to habitat and water quality benefits. While planting additional vegetation alone may be successful, similar salt marsh projects have benefitted from the placement of a log sill to adjust marsh elevation, especially under sea level rise. Sills use natural logs anchored into the sediment at the seaward edge of the desired marsh area (Fig. 11). Sediment can be added to elevate the marsh area so it receives the correct frequency of tidal inundation. Vegetation is then planted behind this sill to establish or expand the salt marsh area. The Home Place Team has installed several successful examples of this technique along the coast of Maine; more information can be found in their presentation at the 2025 OUR SHORE conference.<sup>1</sup>

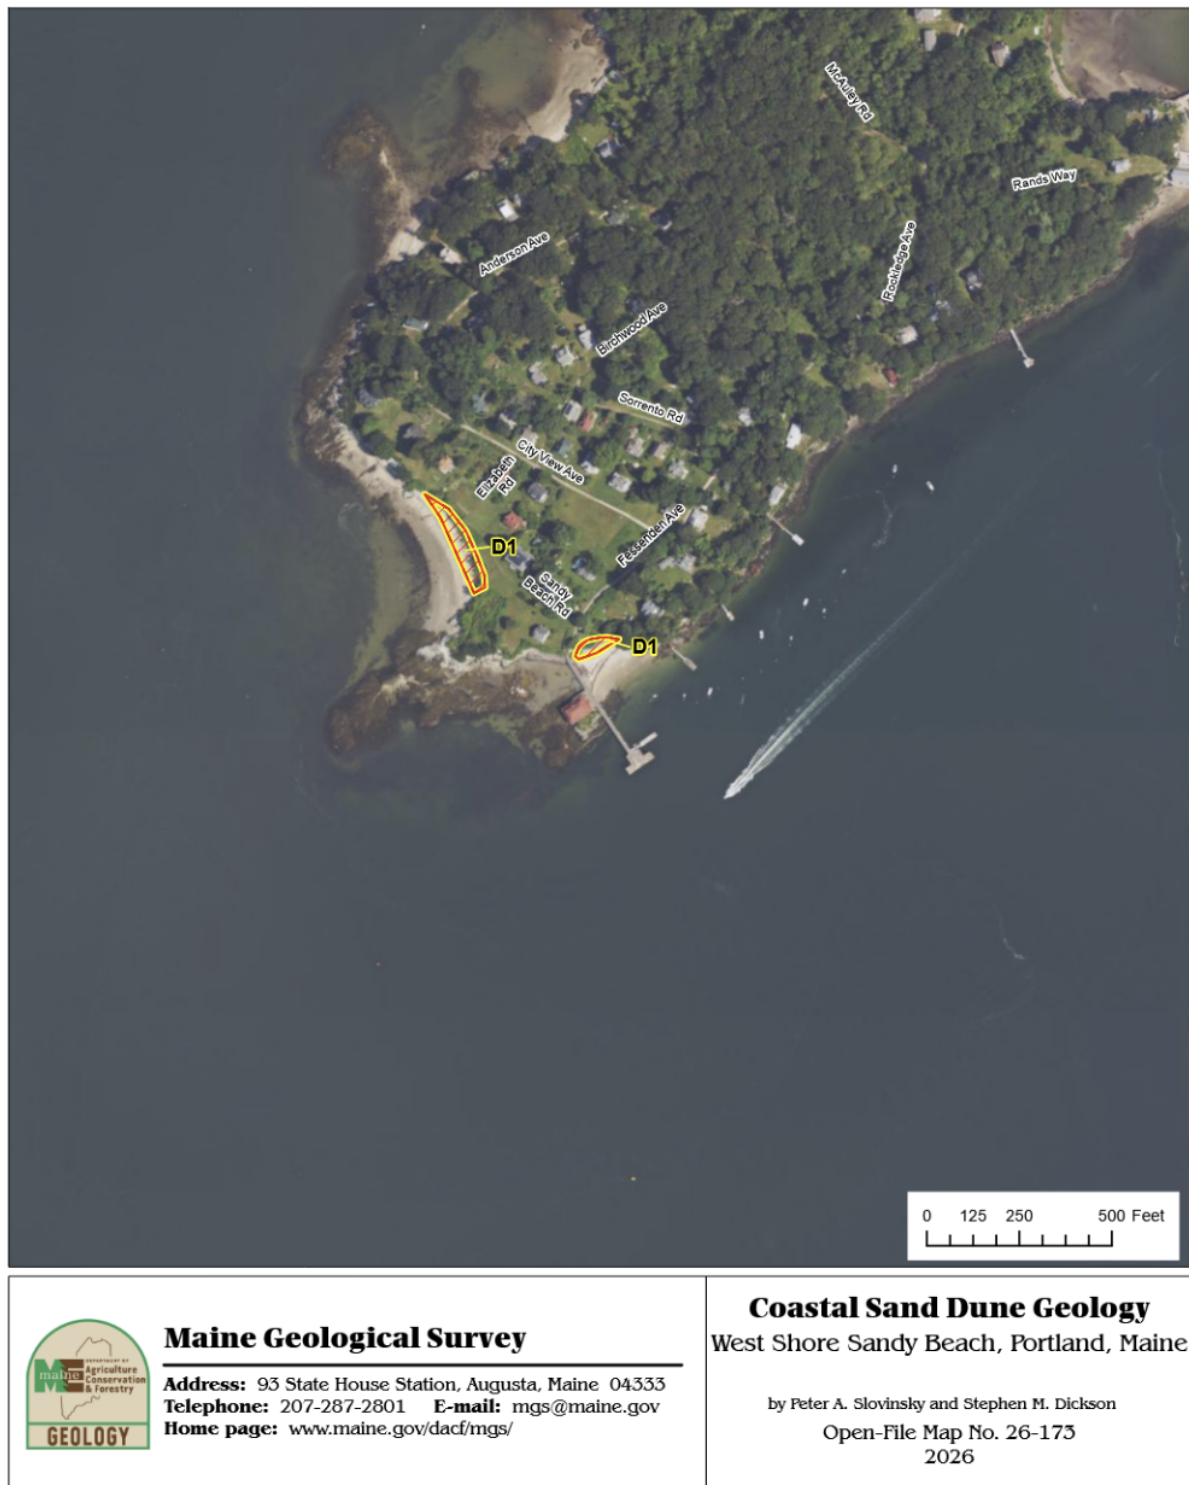
The entire length of West Shore Beach falls within a sand dune system mapped by the Maine Geological Survey in 2026 (Fig. 4). Sand dune vegetation is present in patches of the beach but is absent or has been overtaken by invasive *Phragmites australis* reeds in other areas.

**Figure 4:** Coastal Sand Dune Geology map of West Shore Beach. Sand dune systems are indicated in yellow and dune areas at risk of erosion in red.

Maine Geological Survey maps identify West Shore Beach as a sand dune system. While some sand dune vegetation is present, it does not extend across the entire shoreline. However, environmental conditions at the site are likely conducive to dune restoration. Restoring dune grasses to the beach can mitigate erosion by reducing wave energy hitting the bank. Over time, dune vegetation traps wind-blown sand and builds up taller mounded deposits which provide additional protection from waves.

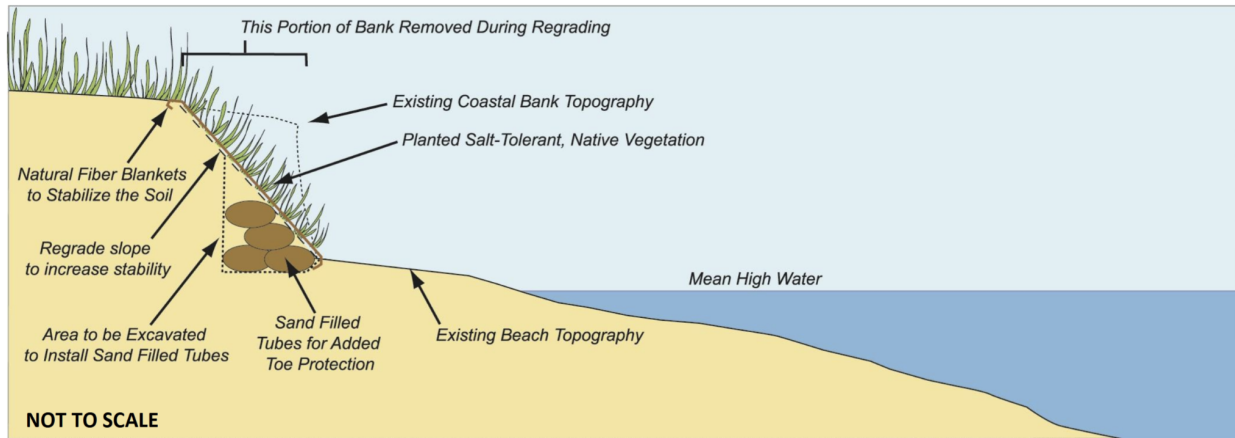
**Figure 7:** Example cross-sectional plan of a bank with an engineered core of soil lifts from *Living Shorelines in New England: State of the Practice*.

Bioengineering options for this section of shoreline include encapsulated soil lifts or a living crib wall. Natural fiber blankets and coir logs can be used to establish and protect the toe of a series of terraces called soil lifts (Fig. 7). Vegetation is then planted in the flat areas of each terrace for long term stability. For coastal areas, a double layer of fiber blankets around each soil lift is recommended to prevent damage if debris hits the lifts during a storm. Encapsulated soil lifts, also called engineered bank cores, are considered suitable for high energy coastal environments.
