# OUR SHORE Coastal Erosion Assessments and Site Reports: Long Island

Emma Polhemus, Shore Corps Steward, Maine Conservation Corps & Island Institute  
May 2026

## **OUR SHORE Coastal Erosion Assessments and Site Reports: Long Island**

Alongside community partners and Island Institute staff, the Shore Corps Steward visited three coastal sites on Long Island in April 2026 to complete OUR SHORE Assessments of coastal erosion. The following report documents the results of these assessments along with recommended erosion management actions that align with OUR SHORE guidelines and prioritize nature-based and hybrid strategies.

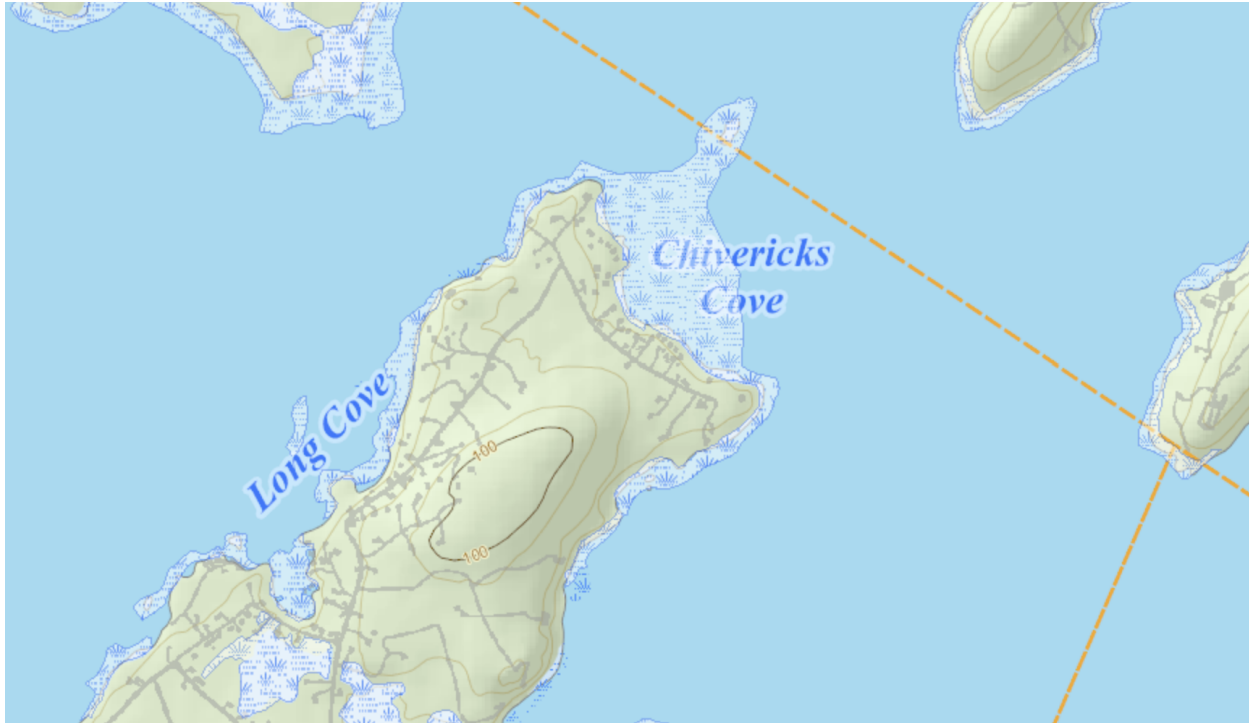
**Figure 7:** Beginning with Habitat map of the East End showing National Wetland Inventory areas (white and blue pattern).

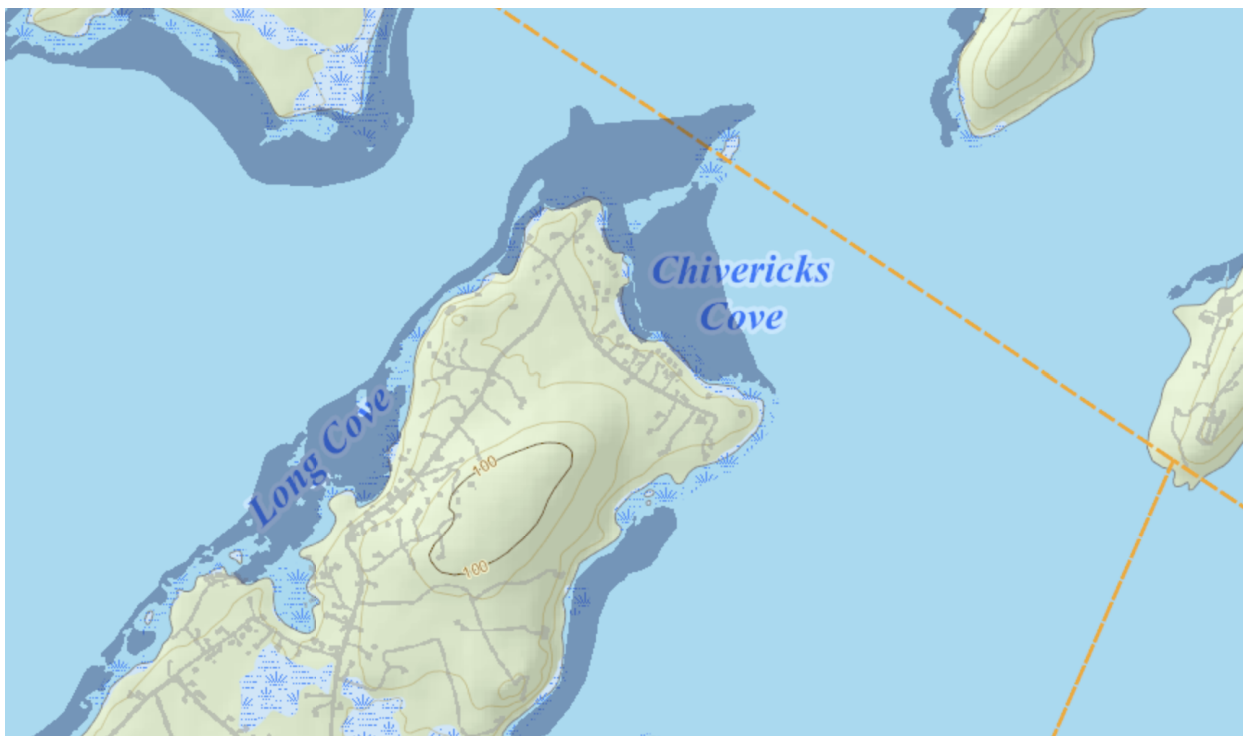
**Figure 8:** Beginning with Habitat map of the East End showing Tidal Waterfowl and Wading Bird habitat areas.

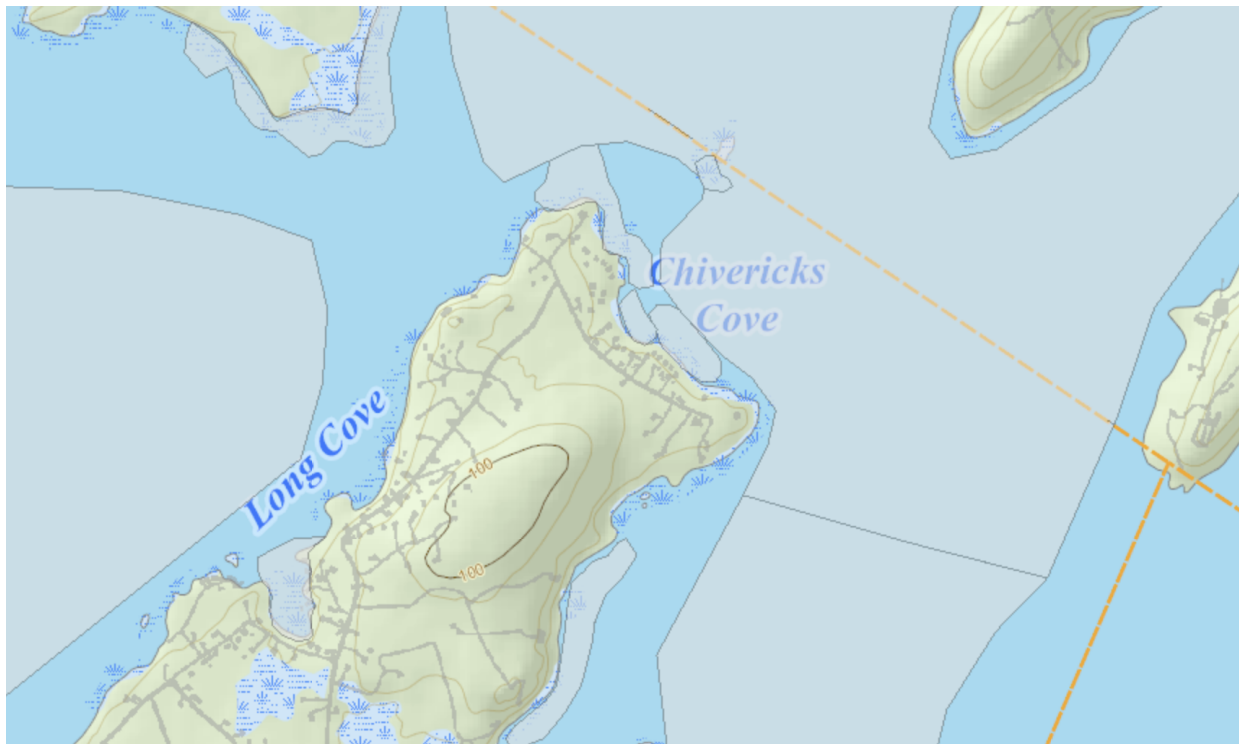
**Figure 9:** Beginning with Habitat map showing shellfish beds for razor clams, sea scallops, and blue mussels.

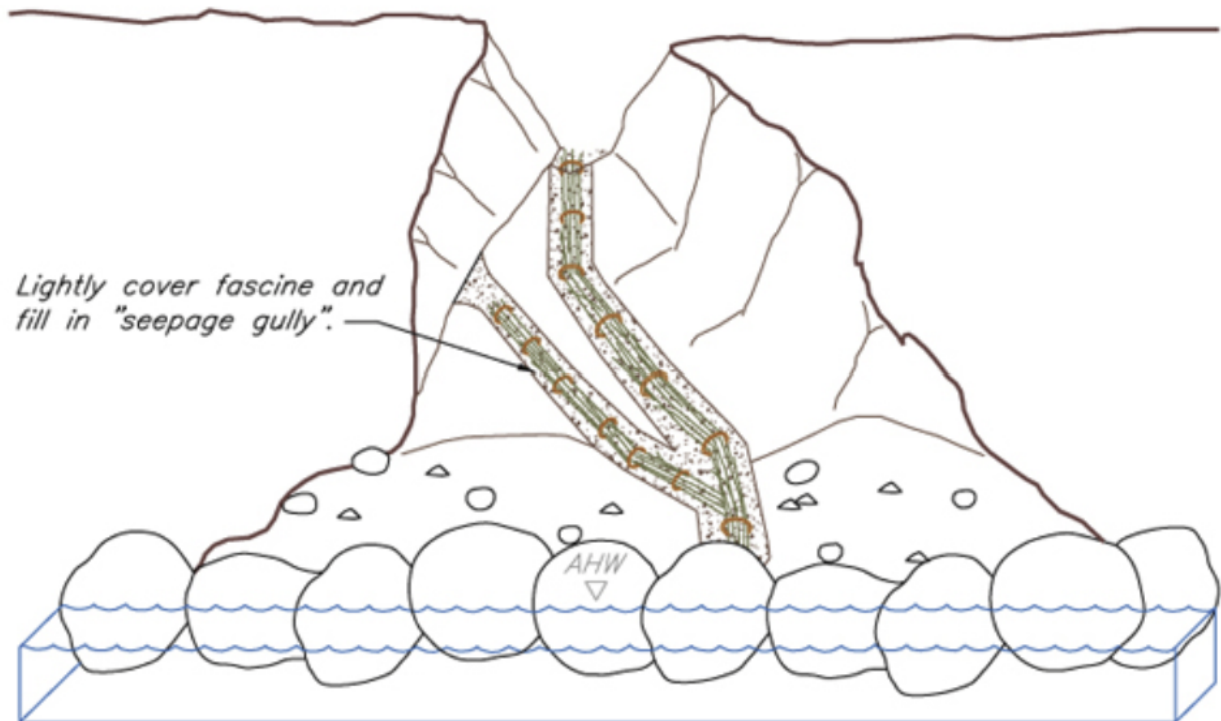
**Figure 10:** Diagram of a live pole drain to address groundwater seepage (Virginia Department of Transportation).

After land use contributions are addressed, groundwater management methods on the bank can be considered if groundwater oversaturation persists. One OUR SHORE recommended option is a live pole drain. This technique uses bundled live branch cuttings installed in trenches into the face of the bluff, providing a path for groundwater to drain from the bank (Fig. 10). The live cuttings will root and grow over time, helping to revegetate the bank and provide additional groundwater uptake.

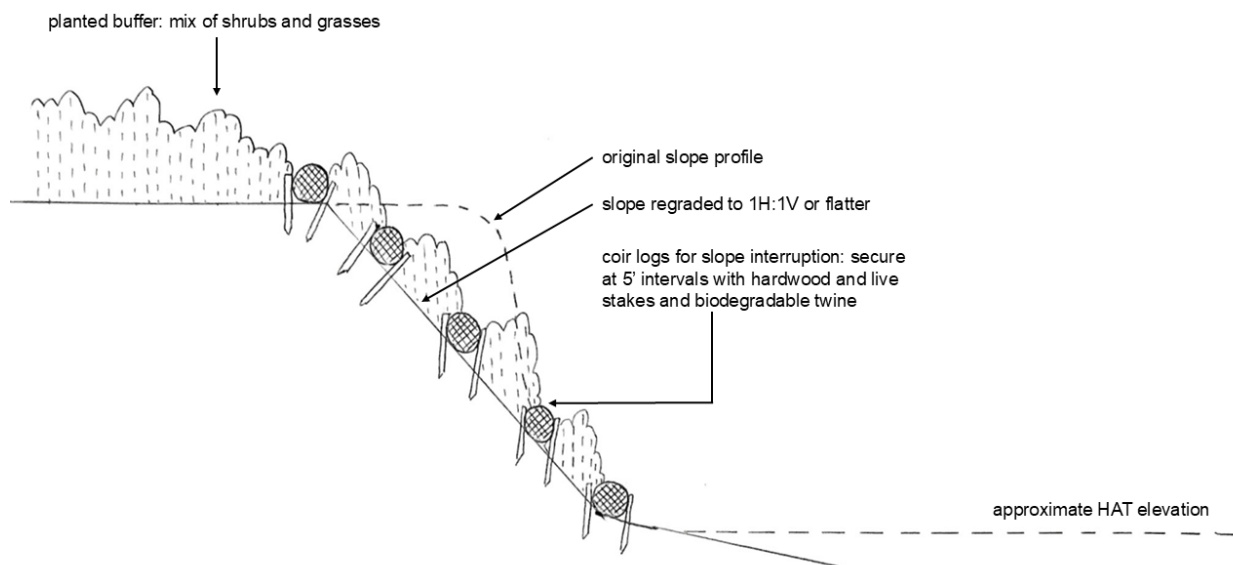
**Figure 11:** Example cross-section of slope regrading.

Regrading the bluff mimics the result of the bluff erosion cycle by cutting the steep slope into a more gentle grade (Fig. 11). After regrading, the shallower slope helps to dissipate wave energy and has a lower risk of slumping, since there is less weight from overlying soil over the slope toe. Slope grading should be combined with temporary erosion protection like erosion control blankets as well as planting of native vegetation as it exposes bare soil on the slope. While regrading projects are more costly than allowing the bluff to erode naturally, they provide more predictability and control compared to natural erosion.

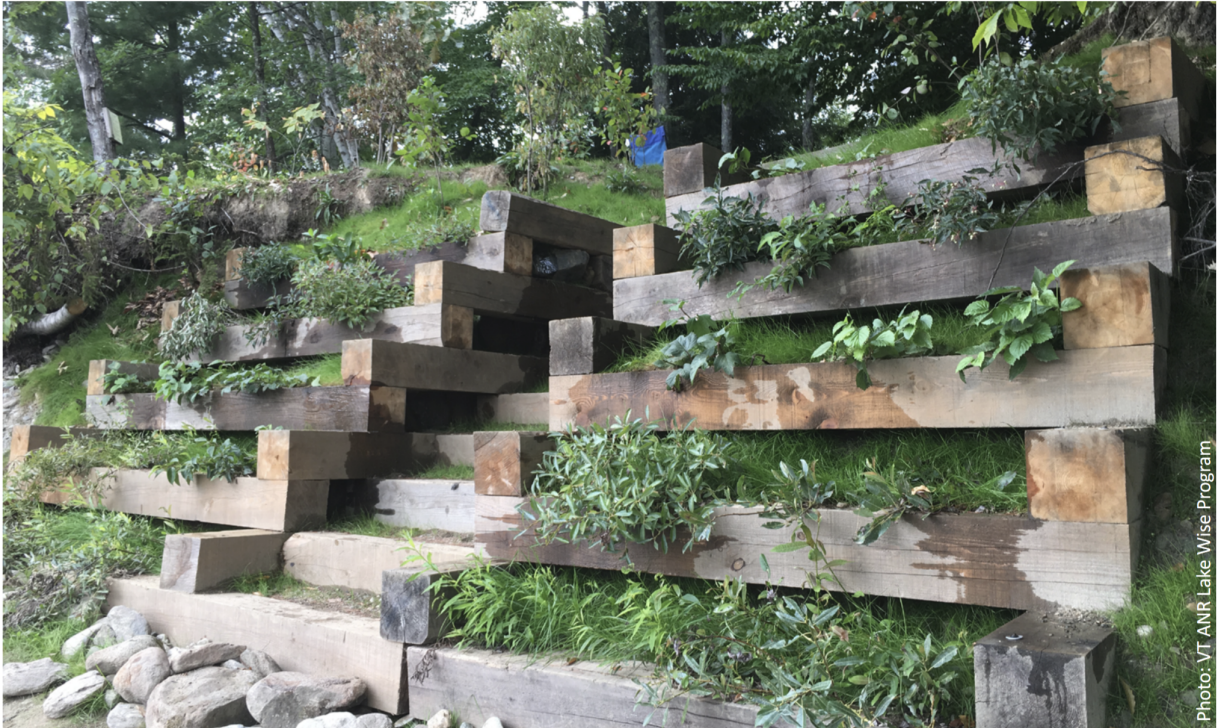
**Figure 12:** Example of a living crib wall from the Vermont Bioengineering Manual.

Lastly, structural stabilization of the toe could be installed. Since the majority of bluff erosion and instability occurs at the toe, OUR SHORE recommends targeting structural intervention to this area of the slope. Structural options following OUR SHORE best practices include living crib walls (Fig. 12) or vegetated riprap (Fig. 13), both of which incorporate structural support from timber beams or stone with native vegetation. Either of these structures can be designed to provide toe protection while maintaining a vegetated slope higher on the bluff. Because there is a potential landslide risk identified at the site, slope stabilization projects should be evaluated by a licensed geologist or geotechnical engineer.

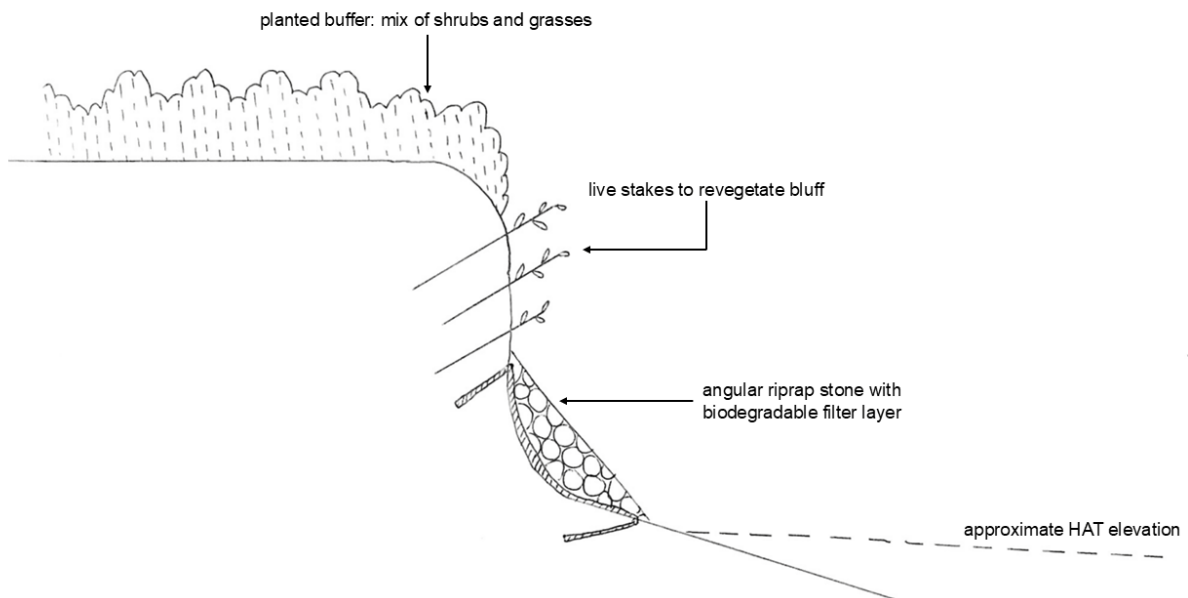
**Figure 13:** Example cross section of bluff stabilization using a riprap stone toe combined with revegetation of the upper bluff face and upland buffer.

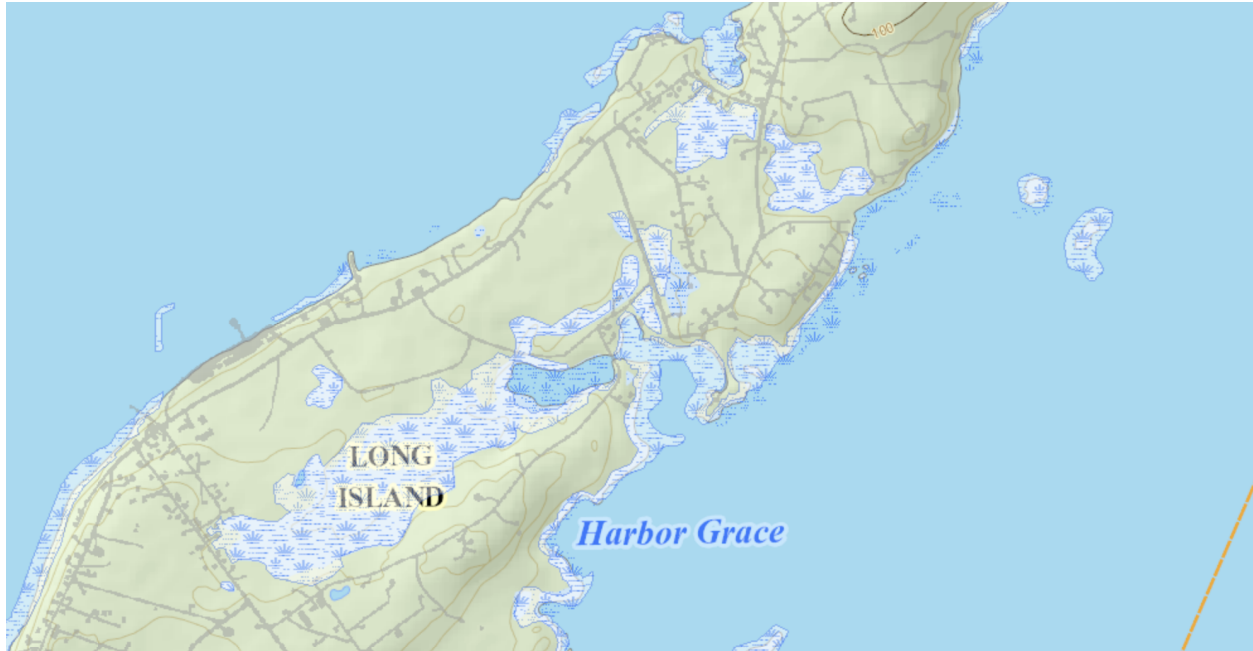
The freshwater shoreline to the west consists of a grassy bank approximately 2 ft wide along the edge of the roadway. The tidal shoreline to the east is a coastal bluff 8-10 ft in height. Riprap stone has been placed along most of the tidal shoreline near the culvert. The shoreline is on a small bay with a large, shallow tidal wetland. This coastal wetland contains salt marsh and mudflat areas. The wetland is mapped in the National Wetland Inventory (Fig. 7) and hosts Tidal Waterfowl and Wading Bird habitat and softshell clam beds (Fig. 8).

**Figure 7:** Beginning with Habitat map showing National Wetland Inventory areas (white and blue pattern).

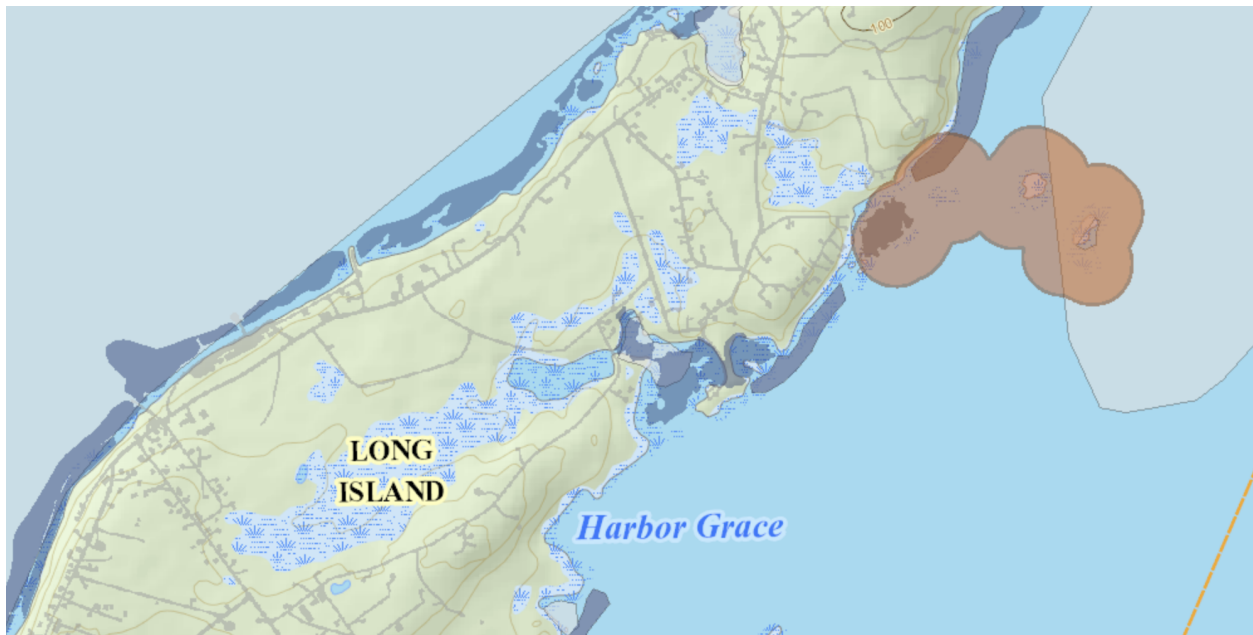
**Figure 8:** Beginning with Habitat map showing moderate value Tidal Waterfowl and Wading Bird habitat (dark blue) and softshell clam beds (light blue).

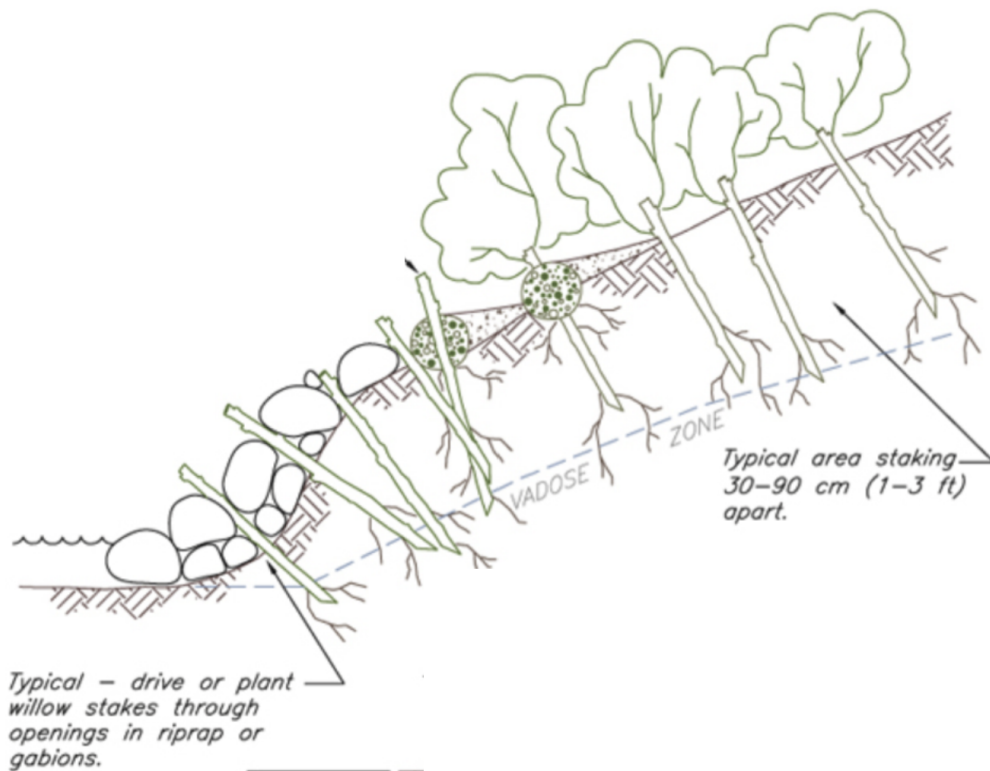
**Figure 9:** Example placement of live stakes into riprap (Virginia Department of Transportation).

Adding vegetation and considering options to add a filter layer are recommended to make the existing riprap design more effective and more resilient to future storms. The structure and root systems of plants growing within riprap help hold the stones in place on the soil of the bank. This will limit movement and downward slumping of the stones that could leave higher areas of the bank exposed. The roots also act as a filter layer to help trap sediment and prevent soil from being washed out. Live staking is a simple and effective method of adding vegetation to existing riprap, as the stakes can be pushed through gaps in the stones into the underlying soil (Fig. 9). Salt tolerant plants should be used, especially in areas that may experience salt spray or tidal inundation. Adding vegetation may not be possible on lower sections of the bank that are frequently submerged at high tide. Adding a filter layer like fine gravel or a natural fiber erosion control blanket is also beneficial for increasing riprap's durability, but can be difficult to add riprap that is already in place. If modifications to the riprap are made during FEMA-funded repairs, the full OUR SHORE guide provides information on selecting filter layers that support vegetation and long-term resilience.

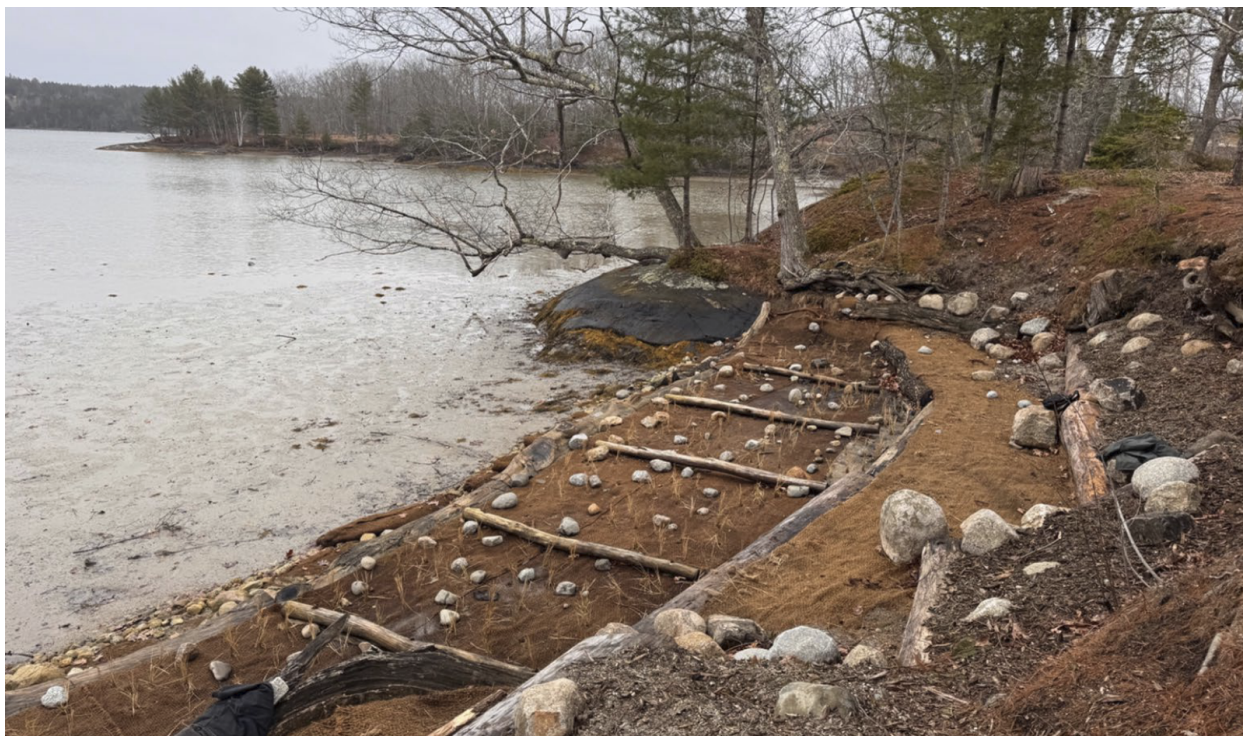
**Figure 10:** Example of a log sill installed for marsh restoration. (Photo from Treyball & Bernacki, 2025).

Healthy salt marshes provide protection from erosion by slowing down storm surges and buffering wave energy. The salt marsh patches at the Fern Ave site can be protected or extended as part of an erosion mitigation plan. Protecting existing marsh vegetation from trampling by designating a foot path to access the shoreline is a simple and cost-effective option. When possible, docks and boats should also be stored away from salt marsh vegetation on stable upland areas. Active salt marsh enhancement or creation through planting new salt marsh vegetation, supplementing sediment supply, or incorporating marsh sills has also been an effective component of living shoreline designs in Maine (Fig. 10).

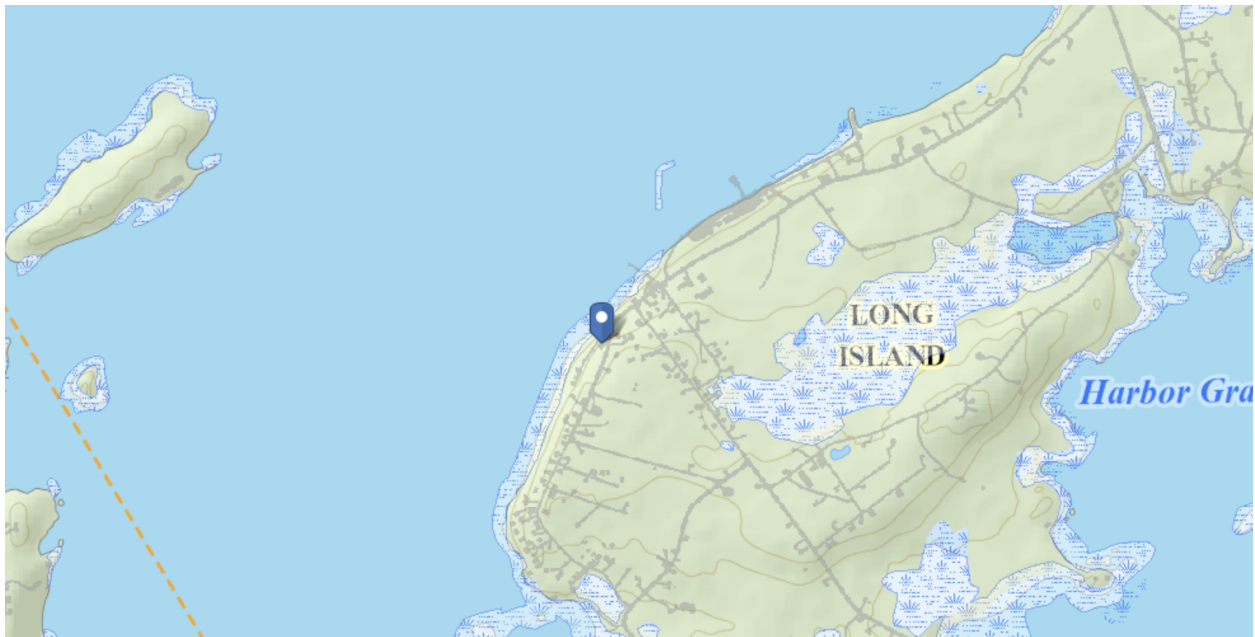
**Figure 6:** Beginning with Habitat map of the VFW Hall site showing National Wetland Inventory areas (white and blue pattern).

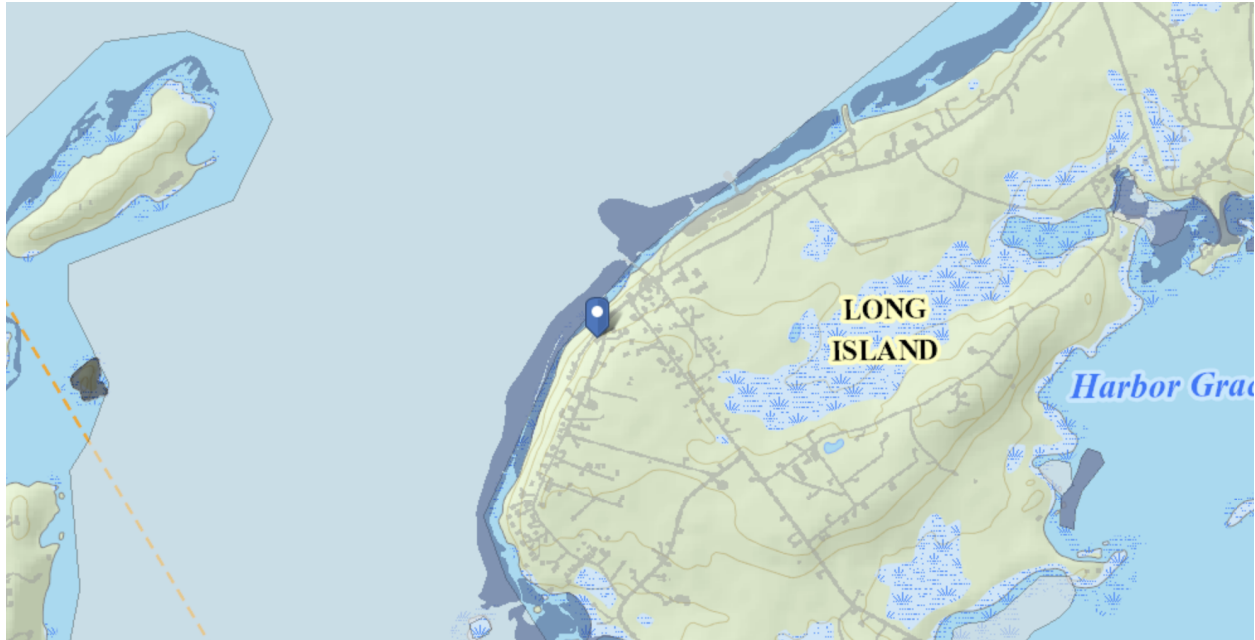
**Figure 7:** Beginning with Habitat map of the VFW Hall site showing Tidal Waterfowl and Wading Bird habitat (dark blue) and sea scallop beds (light blue).

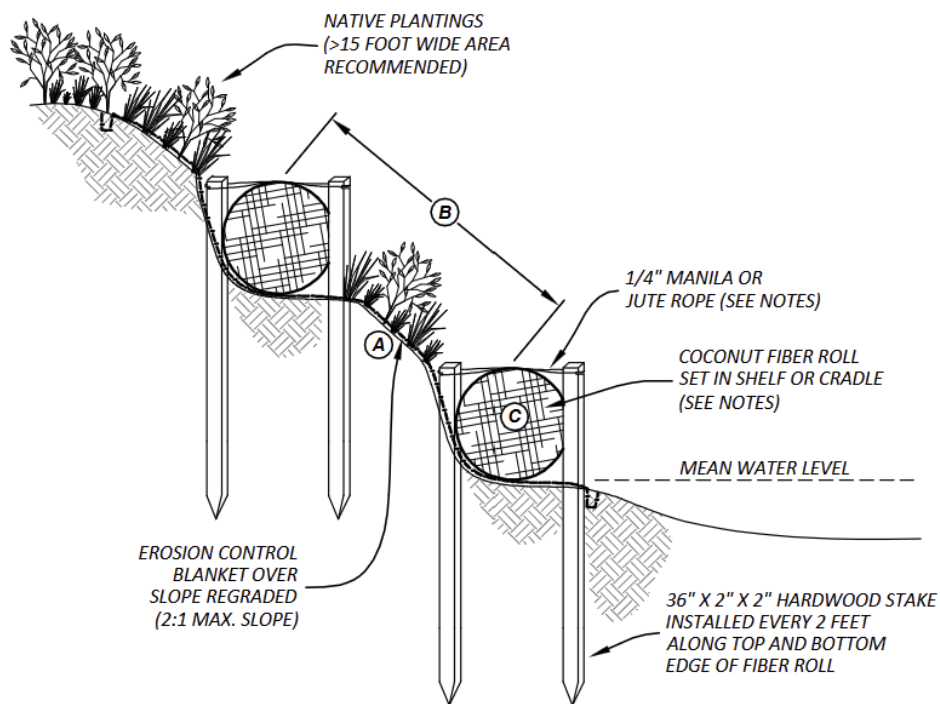
**Figure 9:** Example cross-section of coir logs installed for slope interruption from the Vermont Bioengineering Manual.

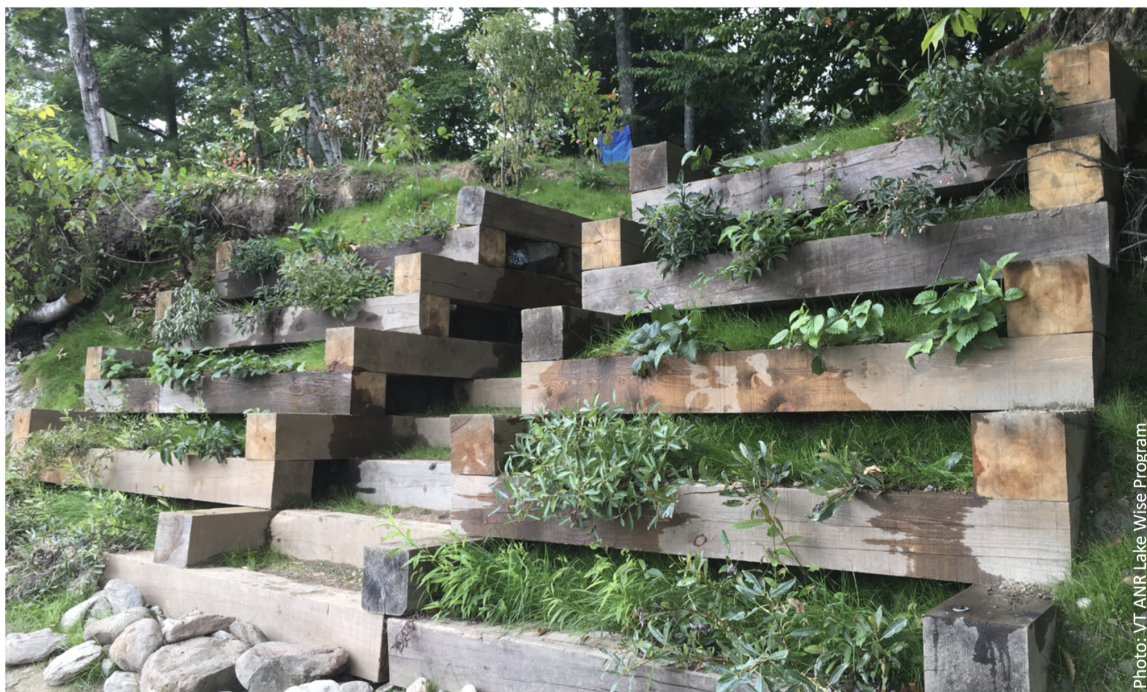
**Figure 10:** Example of a living crib wall from the Vermont Bioengineering Manual.

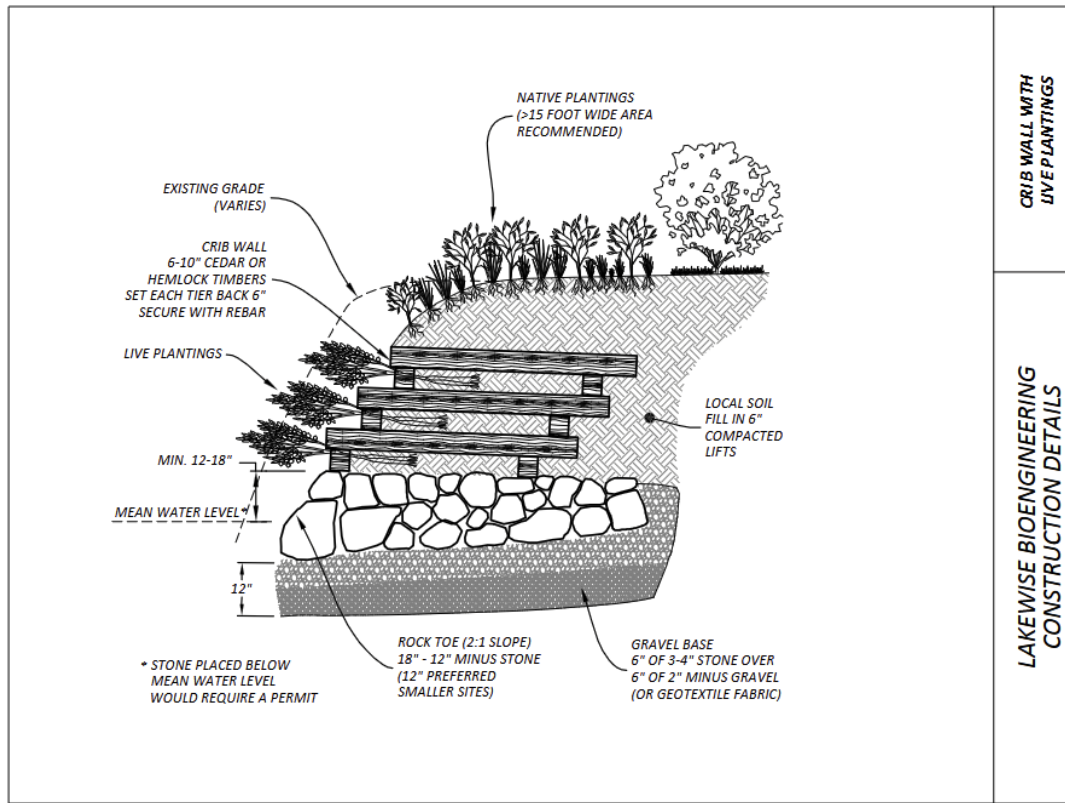
**Figure 11:** Example cross-sectional plan of a living crib wall from the Vermont Bioengineering Manual.

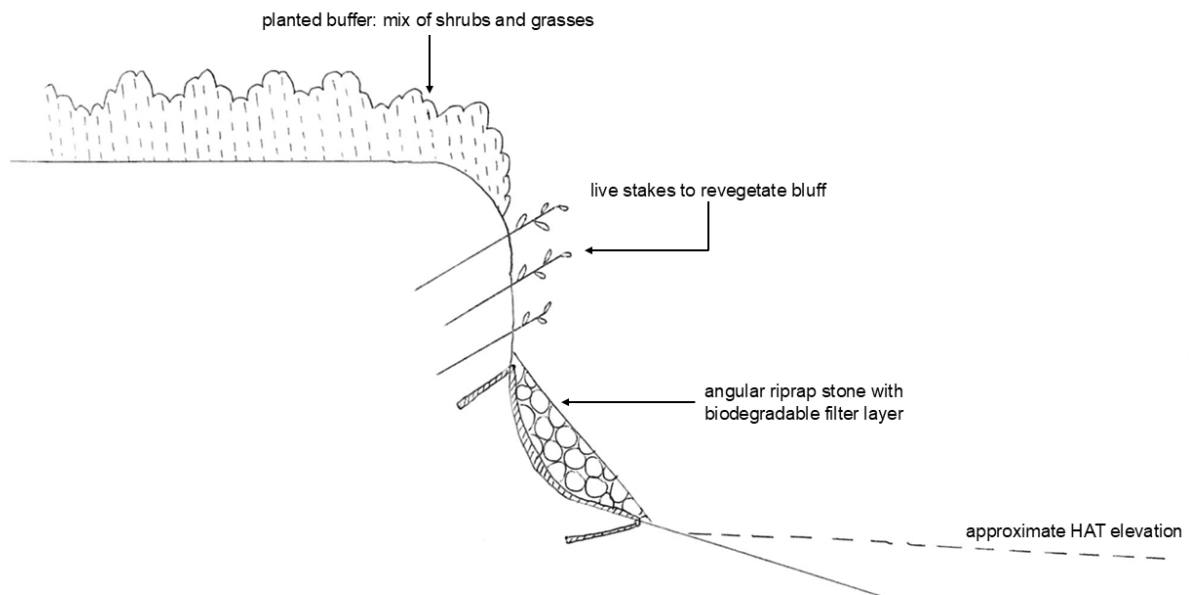
**Figure 12:** Example cross-section of slope stabilization using a riprap stone toe combined with vegetation on the bluff face and buffer.
